David J. Johnson  
Director  
Service Engineering Operations  
Ford Customer Service Division

November 19, 2018

**SUBJECT: Customer Satisfaction Program 18B35**  
Certain 2017 and 2018 Model Year Ford GT Vehicles  
Special Service Update

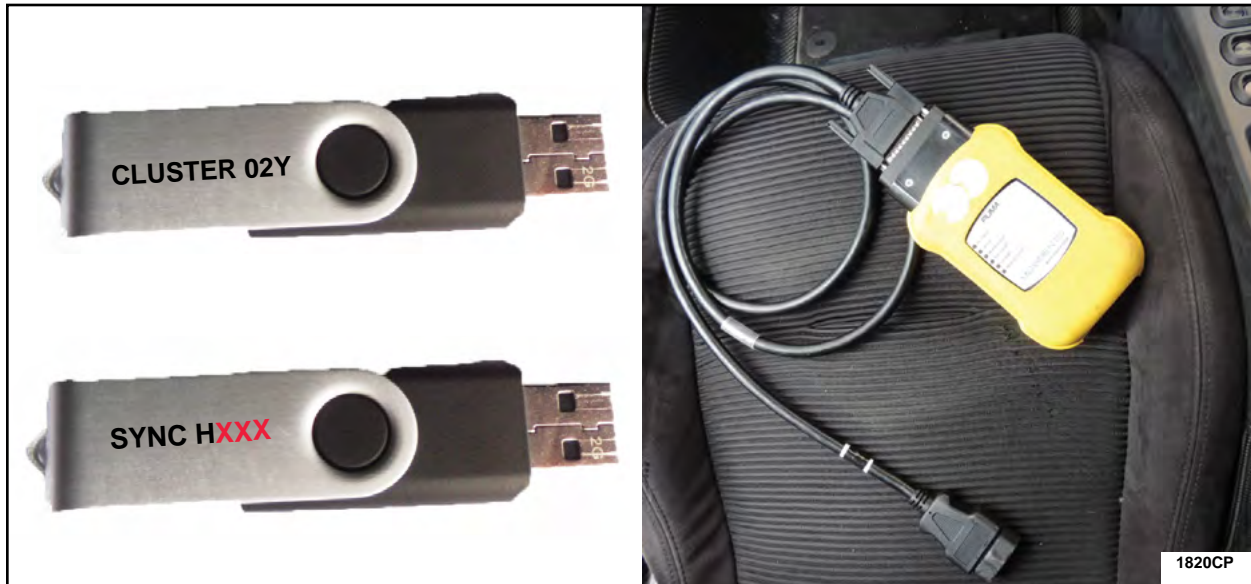
FIGURE 1

**NOTE:** The last 3 digits on the SYNC USB flash drive should match the last 3 digits of the vehicle VIN.
