GROUP Product Improvement	MODEL 2015MY Sorento (XMa) Optima (QF) 2014-2015MY Optima (TF) Sportage (SL)
	NUMBER PI1802W/X (Rev 1, 11/08/2018)	DATE October 2018
PRODUCT IMPROVEMENT CAMPAIGN		
SUBJECT: ENGINE REPLACEMENT INSTRUCTIONS FOR DTC P1326 (PI1802W/X)

This bulletin provides information related to the Technical Service Bulletin previously published in July 2018 ([PI1802](#), Rev 2, 09/24/2018) titled “Knock Sensor Detection System - ECU Logic Improvement”. Specifically, this bulletin provides instructions on which procedures to follow if, after installation of the KSDS, any one of the subject vehicles below returns to the dealer with Diagnostic Trouble Code (“DTC”), P1326.

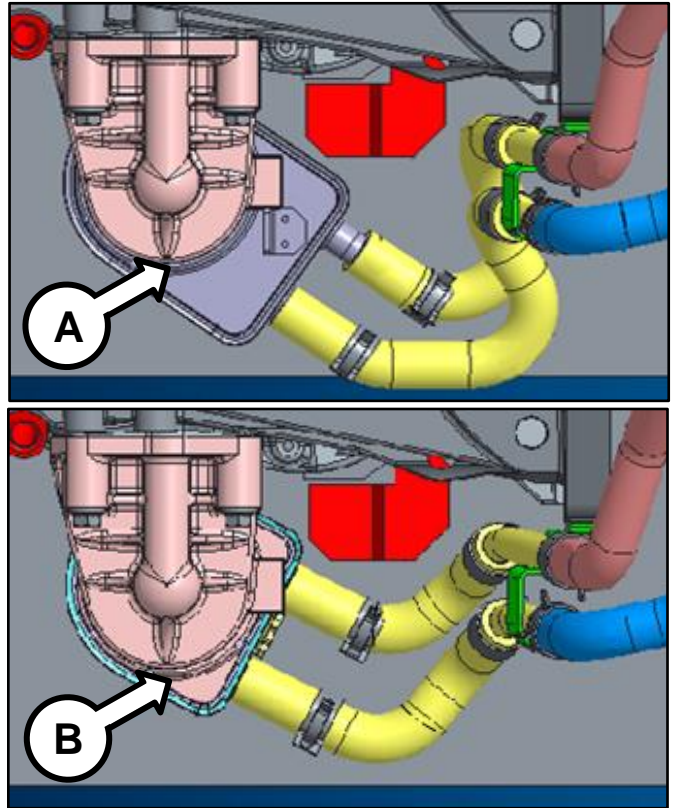
New engines may be supplied with a different oil cooler. Use steps below to determine the need for a replacement oil cooler tube assembly.

- If the new engine's (bigger) oil cooler (A) does not match the old engine's (smaller) oil cooler (B), replace the oil cooler tube assembly with the improved part. See parts table on page 15.
- If the new engine's (bigger) oil cooler (A) matches the old engine's (bigger) oil cooler (A), reuse the old engine's oil cooler tube assembly.
- If the new engine's (smaller) oil cooler (B) matches the old engine's (smaller) oil cooler (B), reuse the old engine's oil cooler tube assembly.
