CAMPAIGN BULLETIN

Rear Sonar Dealer Inventory

Reference: PM837
Date: November 7, 2018

PM837 – KICKS (P15) REAR SONAR

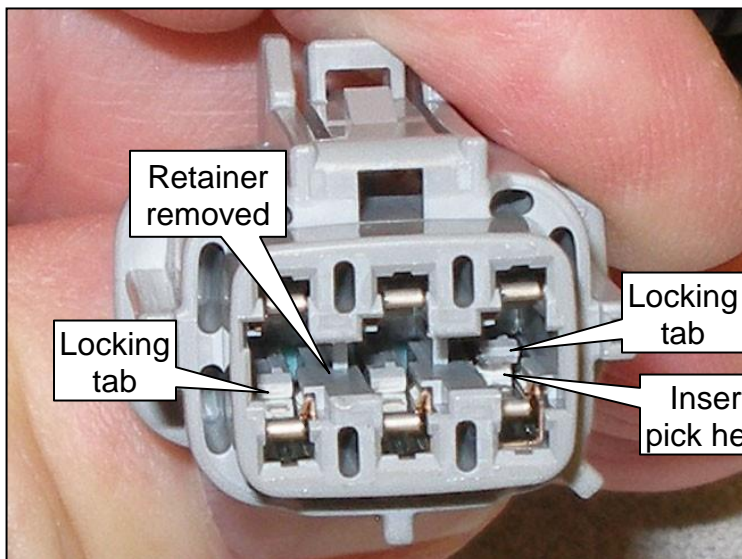
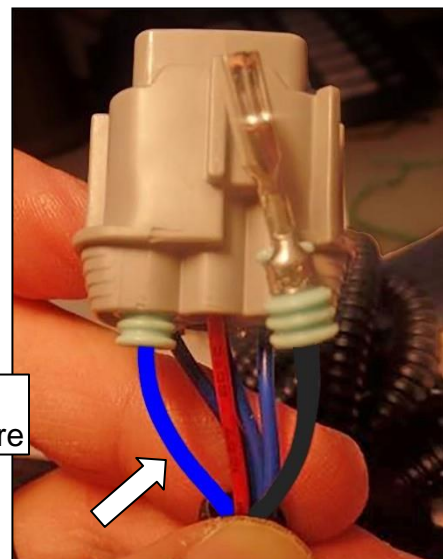
13. Remove the terminals of the **blue** and **black** wires from the combination lamp harness connector.
 - Using a suitable pick, pry inward on the locking tabs, and then pull out the wires from the harness side of the connector. A flashlight may help see the tabs better.
 - The right side locking tab in Figure 7 is shown in the unlocked position.

NOTE: The color of the **blue** wire in Figure 8 is enhanced for easier viewing. Normally, it is the same shade of **blue** as the other **blue** wires.

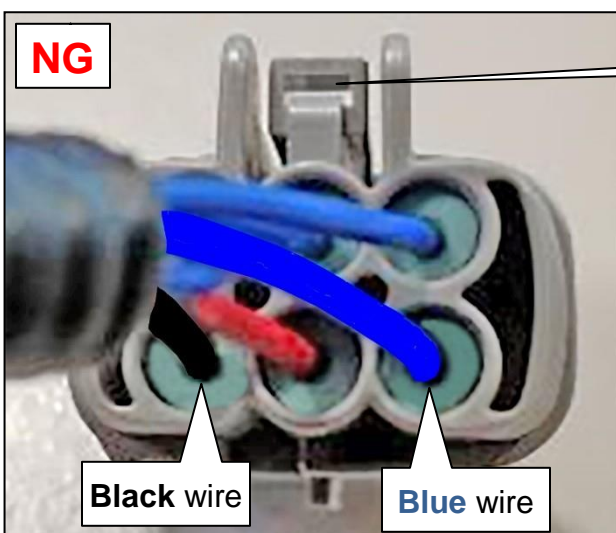
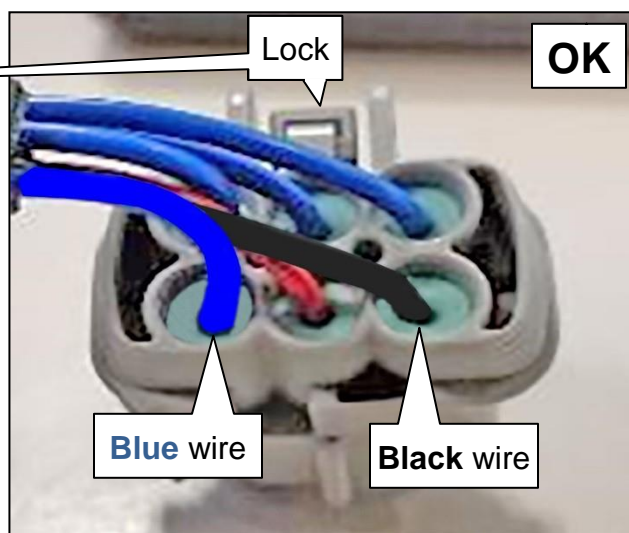
NOTE: The color of the **blue** wire in Figure 9 and Figure 10 is enhanced for easier viewing. Normally, it is the same shade of **blue** as the other **blue** wires.

14. Insert the **black** wire where the **blue** wire was positioned (Figure 9, 10).

15. Insert the **blue** wire where the **black** wire was positioned (Figure 9, 10).

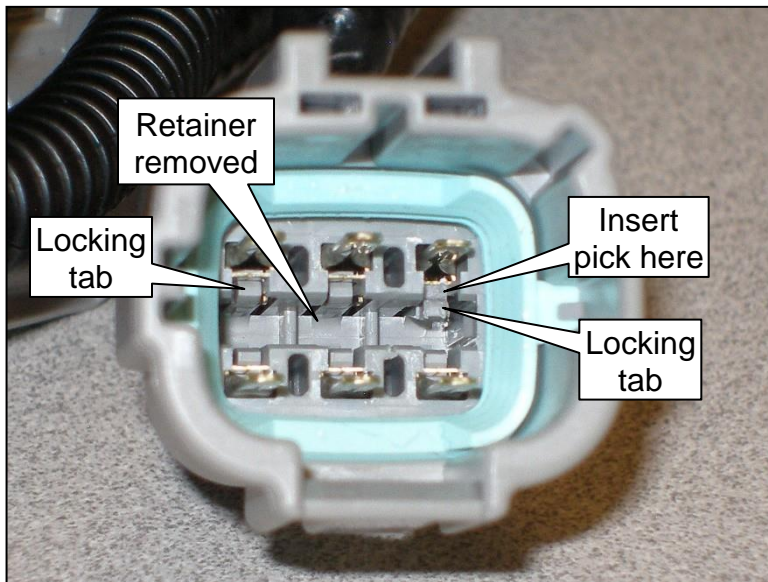
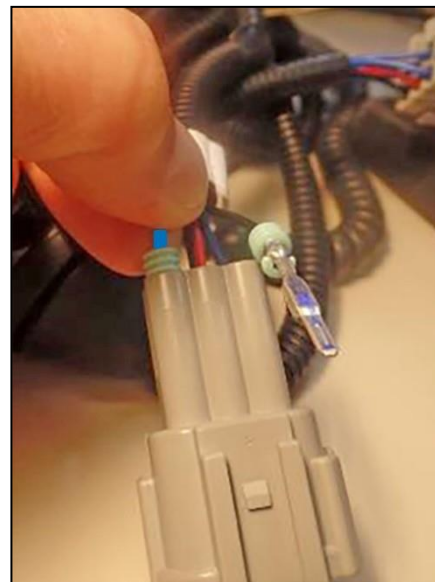
- Using a suitable pick, pry inward on the locking tabs, and then pull out the wires from the harness side of the connector (Figure 18, 19). A flashlight may help see the tabs better.
- The right side locking tab in Figure 18 is shown in the unlocked position.
