# SERVICE BULLETIN

Classification: BT18-016	Reference: NTB18-074	Date: November 6, 2018
-----------------------------	-------------------------	---------------------------

## 2018 KICKS; HIGH-MOUNTED STOP LAMP REMOVAL AND INSTALLATION

**APPLIED VEHICLES:** 2018 Kicks (P15)

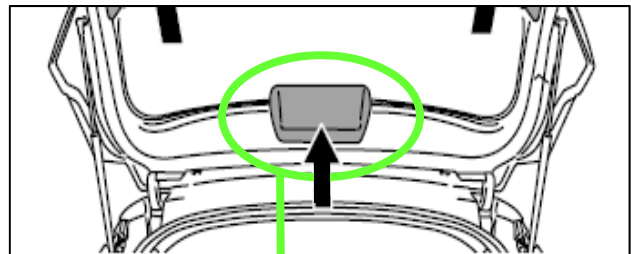
1. Open the back door.
2. Locate the high-mounted stop lamp assembly (stop lamp).
  - See Figure 1 and Figure 2.

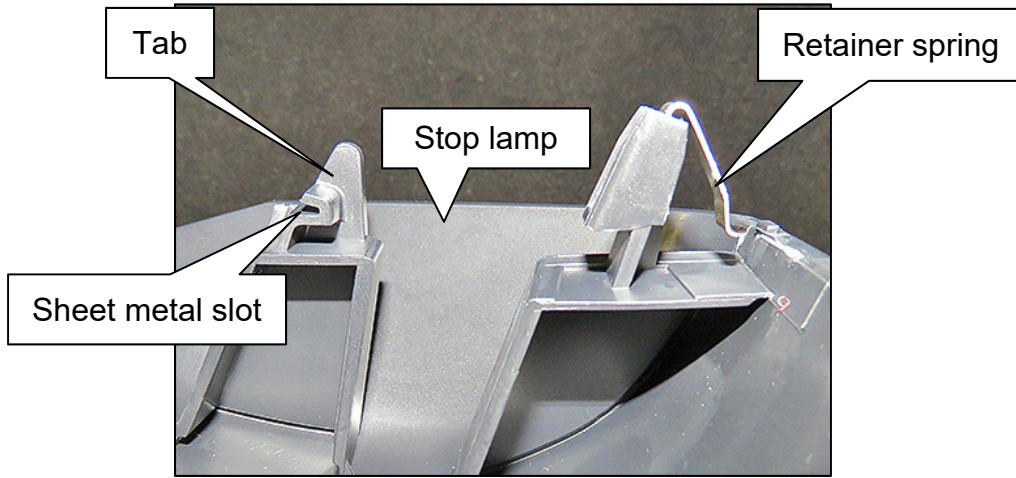
- Figure 3 shows the bottom of the stop lamp, and is an example of a tab and a retainer spring.
- Having a visual of the tabs and retainer springs will help in the next steps.

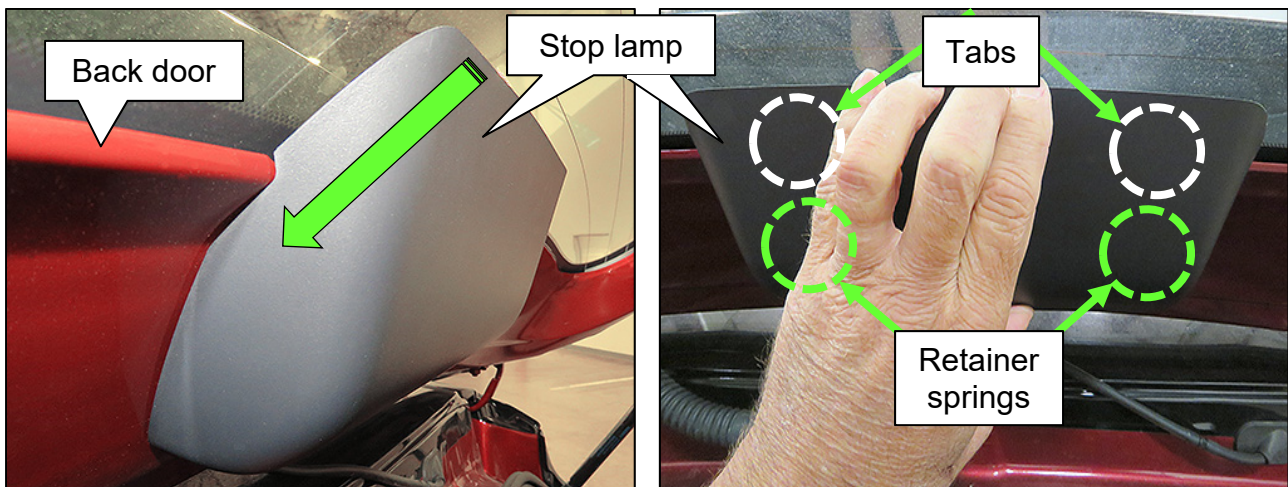
**NOTE:** Approximate location of the tabs and retainer springs are shown.

3. With the tips of your fingers, carefully push the stop lamp in the direction shown in Figure 4 (parallel to the back door).
- Push the stop lamp with enough force to compress the retainer springs and disengage the tabs.
