CAMPAIGN BULLETIN

Fuel Feeder Tube Clip Dealer Inventory

Reference: PC669

Affected Models/Years:	Affected Population:	Dealer Inventory:	SERVICE COMM Activation date:	Stop Sale In Effect
MY2019 Altima (L34)	N/A	~15,800	November 21, 2018	YES

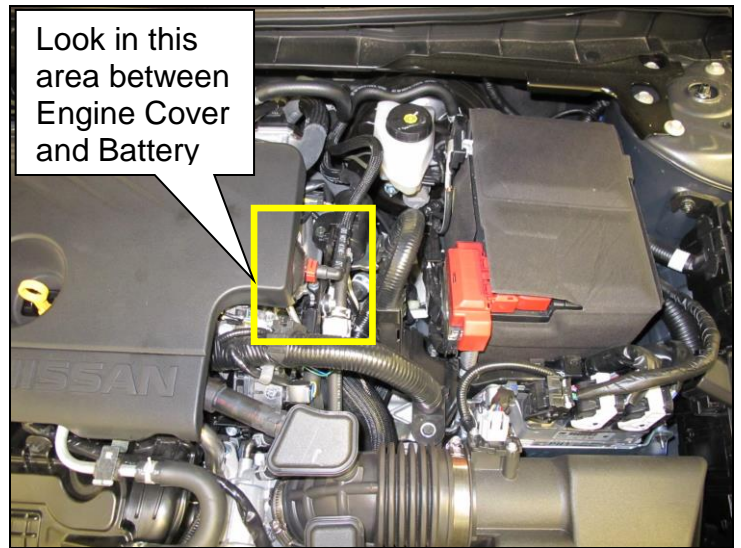
Figure 3

3. Locate Fuel Feed Tube Clip Area (Figure 3).

- Fuel feed tube clip is red in color. It is located in the yellow box

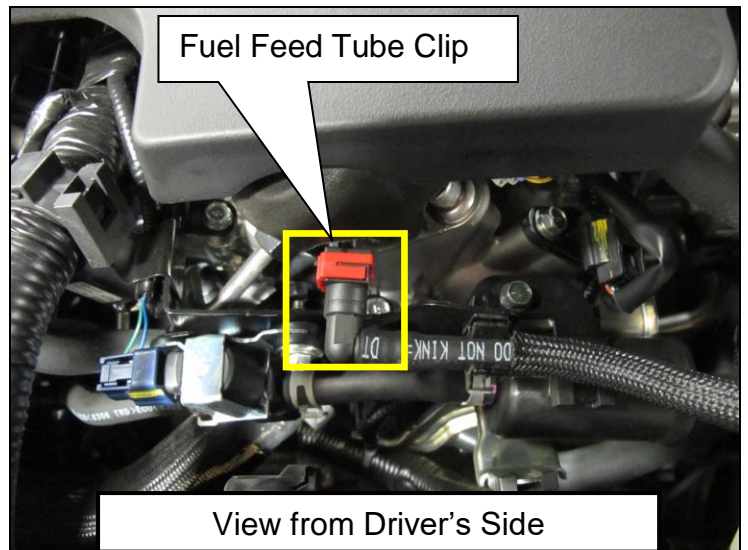
Figure 4

4. Locate Fuel Feed Tube Clip and prepare for inspection in "Step 5" (Figure 4).

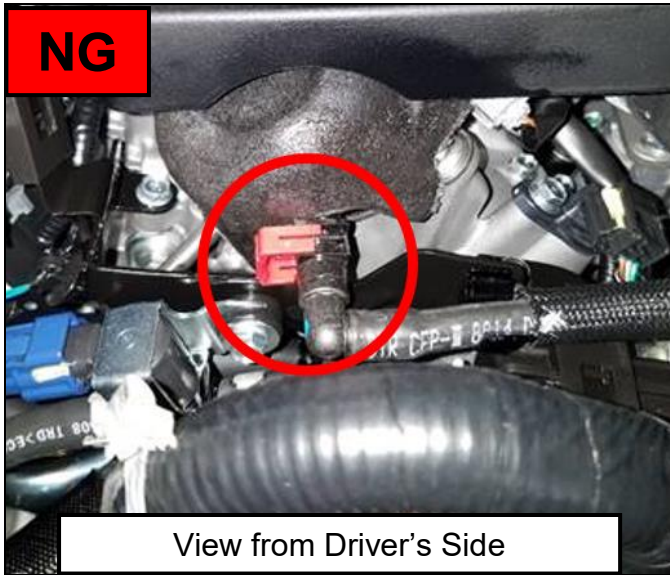
Nissan is issuing a quality hold to require dealers to inspect the Fuel Feeder Tube Clip position and confirm it is in the lock position on ~15,800 specific 2019 Altima vehicles identified in Service Comm. The clips may not be fully locked into place.

- If the "**Fuel Feed Tube Clip**" condition is secured similar to Figure 6 "**GOOD**" submit a warranty claim using OP Code PC6690 (See claims info), and release the vehicle. No further repair is needed.
- If the "**Fuel Feed Tube Clip**" condition is out (Not Fully Seated) similar to Figure 5 and/or 7, take a clear picture and follow the instructions in Step 6.

Email a clear picture of "NG" Clip condition similar to Figure 5, to nafgasupport@nissan-usa.com.

7. Repair Fuel Feed Tube Clip: Insert Fuel Hose until fully seated and push retainer clip until locked. Submit a warranty claim using OP Code PC6691 (See claims info), and release the vehicle (Figure 8).
