Technical Information Bulletin

E224

PACCAR MX Engines with Air in Fuel System after Secondary Fuel Filter Replacement

11/14/2018

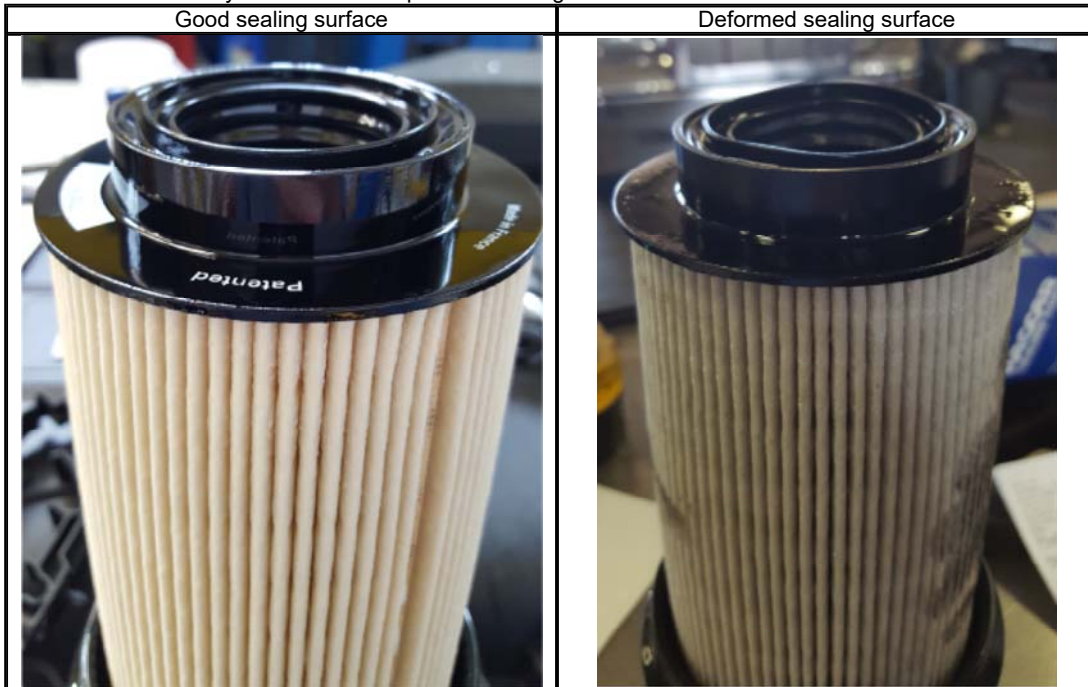
The engine may not start or have a lack of power immediately after replacing the secondary fuel filter. Some fuel filters have been found to be misassembled at the factory, causing a deformation in the sealing surface that allows supply fuel to bypass the seal into the return flow, preventing gallery pressure build-up. This results in the following symptoms after installing the secondary fuel filter:

1. Remove the secondary fuel filter and inspect the sealing surface.

2. If the sealing surface is found to be deformed, record the date code of the filter and file a warranty parts claim. The date code of the sample element shown below is 18109. If the filter is not deformed, perform normal troubleshooting.

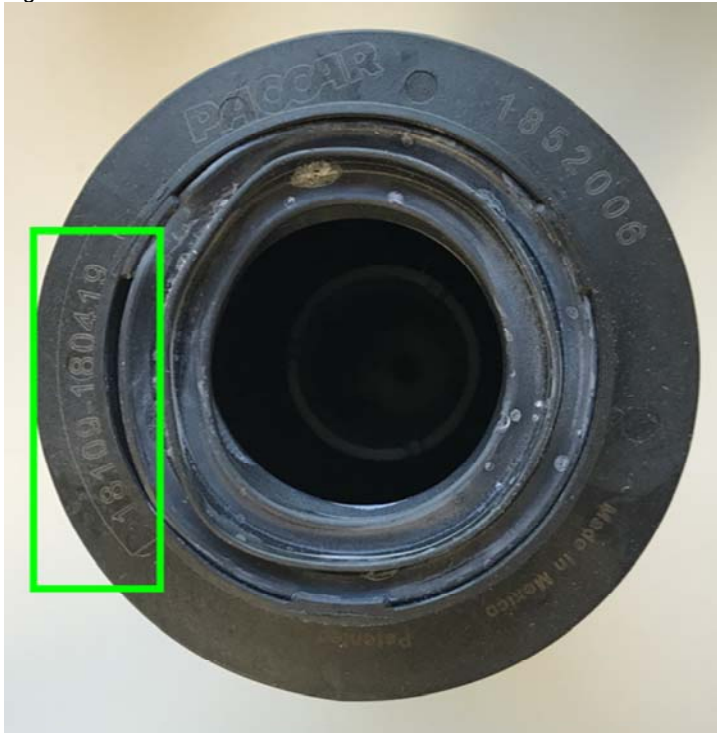
Figure 1 Date Code Location

Elements with date code 18141 or later are not suspect.
