HVAC - A/C Not Cooling - Refrigerant Leak

Market USA

| YEAR(S) | MODEL(S) | ADDITIONAL INFORMATION |
|---|---|---|
| 2018 | C-HR | |

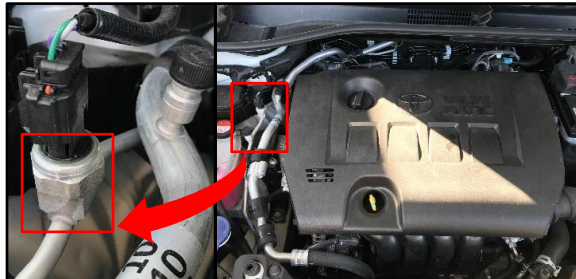
- D. Can ANY refrigerant leaks be located other than at the pressure sensor brazing area on the cooler refrigerant liquid pipe?
 - **YES** — This bulletin does NOT apply. Continue diagnosis using the applicable Repair Manual.
 - **NO** — Continue to step 2.

Due to the brazing process of the pressure sensor (as shown) to the cooler refrigerant liquid pipe, some refrigerant leaks are so small that they CANNOT be detected by conventional leak detection methods. In these cases, it is recommended to replace the cooler refrigerant liquid pipe.

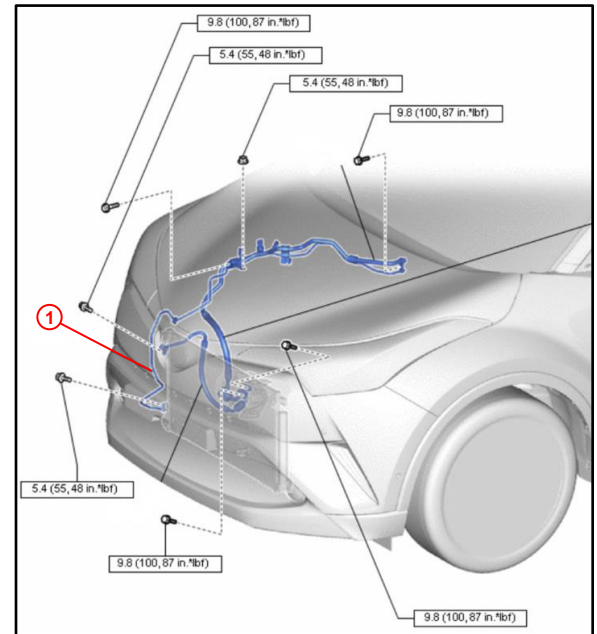
Figure 2.

| 1 | Cooler Refrigerant Liquid Pipe |

2. Recover refrigerant from the refrigeration system and replace the cooler refrigerant liquid pipe as shown.

A label is attached to the NEW cooler refrigerant liquid pipe.
