**Mack Model** Cabover , Conventional

**Volvo Model** Conventional

Title Tech Tool Returns Error Code 140 Failed To Run On-Vehicle Test; Programming, Calibration, Or Test Operations Fail In Premium Tech Tool (PTT), PTT Displays Control Unit Information Correctly - **US10+OBD13 And Newer Emissions, Common Model Year 2014 And Newer**

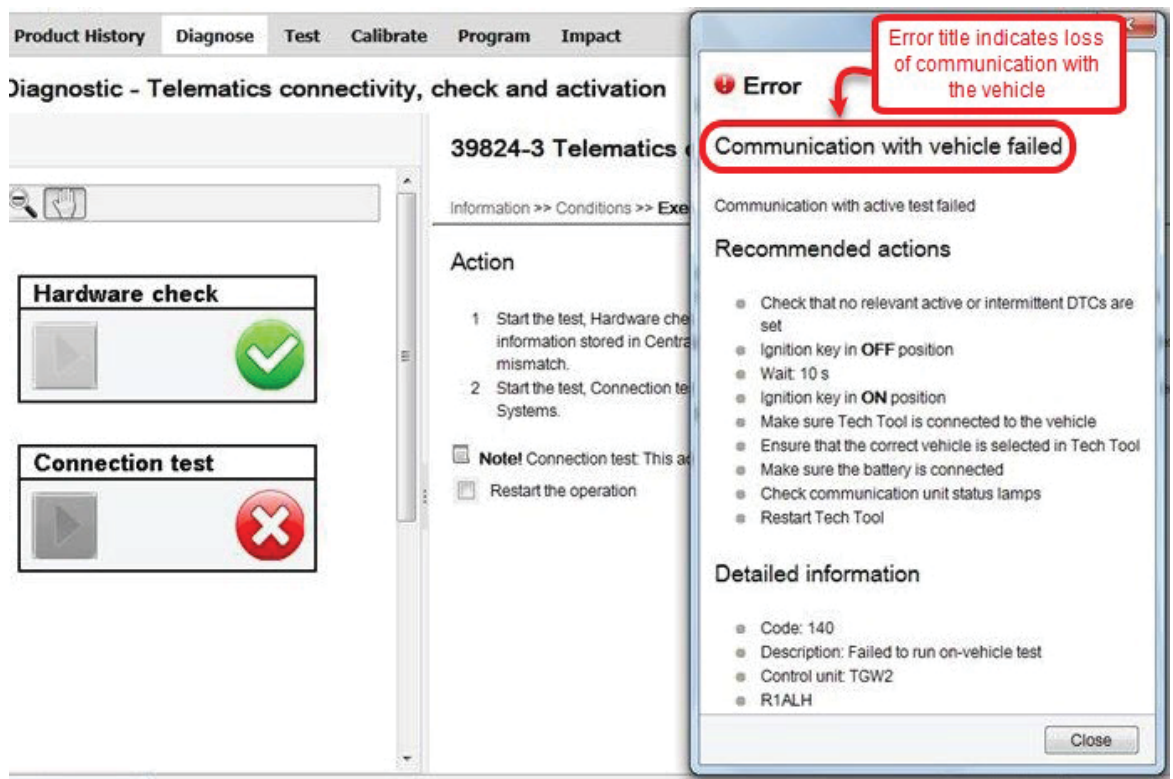
- In the example shown below, the flash screen in PTT looks like the ECU software is sending the error code because it is processing a Routine—R1ALH—that is being run when the failure is detected.

**Note:** This error may appear in a separate window or in the right pane of the PTT screen itself. The location of the error message will depend on the operation being performed.

- **The actual message is indicating loss of communication with the vehicle.**
- The recommended actions give a high level list of general items that could be tried to correct the issue.
- **If the recommended actions do not correct the problem** then the individual circuits to the specific ECU that is being tested should be investigated as outlined below.
