US 64227799-04

Topcase cannot be mounted

**Vehicles affected****E series**

K80 K81

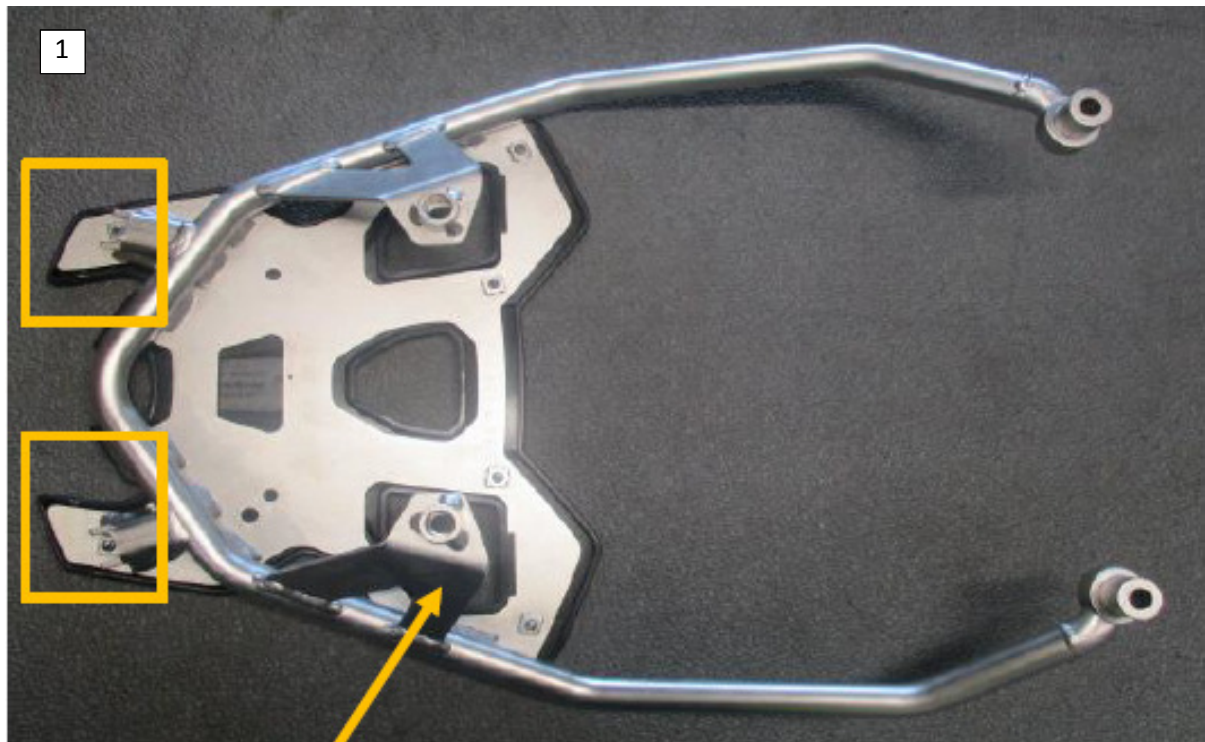
The tabs in image1 (yellow rectangles) which the plastic carrier plate mounts too can vary from the correct alignment.

1. Remove the luggage carrier; disassemble the plastic carrier plate
2. Clamp the luggage carrier tab (image 1) in a vice (image 4) and adjust it until the plastic carrier plate is nearly flush (image 3).
3. Measure dimension A (image 5) with a caliper. Dimension must be less than 12.2 mm.
4. Reinstall the carrier with new screws

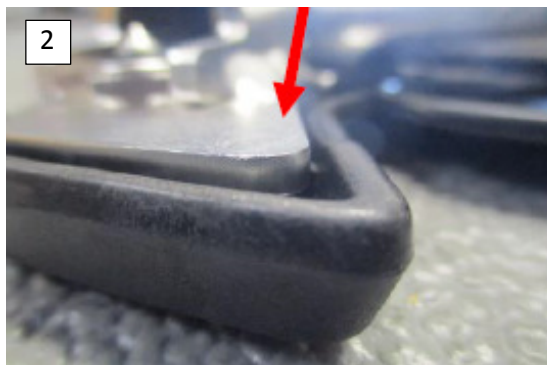
An incorrect alignment can be seen in image 2 (red arrow). The tab of the rear carrier is not flush with the plastic carrier plate.

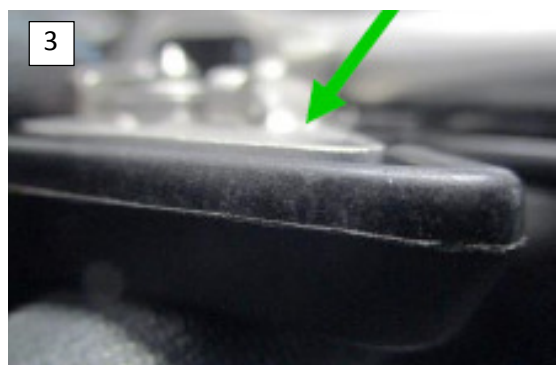
In image 3 (green arrow), the correct fit can be seen. The rear carrier is just about flush with the tab of the carrier.

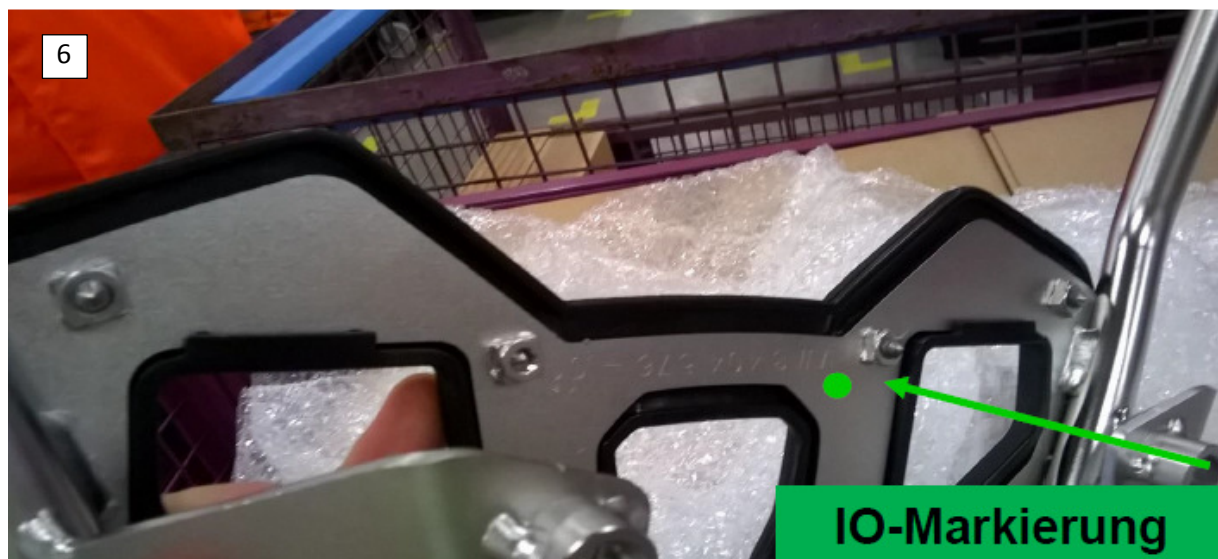
Luggage carriers already reworked from the factory are identified with a colored dot as pictured in image 6 (green arrow).
