WATER INJECTION SYSTEM WATER LEVEL TOO LOW

This Service Information bulletin replaces SI B12 22 16 **dated February 2018**

F82 (M4 GTS Coupe) with S55 engine

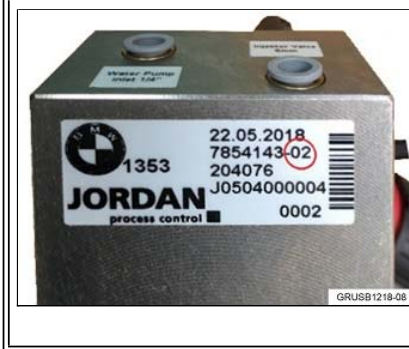
Note: The water injection valve block has been redesigned. The part number has not been changed but the optimized part can be identified by the “-02” revision index.

1. Perform the attached "M4 Water Injection Valve Block Replacement Procedure".
