SI B51 23 18  
Body Equipment

## SERVICE ACTION: RESEAL UNDERBODY BAFFLES

G05 (X5)
----------

This Service Action involves 1,279 G05 X5 vehicles produced from 7/9/2018-9/27/2018.

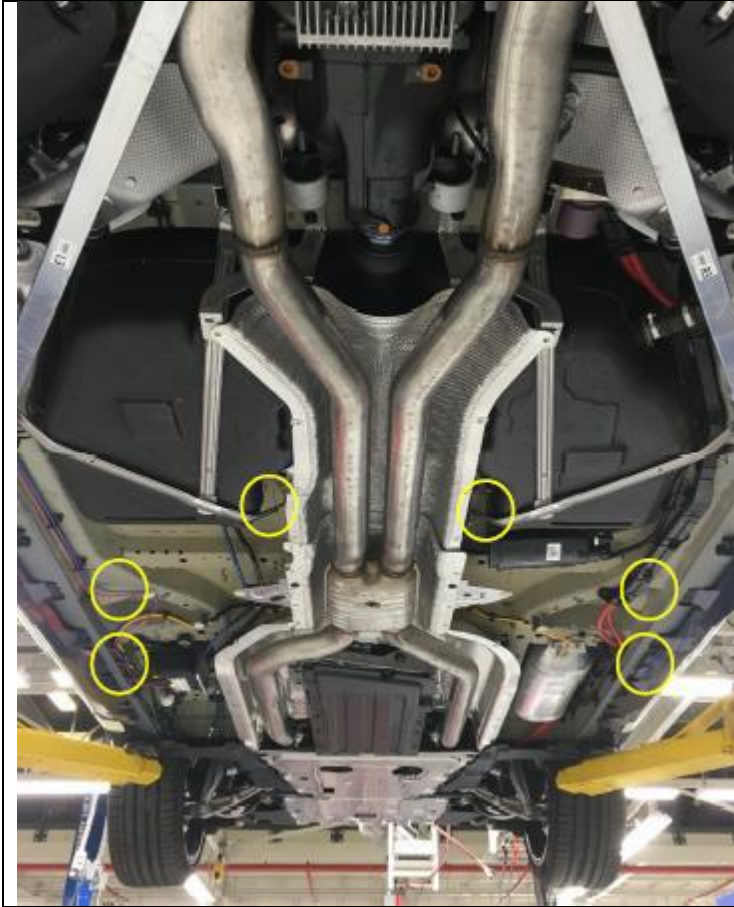
2. Once removed, take note of the circled areas shown to the left. These will be the areas where re-working will occur.

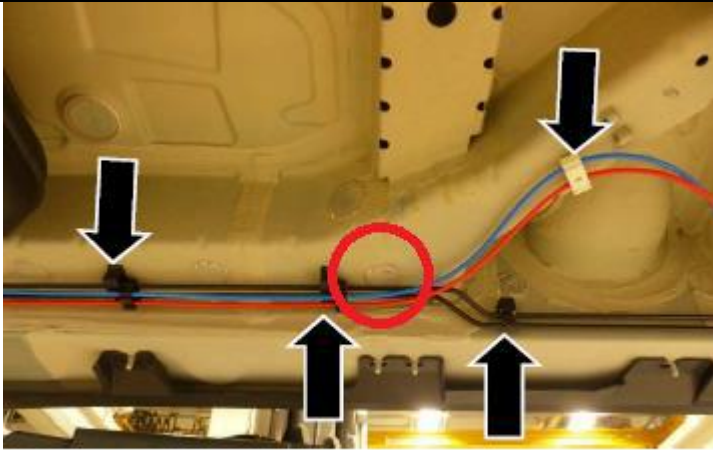
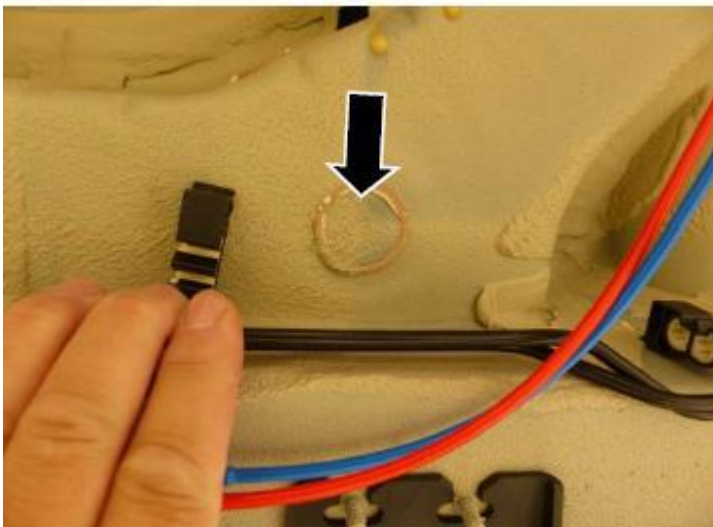
Note: The area shown in the photo to the left is in the area approximately below the driver and passenger seats.

The plug to be drilled is circled in red, and can be found in the same location on both sides of the vehicle.

3. In the areas shown to the left, relocate and secure any lines, wires, or hoses away from the work area of the body plugs to prepare the plugs to be drilled.

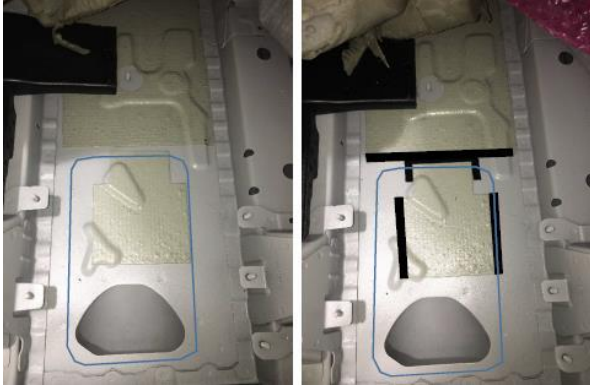
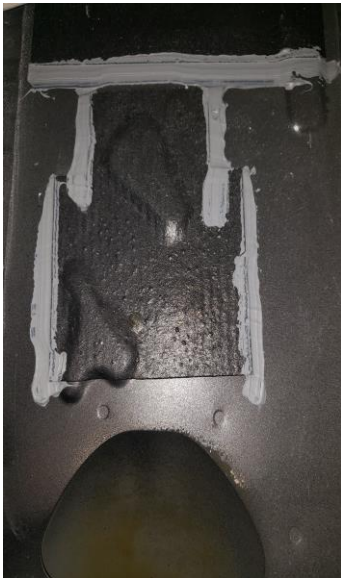
22. The seal at the base of the subwoofer may interfere with the sound absorbing pad attached to the floor, causing improper sealing of the subwoofer. The sharp edges of the sound absorbing pad should be smoothed to ensure proper sealing.

The photo to the left indicates the area of the sound absorbing pad that should be smoothed using body seam sealer.

Using Body seam sealant **PN 83 42 2 409 985**, smooth and taper the edges of the sound absorbing material to the floor. A photo to the left demonstrates the finished tapering.
