EXTERIOR MIRRORS GO TO RANDOM POSITION

This Service Information bulletin supersedes SI B51 29 16 **dated December 2016**.

F48 (X1)

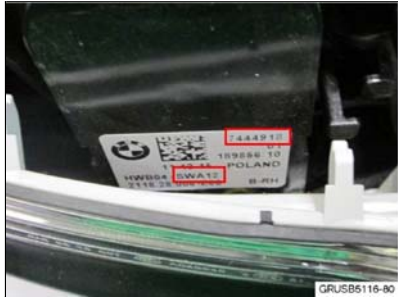
Situation A- Mirror motor electronics module software version. (Only applies to vehicles produced up until March 2016)

<ol style="list-style-type: none"> 1. Verify the customer's complaint as described by the situation statement (A). 2. Remove the cover of either the passenger's or driver's side rear view mirror and note the SWA version as shown. 3. If the SWA version is lower than SWA12, replace both mirror electronics modules and reprogram the vehicle with the latest version of ISTA/P. Refer to RA 61 31 ... "Removing and installing or replacing left and/or right mirror electronics". 4. If the SWA version is already SWA12 or higher, do not replace the mirror electronics module.

Situation A - Install new mirror motor electronics modules on the driver's and passenger's side rear view mirror. (Only applies to vehicles produced up until March 2016)

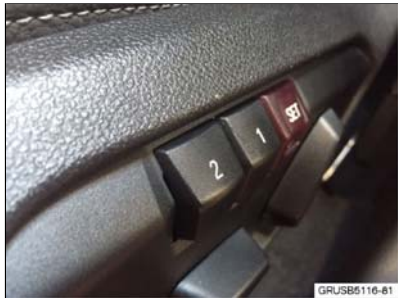
Situation B- Unintentional actuation of seat-mounted memory switch (the switch on this vehicle is mounted in a position where a customer can inadvertently press it when entering or exiting the vehicle), or the Personal Profiles settings have not been set to the customer's preferred mirror and/or seat positions .

<ol style="list-style-type: none"> 1. Verify the customer's complaint and inform the customer of the operation of the seat/mirror memory switches and the possibility of inadvertent operation. 2. Verify that the customer's preferred seat/mirror settings are applied to the correct memory position.

Situation B – Inform the customer on the operation of the seat/mirror memory buttons, and make the customer

aware of the possibility of unintended switch operation.
