MANUAL TRANSMISSION - STIFF DIAGONAL GEARSHIFT LEVER MOVEMENT

This Service Information bulletin replaces SI B23 01 08 dated **January 2009**.

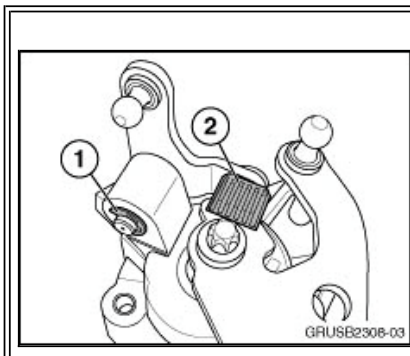
The customer may complain of a "stiff diagonal shift" (e.g., N-R, R-N, 2-3/3-2 or 4-5/5-4). Also, in some cases, gears cannot be selected, or the selector gear does not go into the neutral position.

1. The deflection lever circlip of the gearshift mechanism is damaged or missing.
2. Possible corrosion at the gearshift mechanism (shift cables or transmission gearshift unit)

1. Inspect the shifting gear mechanism deflection lever for the missing or damaged circlip (1) and the plastic sliding sleeve (2).
2. Install or replace, as needed, using new parts P/N 23 11 7 593 200 (circlip) and P/N 23 11 7 593 217 (sliding sleeve).
3. In case the cables move freely after disconnection and the level circlip and/or sliding sleeve are not found to be defective, then replace the transmission gearshift switching
