## Technical Service Bulletin

| GROUP<br><b>CAMPAIGN</b> | NUMBER<br><b>18-01-040</b> |
| DATE<br><b>DECEMBER, 2018</b> | MODEL(S)<br><b>Elantra GT (PD)</b> |

**SUBJECT** TAILGATE OUTSIDE HANDLE REPLACEMENT  
(SERVICE CAMPAIGN T3K)

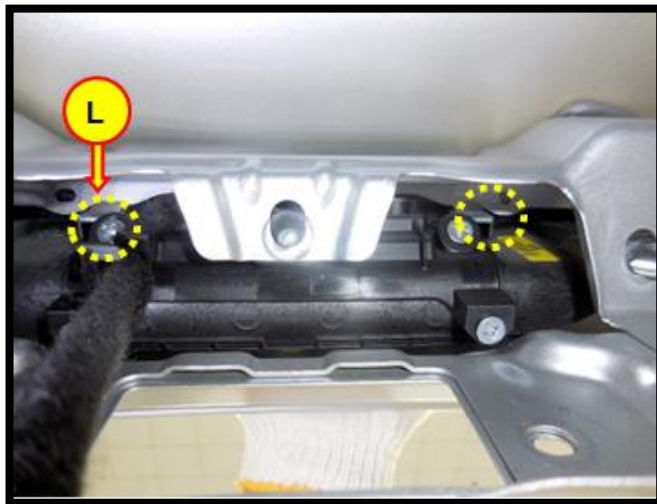
14. To unlock the tailgate outside handle mounting clips, push the lock on the outside handle mounting clips (L) using a flat screwdriver.

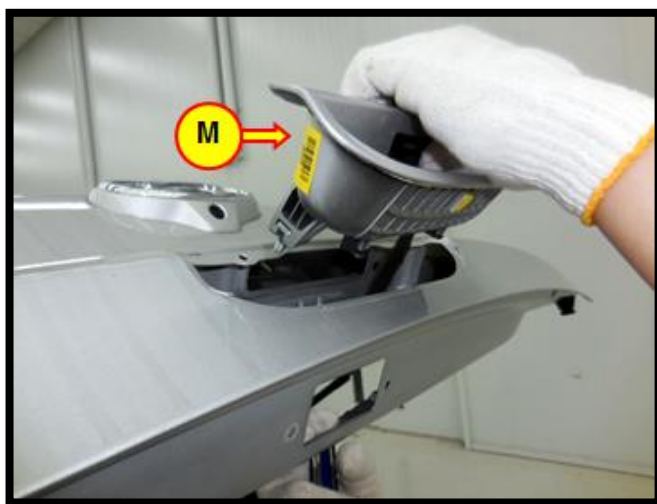
**Description:** On certain 2018MY Elantra GT (PD) vehicles, the tailgate outside handle may exhibit cracking. Follow the procedure outlined in this bulletin to replace the tailgate outside handle.

15. Remove the tailgate outside handle assembly (M) and install the replacement tailgate outside handle assembly in the reverse order of removal.

Operate the tailgate by opening and closing a few times to ensure proper operation. Ensure proper operation of the backup camera if applicable.
