Technical Service Bulletin

GROUP	NUMBER
CAMPAIGN	18-01-042
DATE	MODEL(S)
DECEMBER, 2018	ELANTRA
	(AD)

PASSENGER SIDE OUTSIDE MIRROR NOISE REPAIR (SERVICE CAMPAIGN T3N)

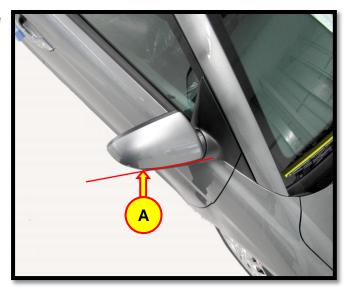
1. Check the standard line (A) of the outside mirror base cover on the passenger side (normal mirror design position).
