Technical Service Bulletin		GROUP	NUMBER 18-AT-017-1	
		AUTOMATIC TRANSMISSION		
		DATE	MODEL(S)	
		DECEMBER, 2018	GENESIS (DH, HI)	
SUBJECT:	COOLANT LEAK AT ATF WARMER CONNECTOR

This TSB supersedes TSB 18-AT-017 to revise the Warranty Information.

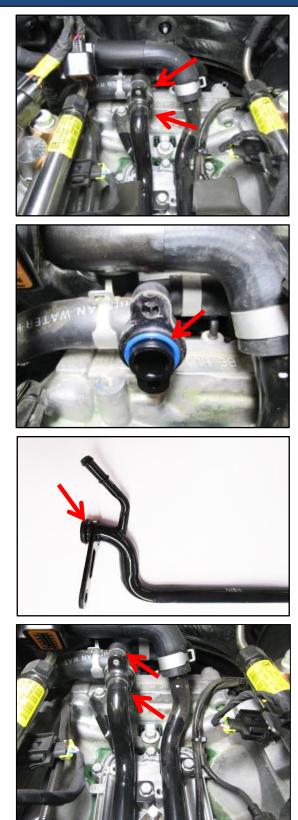
This bulletin provides the procedure to replace the automatic transmission fluid (ATF) warmer connector on some vehicles which may exhibit a coolant leak between the ATF connector and engine side heater pipe.

8. Reconnect the pipe to the housing and connector.

Reinstall the 2 nuts to the connector. Torque: 5~7 lb.ft, 0.7~1.0 kgf.m, 6~10 N.m)

Tighten the nuts gradually and evenly until tightened.

Install the 3 bolts that secure the pipe.
