Technical Service Bulletin

SUBJECT: DOOR & WINDOW LOCK SWITCHES STICK AT DRIVER'S DOOR			No: TSB-18-54-011
			DATE: December 2018
			MODEL: 2018-19 Eclipse Cross
CIRCULATE TO:	<input type="checkbox"/> GENERAL MANAGER	<input checked="" type="checkbox"/> PARTS MANAGER	<input checked="" type="checkbox"/> TECHNICIAN
<input checked="" type="checkbox"/> SERVICE ADVISOR	<input checked="" type="checkbox"/> SERVICE MANAGER	<input checked="" type="checkbox"/> WARRANTY PROCESSOR	<input type="checkbox"/> SALES MANAGER

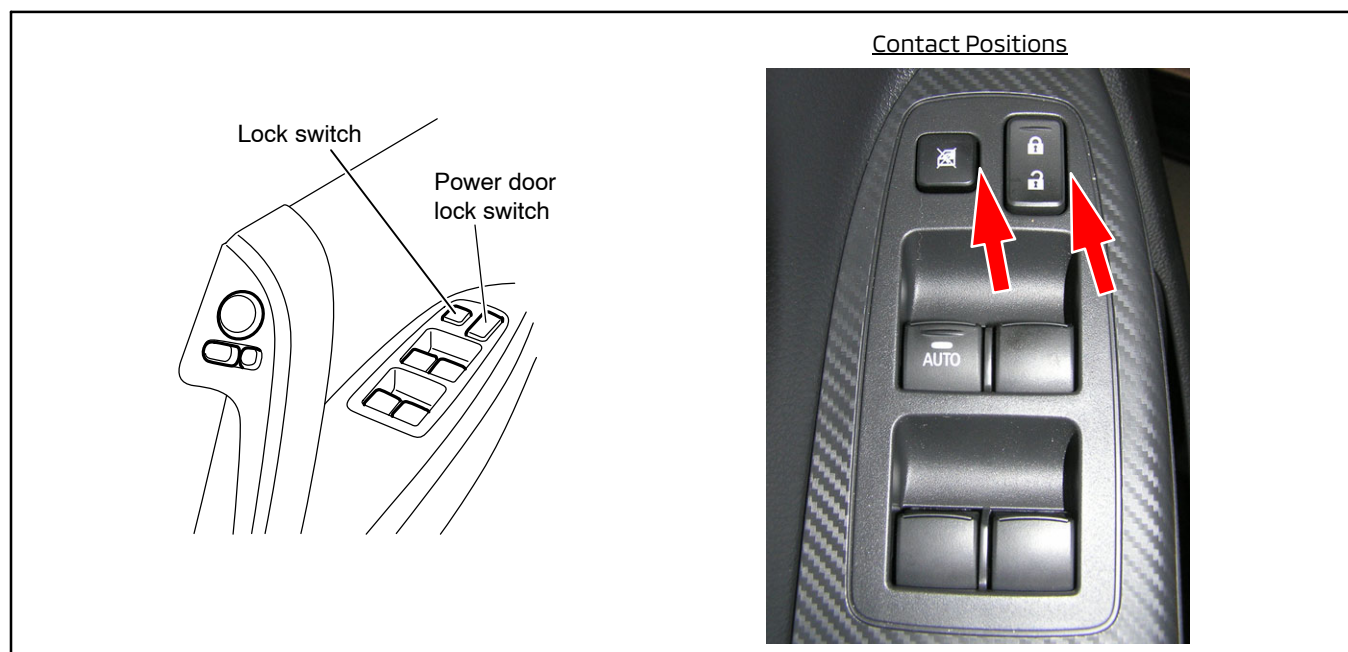
A customer may report a condition where the door and window lock switches on the interior of the driver's door stick and do not return to the neutral position.

This may be caused by the driver's door harness having more stiffness than necessary (no flexibility), and the extra length of the door harness may make the buttons push up and incline. Then, the buttons contact the switch panel as shown below, and do not return to the neutral position.

This TSB instructs dealers how to modify the taping of the branch harness to reduce the stiffness and allow more flexibility, reducing the risk of the buttons contacting the panel and sticking.
