Technical Service Bulletin

SUBJECT:			No:	TSB-18-27-001
TORQUE UPDATES: UNITS OF TIGHTENING TORQUE & NUMERICAL VALUE FOR REAR AXLE - SERVICE MANUAL REVISION			DATE:	December 2018
			MODEL: 2008-2014 Lancer Evolution	
CIRCULATE TO:	[] GENERAL MANAGER	[X] PARTS MANAGER		[X] TECHNICIAN
[X] SERVICE ADVISOR	[X] SERVICE MANAGER	[X] WARRANTY PROCESS	OR	[] SALES MANAGER

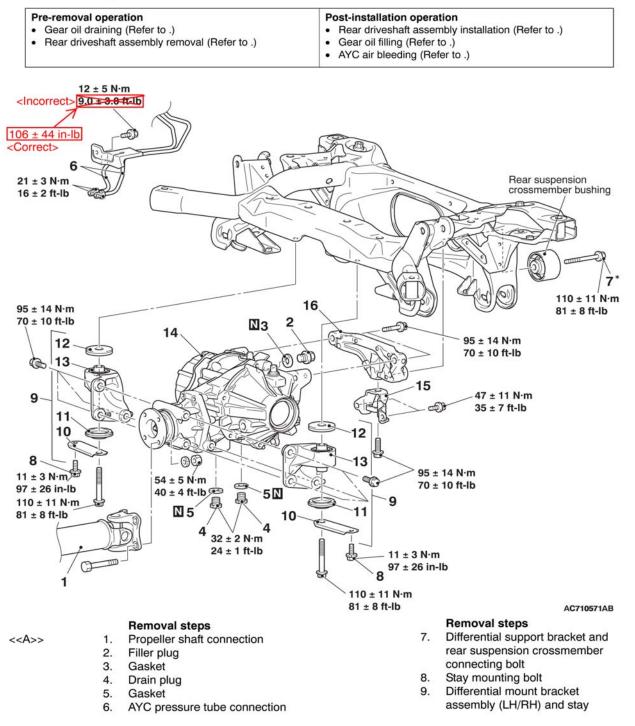
REMOVAL AND INSTALLATION

This TSB updates the Rear Axle section of the affected Service Manuals to correct the tightening torque for the Differential Carrier Assembly.

• The part indicated by ^{*} is the bolt with friction coefficient stabilizer. In removal, ensure there is no damage, clean dust and soiling from the bearing and thread surfaces, and tighten them to the specified torque.

Please make the indicated changes to the 2008 - 2014 Lancer Evolution Service Manual, Group 27 - Rear Axle -> Differential Carrier Assembly -> Removal and Installation.
