SUBJECT:			No:	TSB-18-37-001
TORQUE UPDATES: UNITS OF TIGHTENING TORQUE & NUMERICAL VALUE			DATE:	December 2018
FOR POWER STEERING - SERVICE MANUAL REVISION MODEL: See below				
CIRCULATE TO:	[] GENERAL MANAGER	[X] PARTS MANAGER		[ <b>X</b> ] TECHNICIAN
[X] SERVICE ADVISOR	[X] SERVICE MANAGER	[X] WARRANTY PROCESSO	DR	[] SALES MANAGER

This TSB updates the Power Steering section of the affected Service Manuals to correct the tightening torque for the Power Steering Gear Box, Power Steering Control Unit (EPS-ECU), Steering Shaft, Power Steering Oil Pump Assembly and Power Steering Hoses.

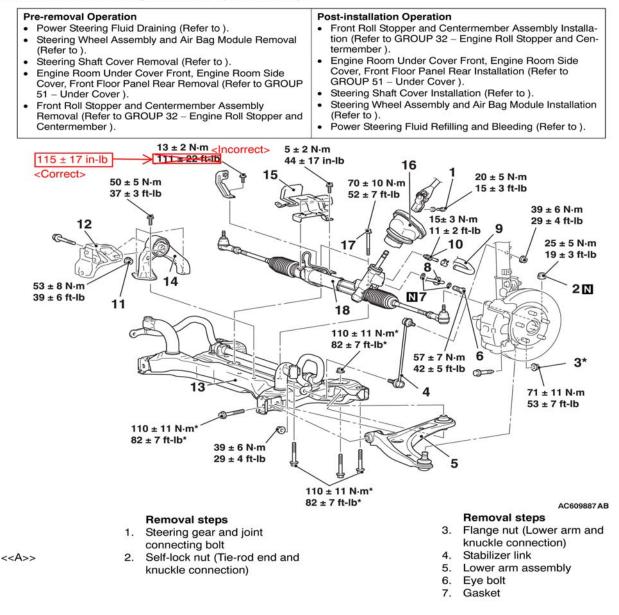
Please make the indicated changes to the 2008 Lancer Service Manual, Group 37 - Power Steering -> Power Steering Gear Box and Linkage.

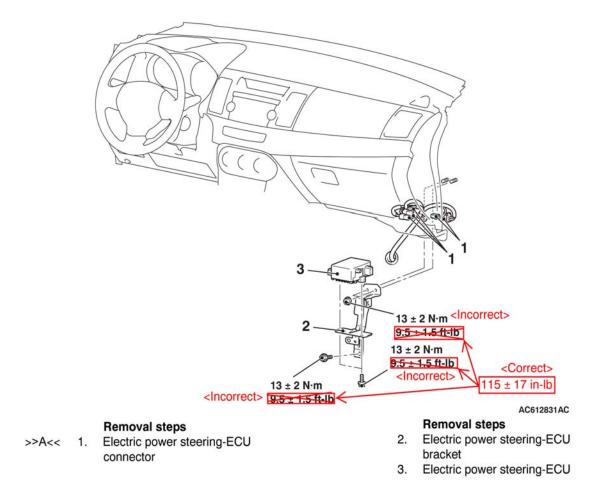
Please make the indicated changes to the 2011 - 2015 Lancer/Lancer Sportback Service Manual, Group 37 - Power Steering -> Electric Power Steering (EPS) -> Electric Power Steering Control Unit (EPS-ECU).

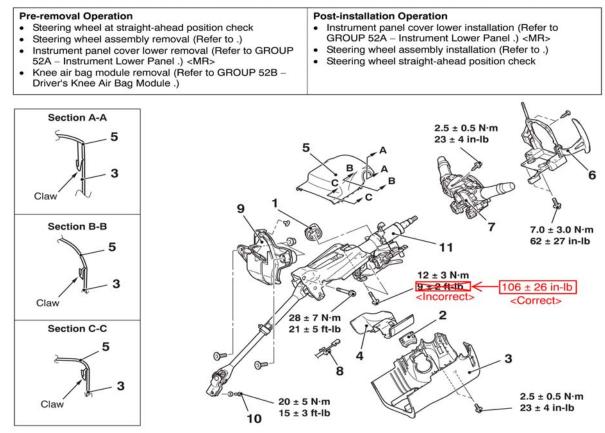
Please make the indicated changes to the 2008 Lancer Evolution Service Manual, Group 37 - Power Steering -> Steering Shaft -> Removal and Installation.

# Tightening torque a: $28 \pm 7$ N·m ( $21 \pm 5$ ft-lb) Tightening torque b,c: $12 \pm 3$ N·m $9 \pm 2$ ft-lb) < Incorrect>

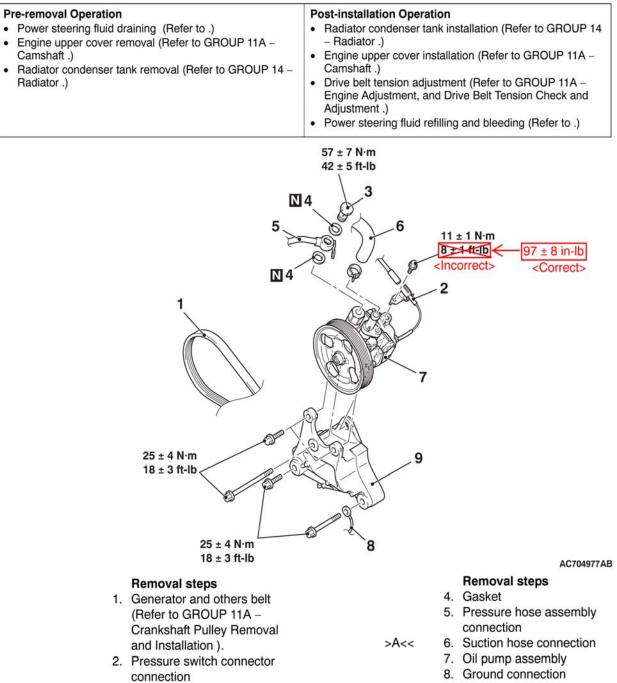
Please make the indicated changes to the 2008 Lancer Evolution Service Manual, Group 37 -Power Steering -> Power Steering Oil Pump Assembly -> Removal and Installation.

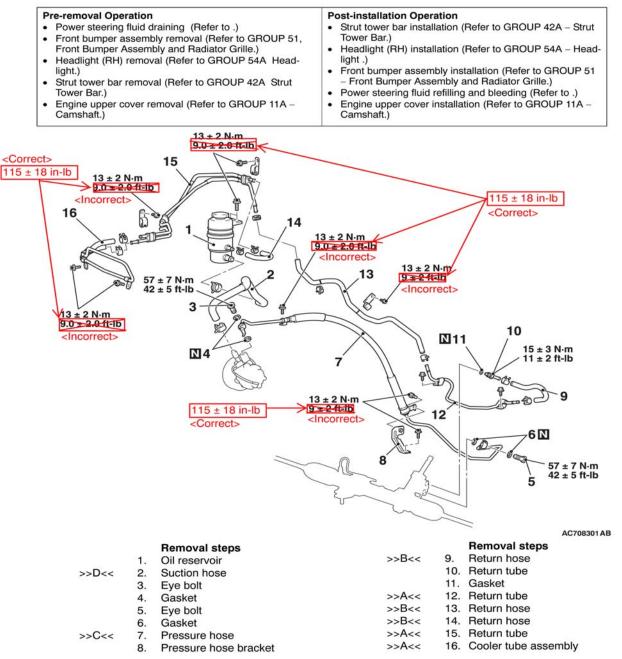
Please make the indicated changes to the 2008 Lancer Evolution Service Manual, Group 37 - Power Steering -> Power Steering Hoses -> Removal and Installation.

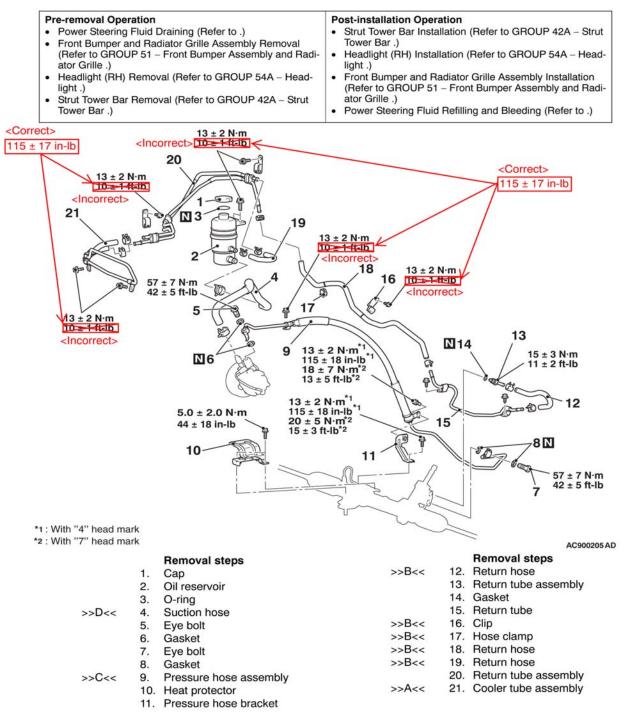
Please make the indicated changes to the 2014 Lancer Evolution Service Manual, Group 37 - Power Steering -> Power Steering Hoses -> Removal and Installation.
