Technical Service Bulletin

SUBJECT: UPDATES TO HOOD LATCH MOUNTING BOLT & TIGHTENING TORQUE - SERVICE MANUAL REVISION			No:	TSB-18-42A-004
			DATE:	December 2018
			MODEL: See below	
CIRCULATE TO:	[] GENERAL MANAGER	[X] PARTS MANAGER		[X] TECHNICIAN
[X] SERVICE ADVISOR	[X] SERVICE MANAGER	[X] WARRANTY PROCESSOR		[] SALES MANAGER

This TSB updates the Body section of the affected Service Manuals to add the type of the hood latch mounting bolts and to correct the tightening torque for the hood.

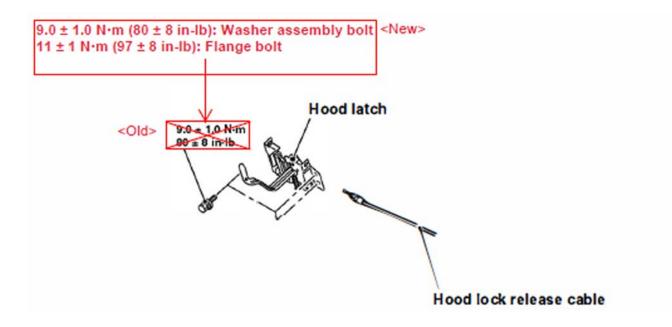
Please make the indicated changes to the 2014 - 2019 Outlander, 2011 - 2018 Outlander Sport, 2018 Outlander PHEV Service Manual, Group 42 - Body -> Hood -> Removal and Installation.
