# Technical Service Bulletin

SUBJECT: <b>TORQUE UPDATES: UNITS OF TIGHTENING TORQUE &amp; NUMERICAL VALUE FOR INTERIOR - SERVICE MANUAL REVISION</b>			No: <b>TSB-18-52A-002</b>
			DATE: <b>December 2018</b>
			MODEL: <b>See below</b>
<b>CIRCULATE TO:</b>	<input type="checkbox"/> GENERAL MANAGER	<input checked="" type="checkbox"/> PARTS MANAGER	<input checked="" type="checkbox"/> TECHNICIAN
<input checked="" type="checkbox"/> SERVICE ADVISOR	<input checked="" type="checkbox"/> SERVICE MANAGER	<input checked="" type="checkbox"/> WARRANTY PROCESSOR	<input type="checkbox"/> SALES MANAGER

This TSB updates the Interior section of the affected Service Manuals to correct the tightening torque for the Floor Console Assembly.

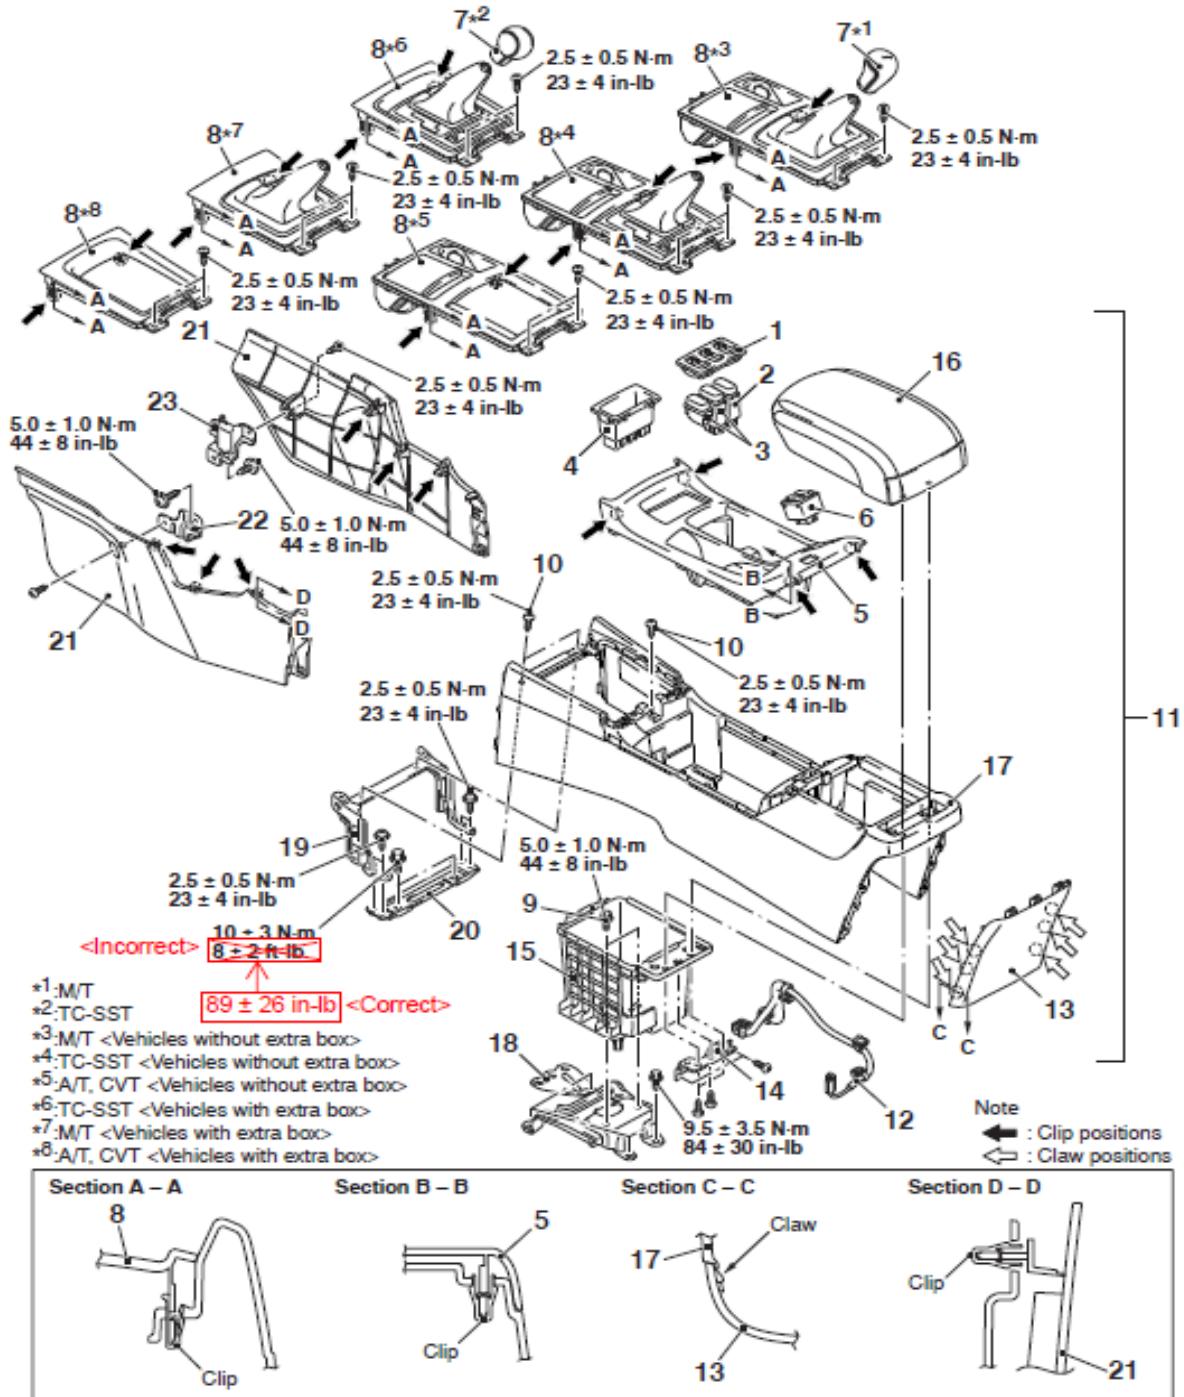
**REMOVAL AND INSTALLATION**

Please make the indicated changes to the 2011 - 2015 Lancer/Lancer Sportback Service Manual, Group 52A - Interior -> Floor Console Assembly -> Removal and Installation.

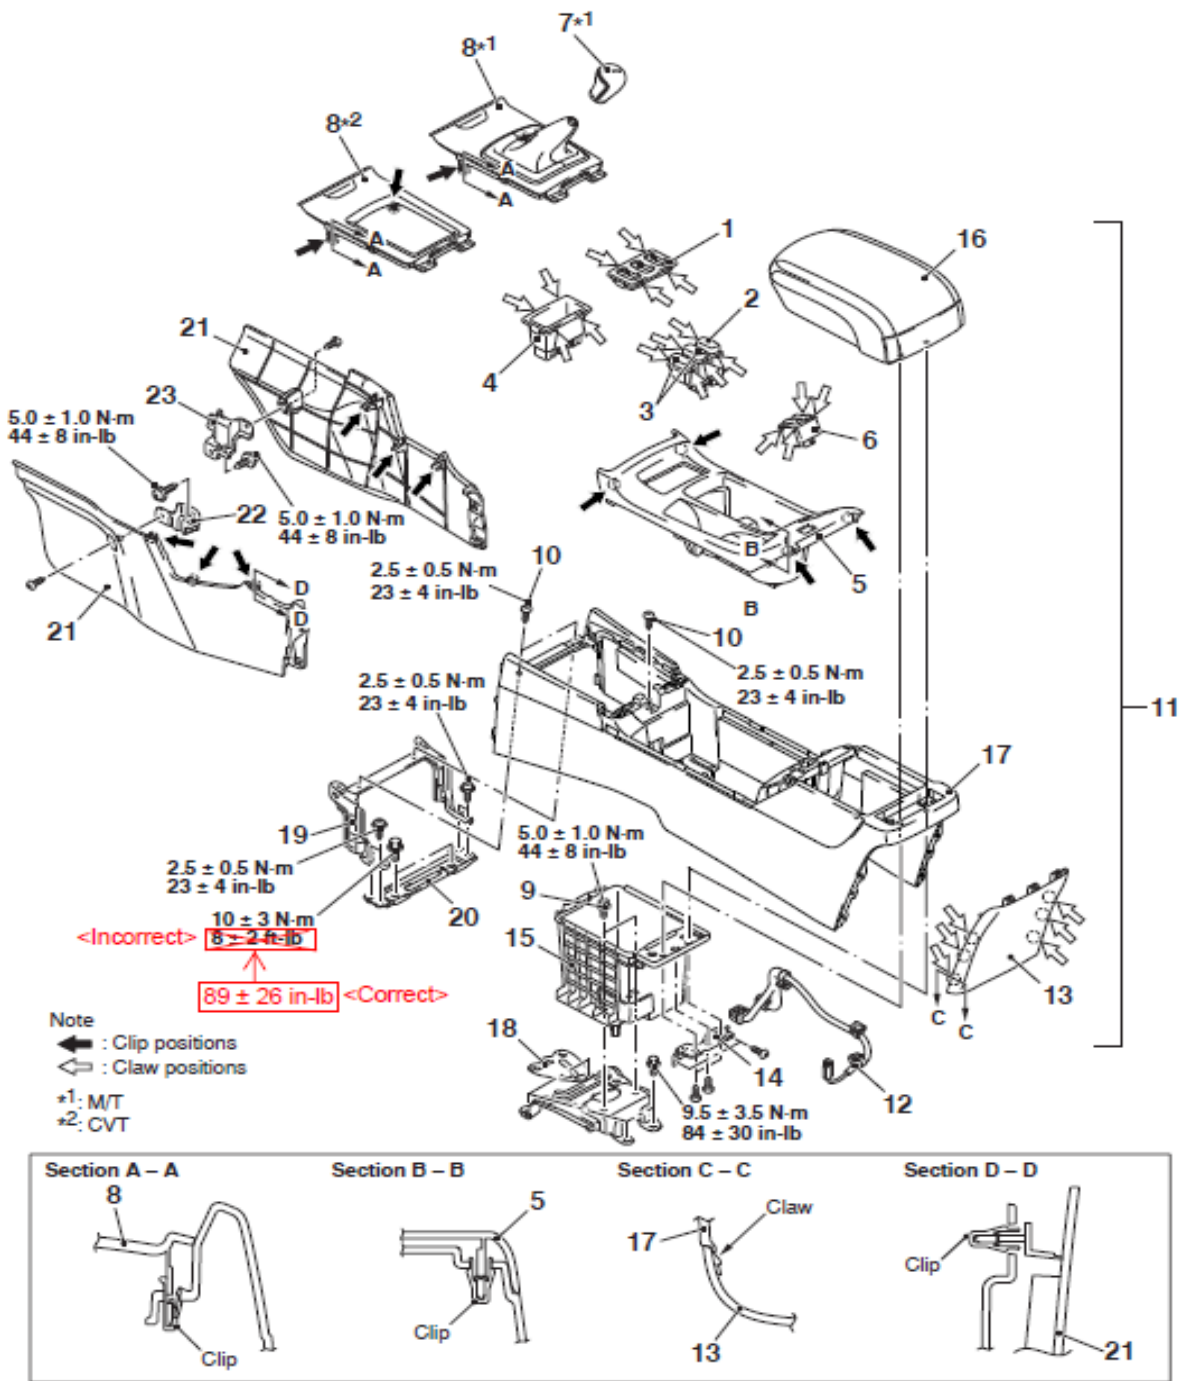
**REMOVAL AND INSTALLATION**

Please make the indicated changes to the 2016 - 2017 Lancer/Lancer Sportback Service Manual, Group 52A - Interior -> Floor Console Assembly -> Removal and Installation.

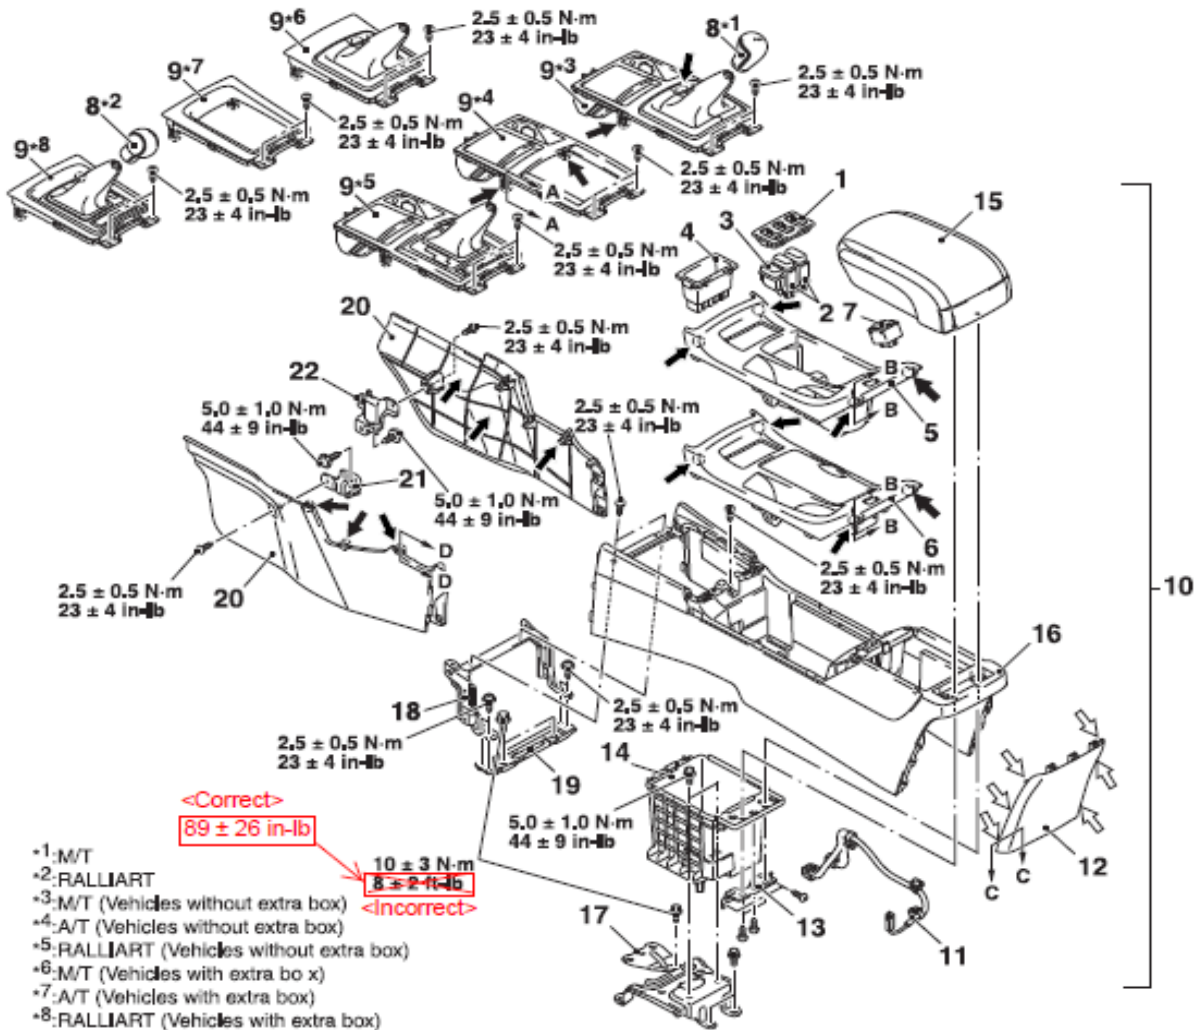
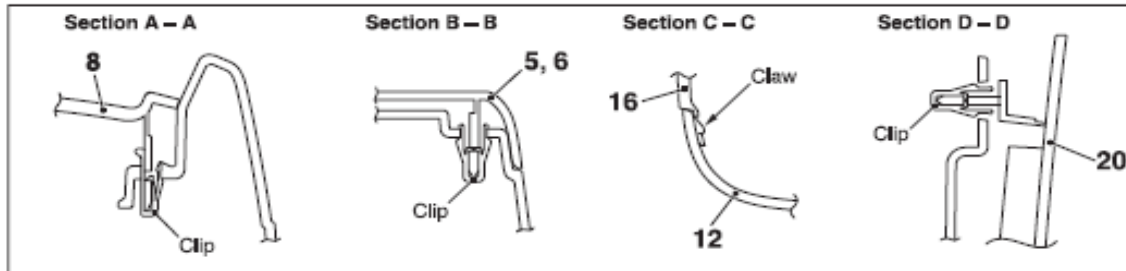
AC901812AB

Please make the indicated changes to the 2010 Lancer Sportback Service Manual, Group 52A - Interior -> Floor Console Assembly -> Removal and Installation.

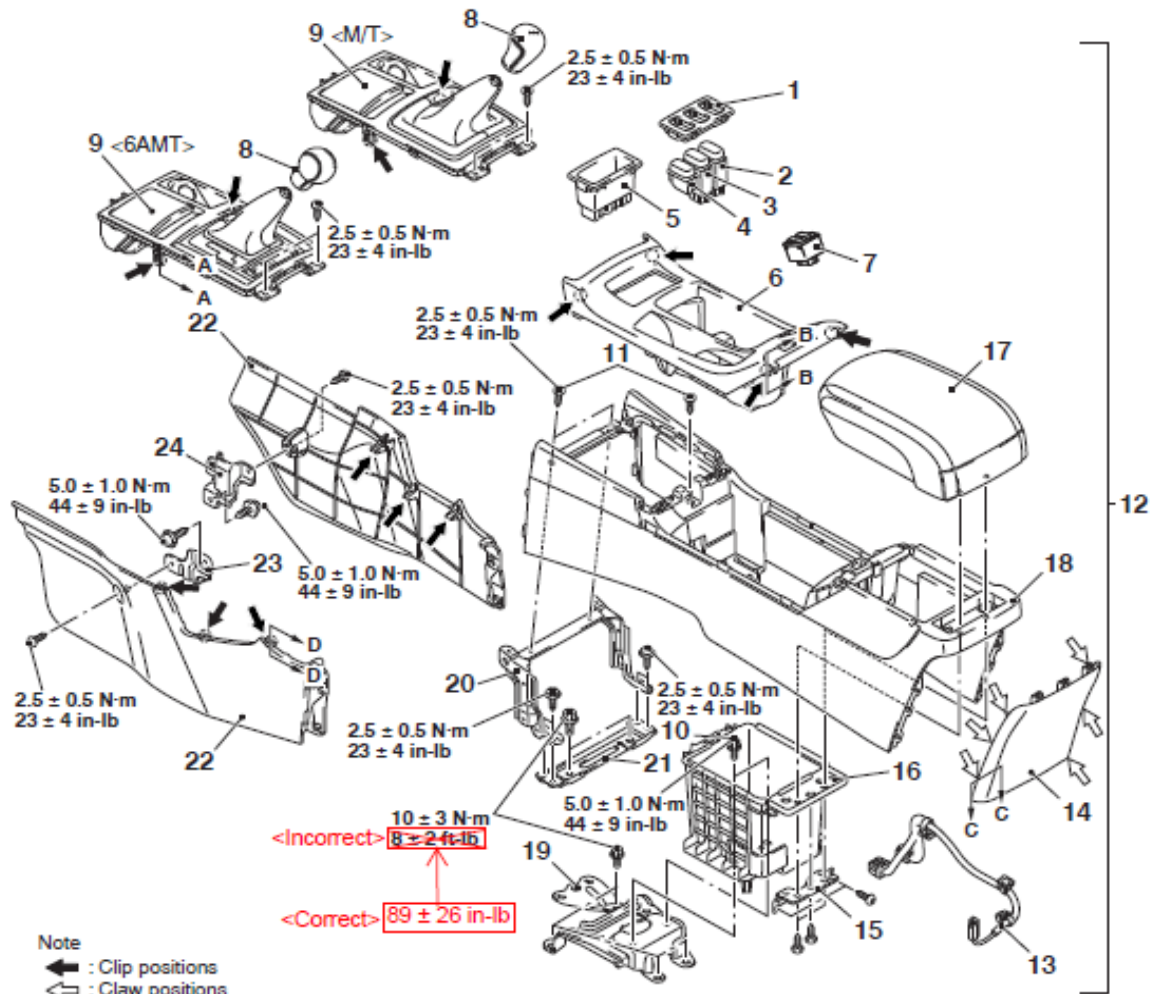
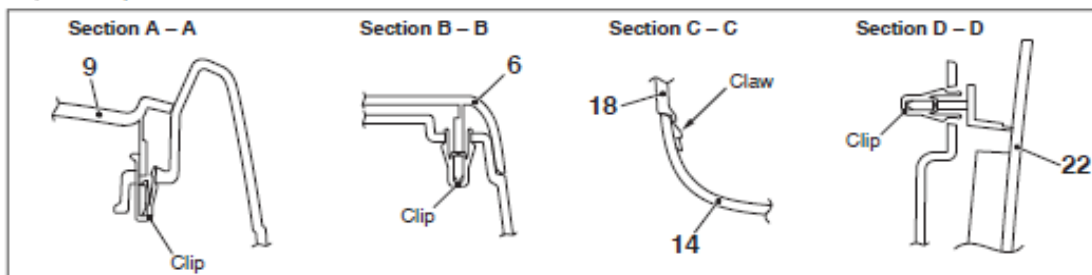
AC708396AB

Please make the indicated changes to the 2008 Lancer Evolution Service Manual, Group 52A - Interior -> Floor Console Assembly -> Removal and Installation.

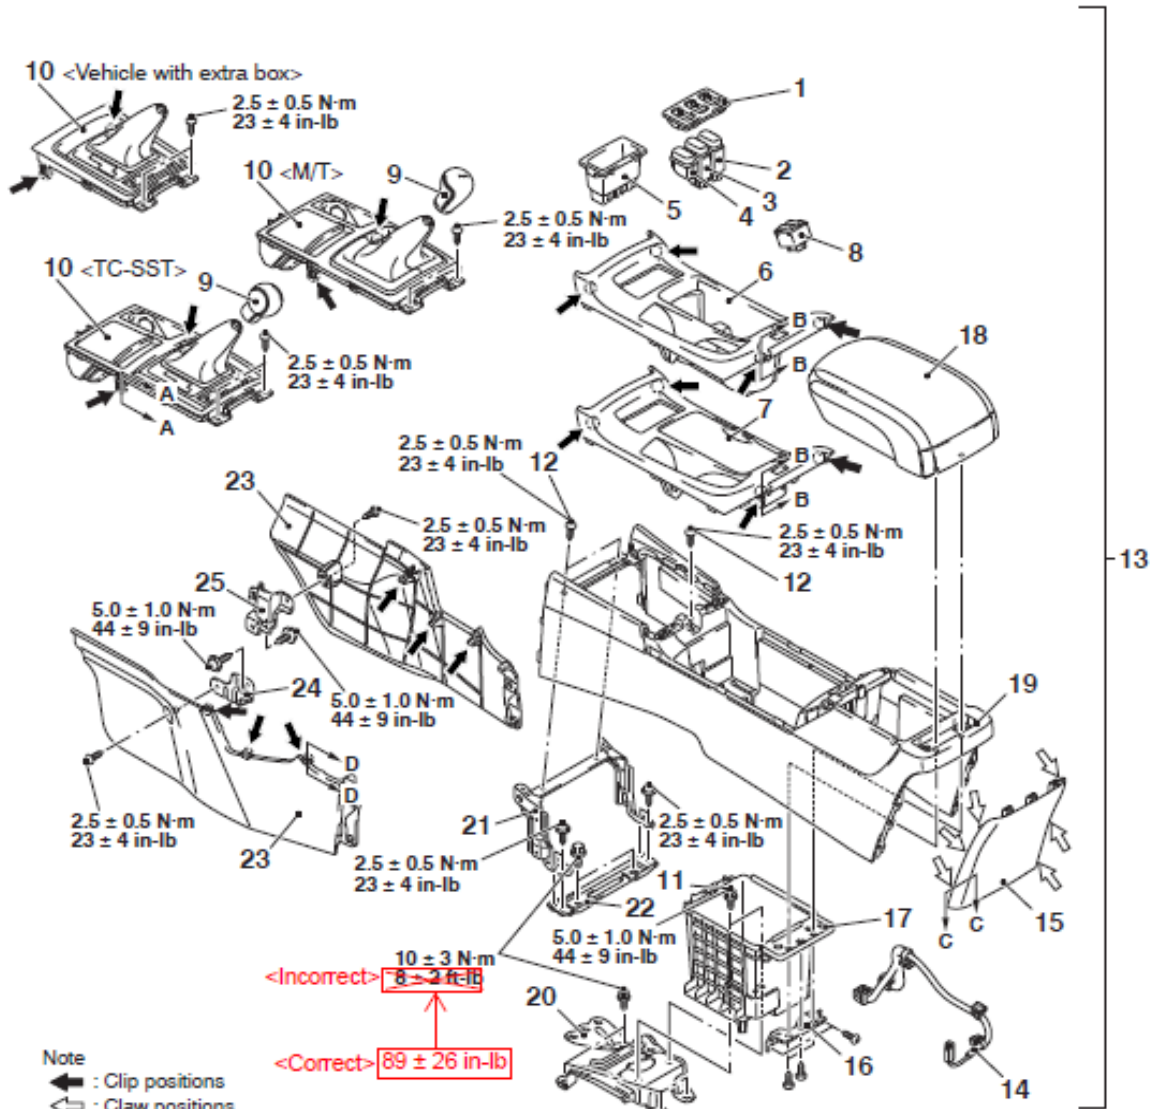
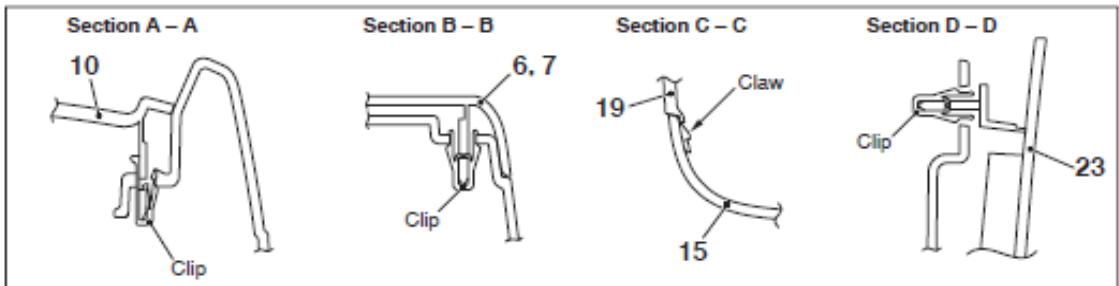
**REMOVAL AND INSTALLATION**

Please make the indicated changes to the 2009 - 2013 Lancer Evolution Service Manual, Group 52A - Interior -> Floor Console Assembly -> Removal and Installation.

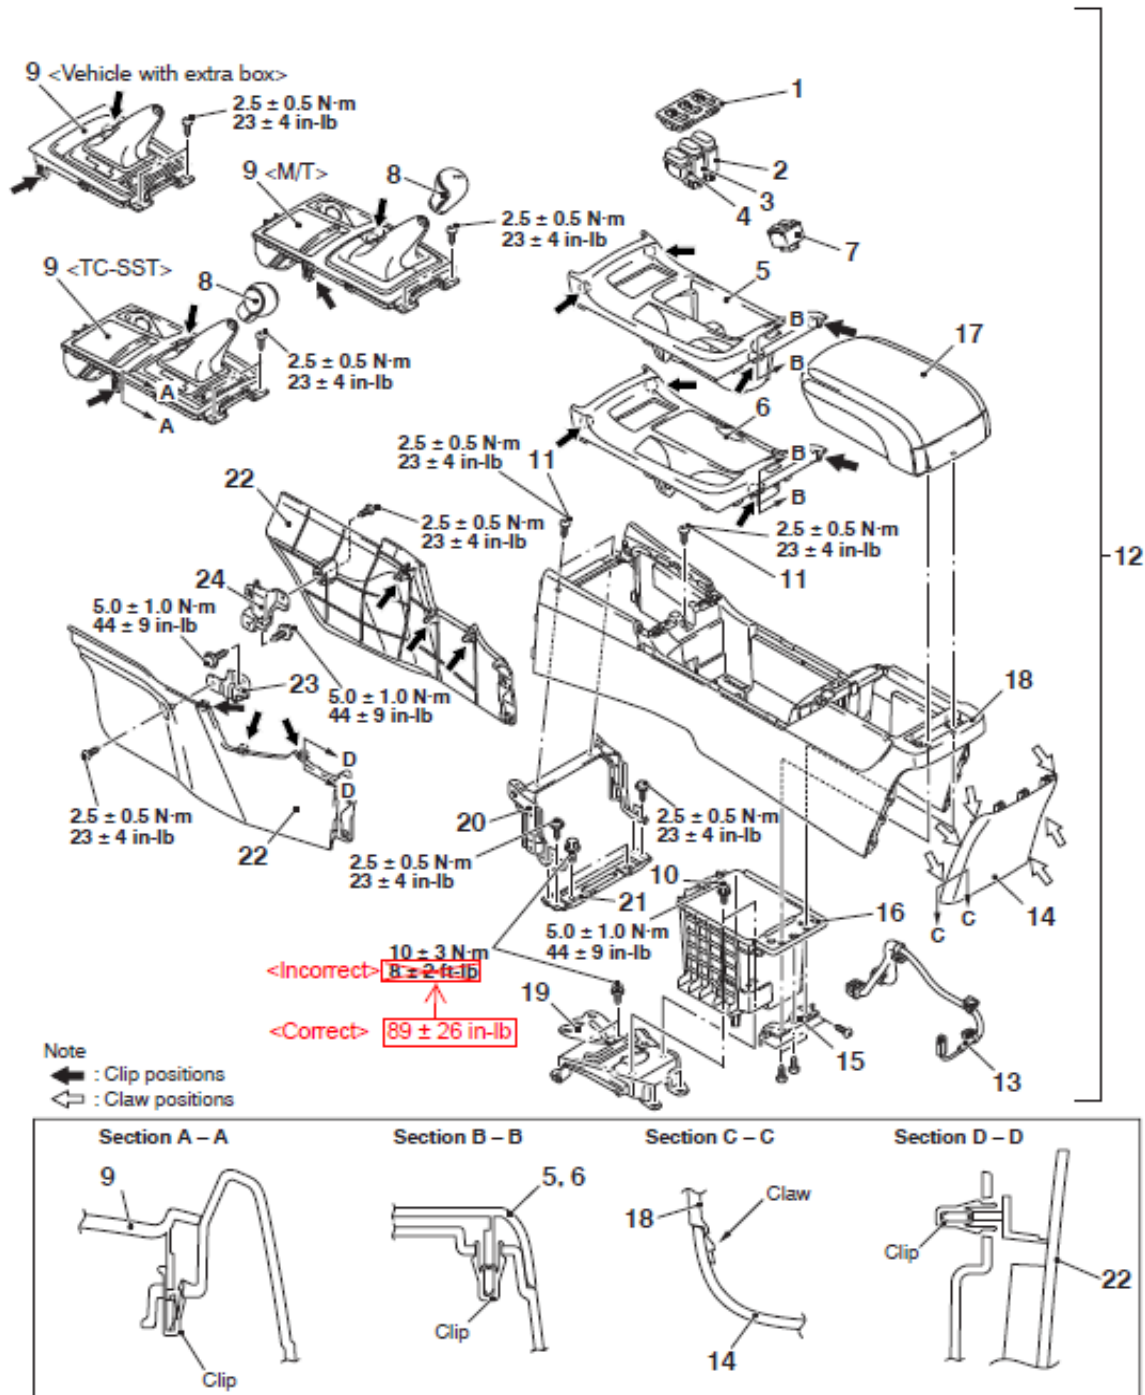
### REMOVAL AND INSTALLATION

Please make the indicated changes to the 2014 Lancer Evolution Service Manual, Group 52A - Interior -> Floor Console Assembly -> Removal and Installation.
