GROUP ELE	MODEL 2018-2019MY Niro (DE PHEV)
NUMBER 161	DATE December 2018

TECHNICAL SERVICE BULLETIN

SUBJECT: COMBINATION TSB / SERVICE ACTION: COOLANT LEAK – OBC INLET HOSE DETACHING (SA365)

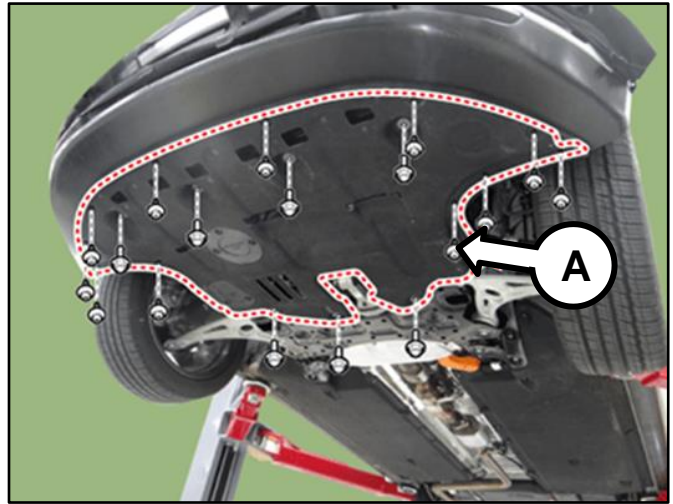
1. With the vehicle raised on a lift, remove the engine under cover (A).

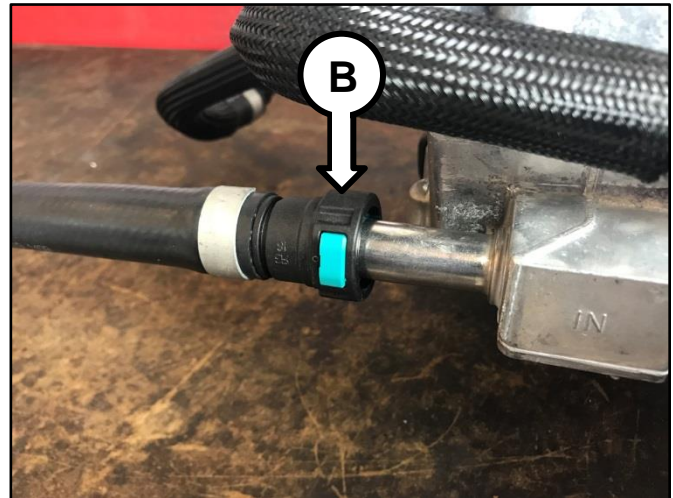
2. Ensure the OBC inlet hose (B) is fully installed.

OBC assembly and inlet hose removed from vehicle for demonstration purposes only.
