GROUP TRA	MODEL 2019MY K900 (RJ)
	NUMBER 081	DATE December 2018
TECHNICAL SERVICE BULLETIN		
SUBJECT: SERVICE ACTION: TRANSMISSION FLUID COOLER HOSE INSPECTION (SA368)

SERVICE ACTION: TRANSMISSION FLUID COOLER HOSE INSPECTION (SA368)

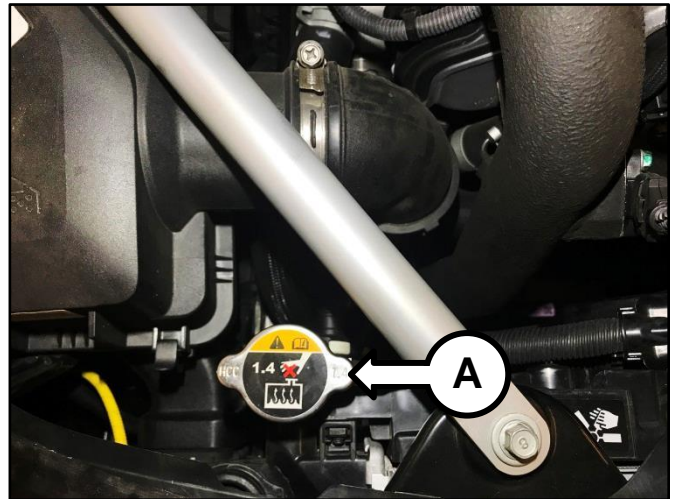
1. Open the hood and locate the two (2) transmission cooler hoses on the passenger side of the vehicle, directly below the radiator cap (A).

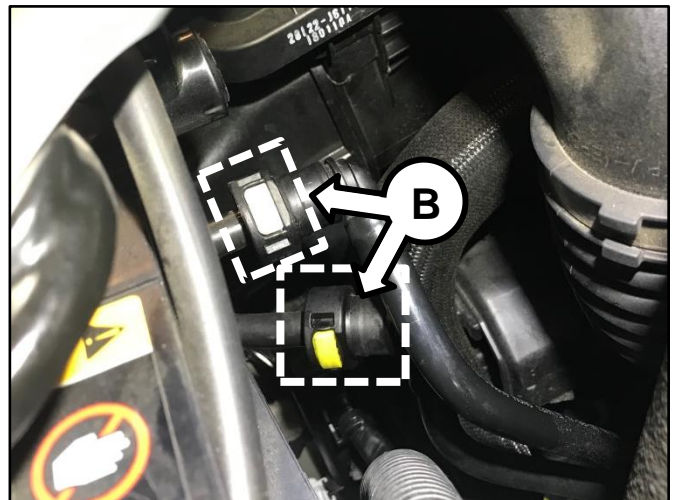
2. Firmly grasp and pull on each transmission cooler hose (B).
 - If any of the hoses comes loose, open a Techline case online and attach a photo of the loose hose(s) to the case. Additional information will be provided by Techline. Once the concern has been addressed, fulfill the photo requirement* below for claim submission.
 - If none of the hoses comes loose, fulfill the photo requirement* below. No further action is required.

***Required:** Take one (1) KVID photo for either inspection result (Attachment Type: 'XX').
