SUBJECT:			No:	TSB-18-55-001
TOR	QUE UPDATES: UNI	rs of		
	G TORQUE & NUMER		DATE:	December 2018
FOR HEATER,	AIR CONDITIONING 8	& VENTILATION	MODEL	Soo balaw
-	AIR CONDITIONING A		MODEL	See below
-				See below

This TSB updates the Heater, Air Conditioning & Ventilation section of the affected Service Manuals to correct the tightening torque for the Compressor Assembly.

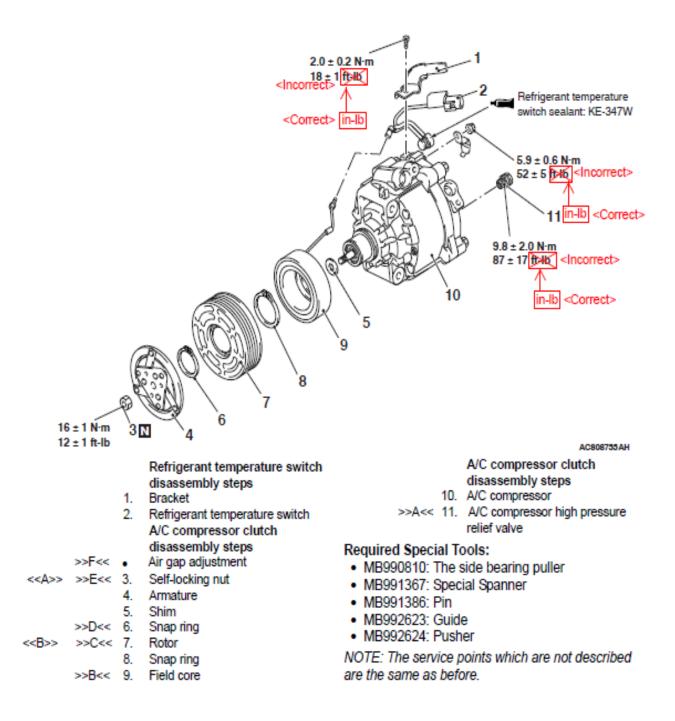
## DISASSEMBLY AND ASSEMBLY

Please make the indicated changes to the 2010 Lancer, 2010 Lancer Sportback, 2011 - 2014 Lancer /Lancer Sportback, 2011 - 2014 Lancer Evolution Service Manual, Group 55 - Heater, Air Conditioning and Ventilation -> Compressor Assembly -> Removal and Installation.

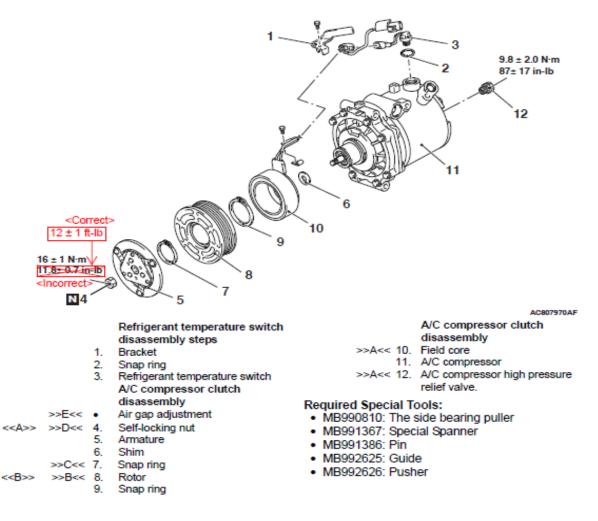
#### DISASSEMBLY AND ASSEMBLY

Please make the indicated changes to the 2009 & 2010 Lancer Evolution Service Manual, Group 55 - Heater, Air Conditioning and Ventilation -> Compressor Assembly -> Removal and Installation.
