RECALL CAMPAIGN BULLETIN

Classification:	Reference:	Date:
EC18-032	NTB18-082	December 3, 2018

VOLUNTARY RECALL CAMPAIGN 2019 ALTIMA; ENGINE CONTROL MODULE

CAMPAIGN ID #: R1813
APPLIED VEHICLES: 2019 Altima (L34)

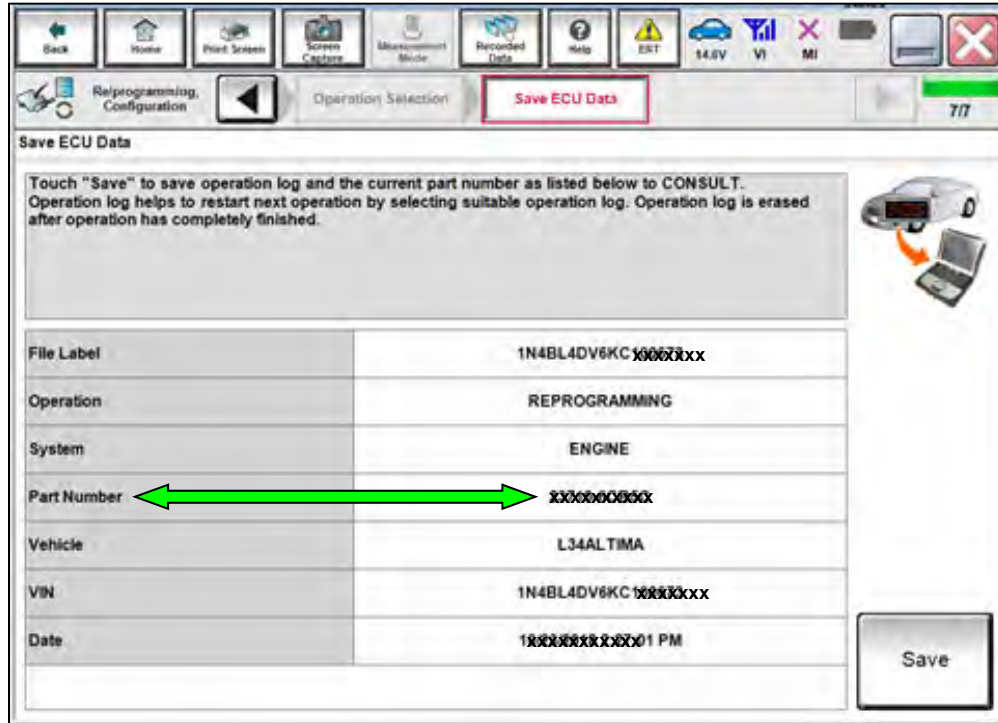
16. When the screen in Figure 8 displays, confirm this bulletin applies as follows:

- a. Find the ECM **Part Number** and write it on the repair order.

NOTE: This is the current Part Number (P/N).

- b. Compare the P/N written down to the P/Ns in the **Current ECM Part Number** column in **Table A** below.

- If there is a match, continue with the reprogramming procedure Proceed to step 17.
- If there is not a match, reprogramming is not needed or it has already been done. Proceed to **CLAIMS INFORMATION**, “Does Not Require ECM Reprogram”.

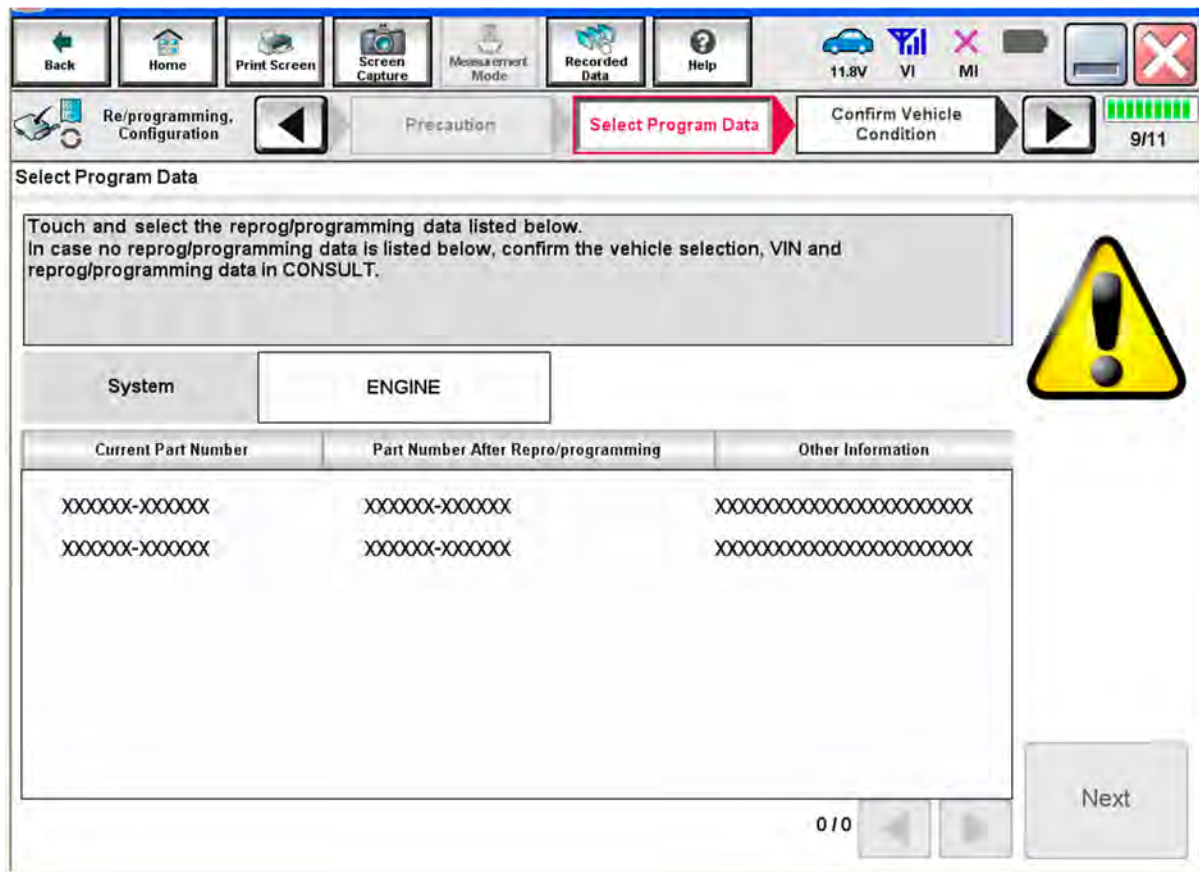
- In some cases, more than one new part number for reprogramming is available.
 - In this case, the screen in Figure 12 displays.
 - Select and use the reprogramming option that does not have the message “Caution! Use ONLY WITH NTBXX-XXX”.
- If the screen below displays as blank (no reprogramming listed), it means there is no ECM reprogramming available for this vehicle. Proceed to **CLAIMS INFORMATION**, “Does Not Require ECM Reprogram”.

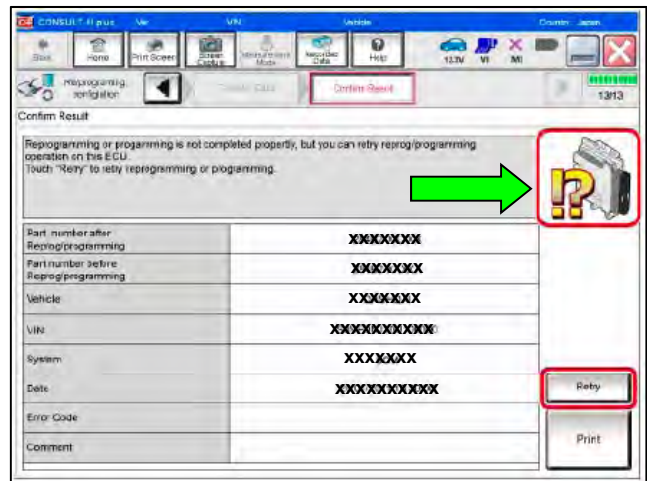
Figure 20

If reprogramming does not complete and the “!?” symbol displays as shown in Figure 20:

- Check battery voltage (12.0 – 15.5V).
- Ignition is ON, Ready Mode is OFF.
- External Bluetooth® devices are OFF.
- All electrical loads are OFF.
- **Select Retry and follow the on screen instructions.**

NOTE: **Retry** may not go through on the first attempt and can be selected more than once.

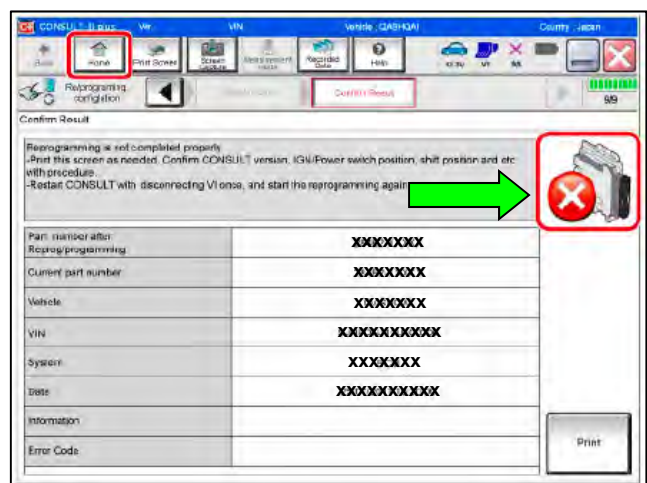
Figure 21

If reprogramming does not complete and the “X” symbol displays as shown in Figure 21:

- Check battery voltage (12.0 – 15.5V).
- CONSULT A/C adapter is plugged in.
- Ignition is ON, engine is OFF.
- Transmission is in Park.
- All C-III plus / plus VI cables are securely connected.
- All C-III plus updates are installed.
- **Select Home, and then restart the reprogram procedure from the beginning.**

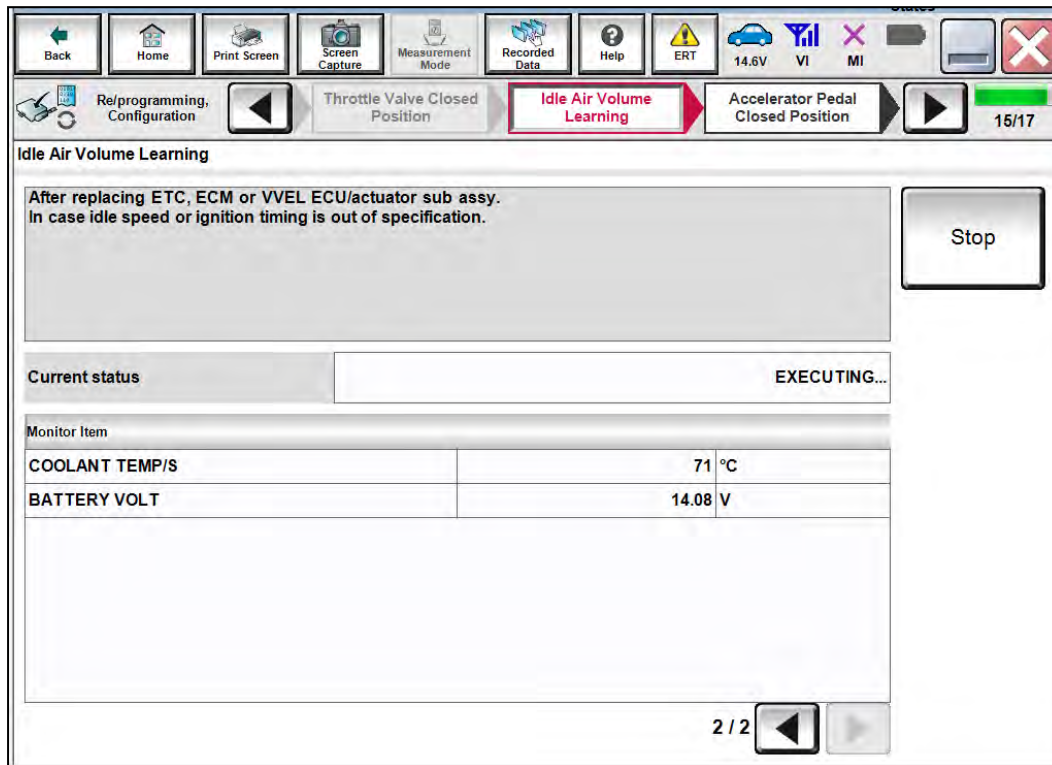
- d. Wait for IAVL to complete.
- The screen in Figure 25 will display.

- Listed below are the specific conditions required for IAVL to complete.
- If IAVL does not complete within a few minutes, a condition may be out of range.
- Verify the following specific conditions are met:
 - Engine coolant temperature: 70 – 105°C (158 – 221°F)
 - Battery voltage: More than 12.9V (At idle)
 - Shift selector lever: P or N
 - Electric load switch: OFF (Air conditioner, headlamp, rear window defogger)
 - Steering wheel: Neutral (Straight-ahead position)
 - Vehicle speed: Stopped
 - Transmission: Warmed up
 - **ATF TEMP SEN** in **DATA MONITOR** mode of the **CVT** system indicates less than 0.9V

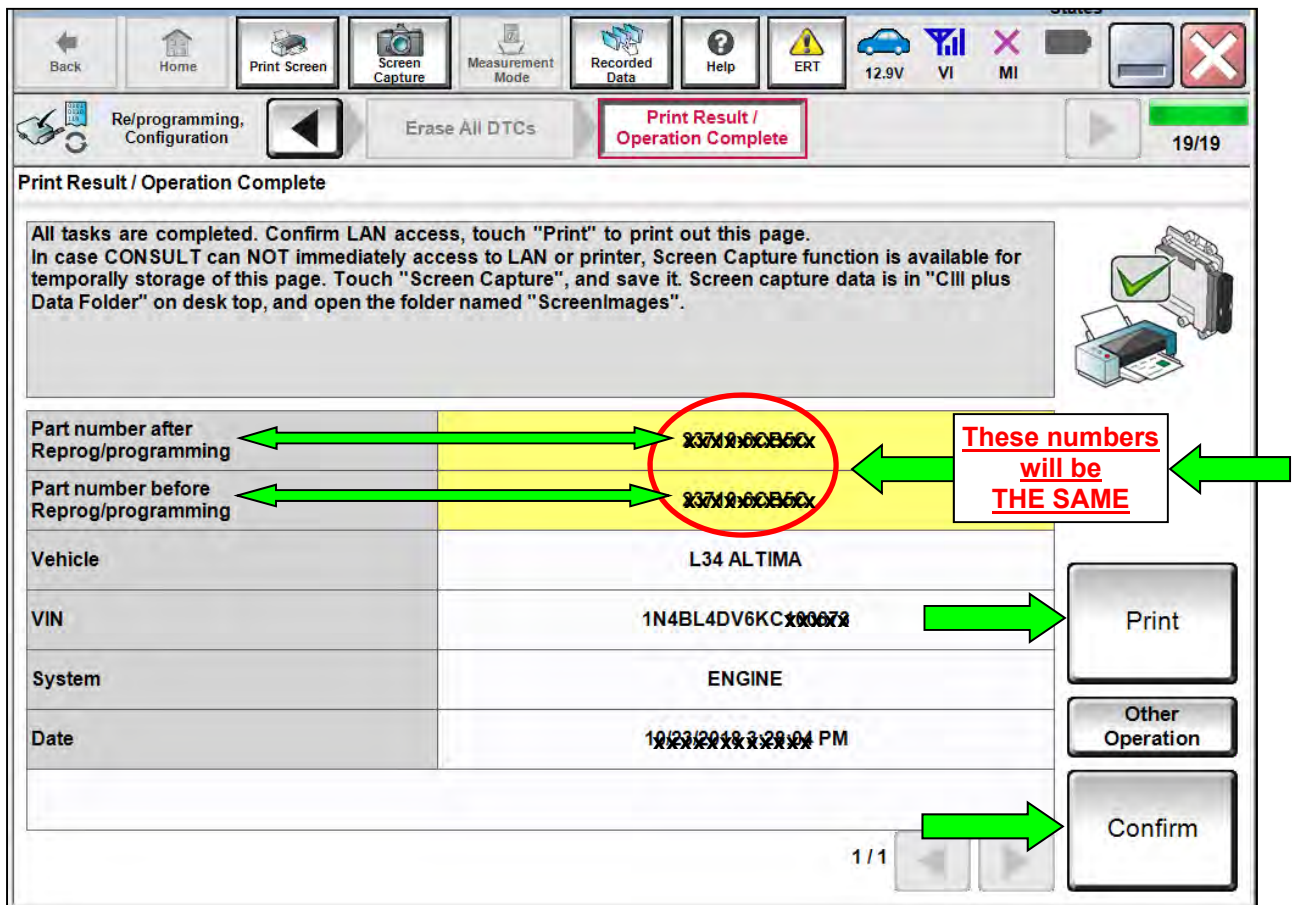
Figure 30

39. Figure 30: Verify the before and after part numbers are the same.

40. Figure 30: Print a copy of this screen (select **Print**) and attach it to the repair order.
