SERVICE BULLETIN

Classification: FA18-003	Reference: NTB18-083	Date: December 7, 2018
-----------------------------	-------------------------	---------------------------

2014 – 2019 ROGUE; SQUEAK/CREAK NOISE FROM FRONT SUSPENSION BOUND BUMPER DRIVING OVER BUMPS

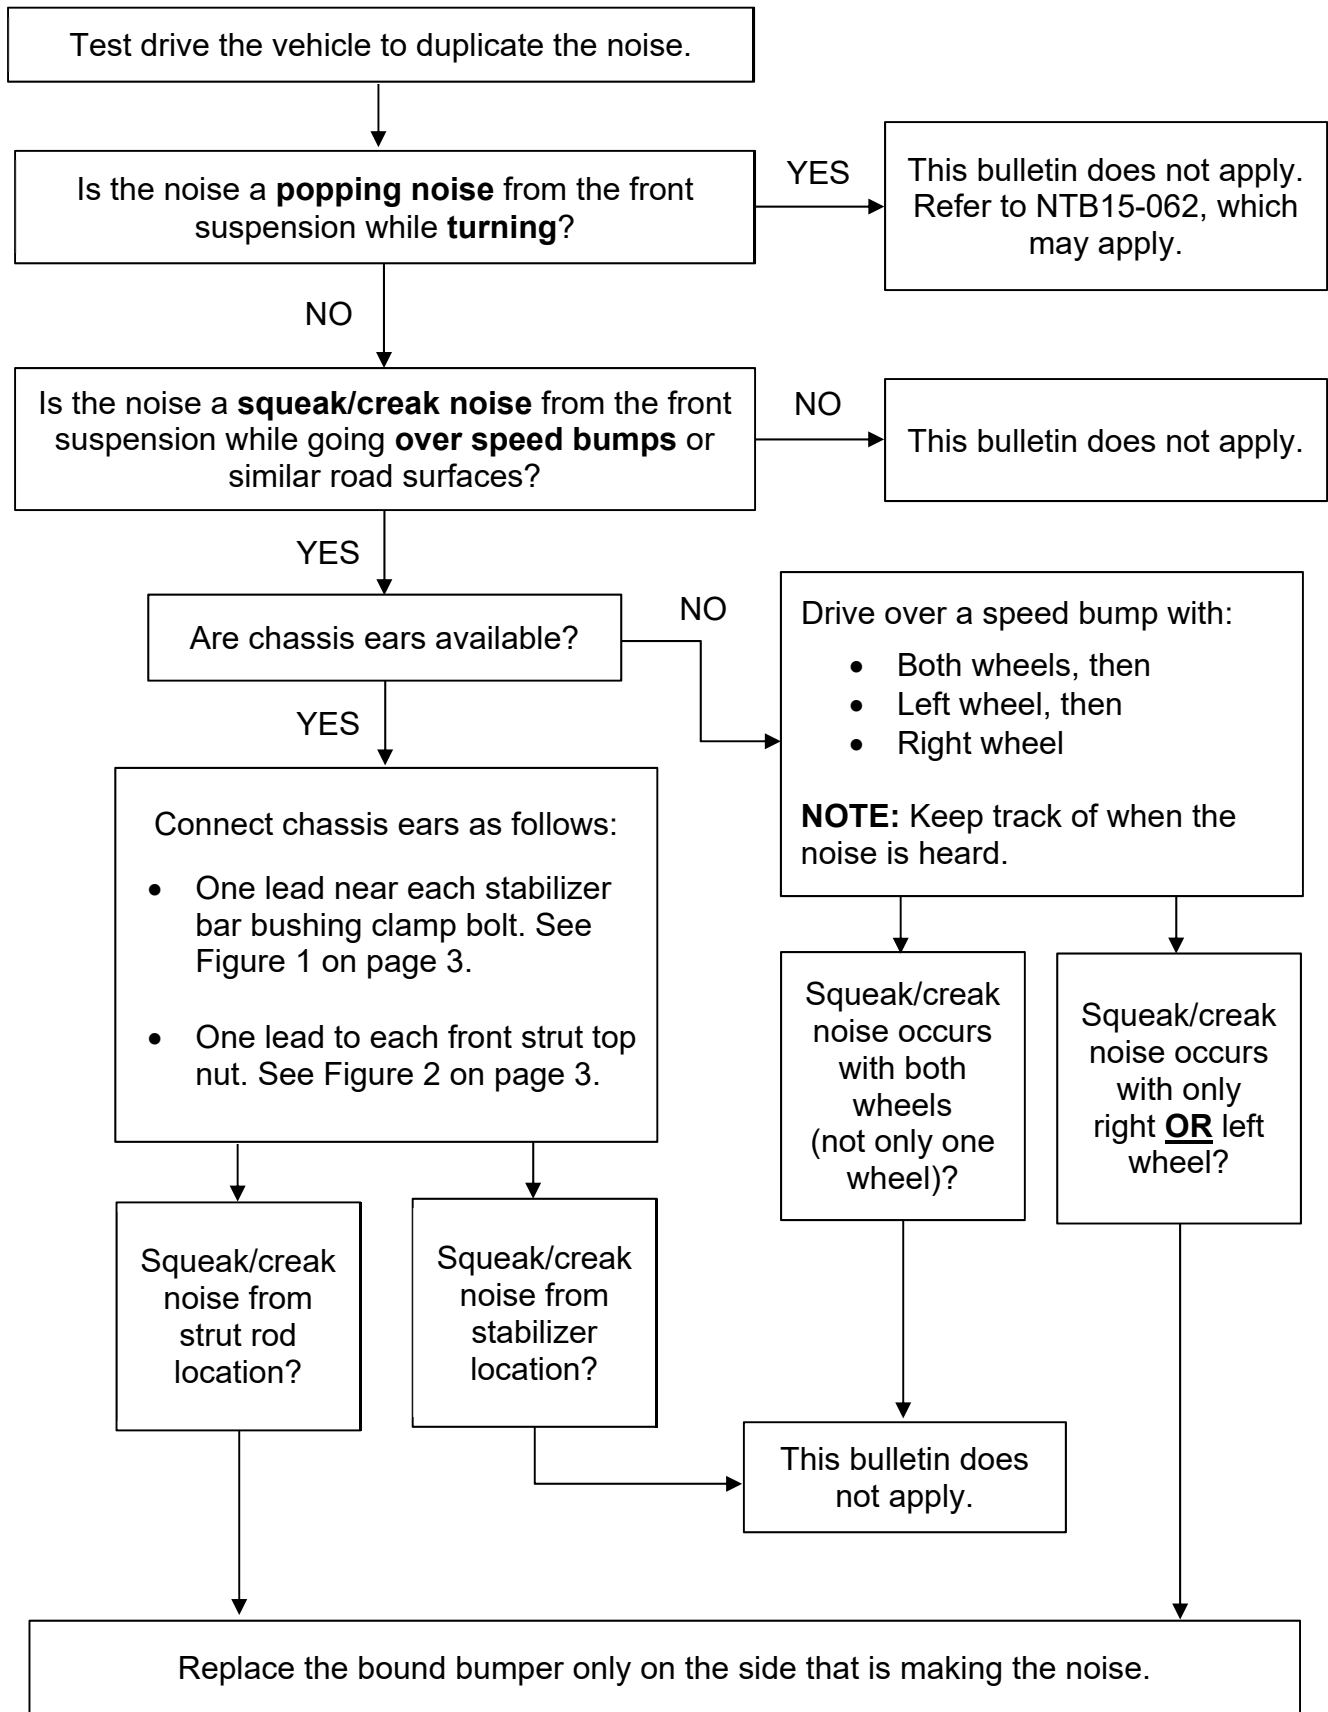
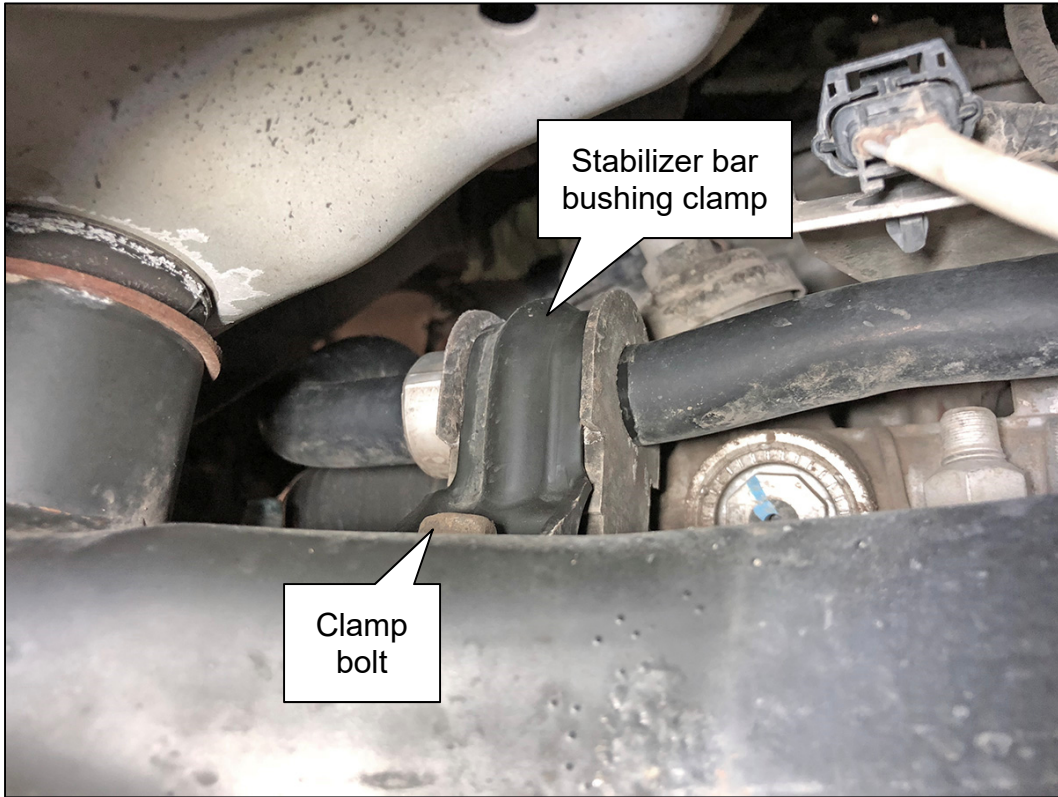
FLOW CHART

Using the flow chart on page 2, a squeak/creak noise is heard coming from the left or right front suspension bound bumper when driving over speed bumps or similar road surfaces.

Replace the front suspension bound bumper, only on the side that is making noise.

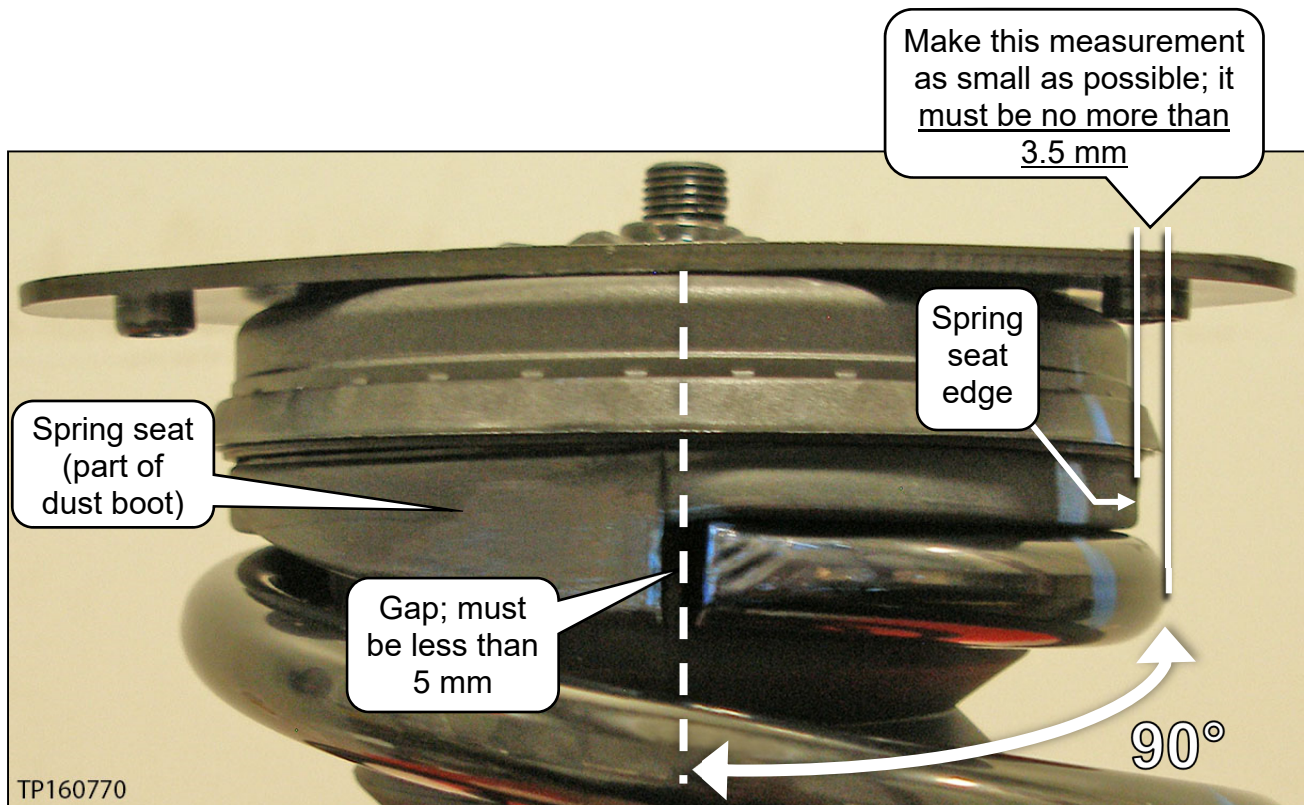
Figure 7

- The side edge of the upper coil spring (at about 90° counterclockwise from the gap), should stick out as little as possible. It must be no more than 3.5 mm from the edge of the spring seat (see Figure 7).
- If the measurement is greater than 3.5 mm, rotate the coil spring into the spring seat (close the gap).
