SERVICE BULLETIN Classification: EL18-041 Reference: NTB18-086 Date: December 18, 2018

2018-2019 LEAF; REPLACING OR ALIGNING DISTANCE SENSOR (ICC SENSOR) BRACKET OR CHARGE PORT LID

APPLIED VEHICLES: 2018-2019 LEAF (ZE1)

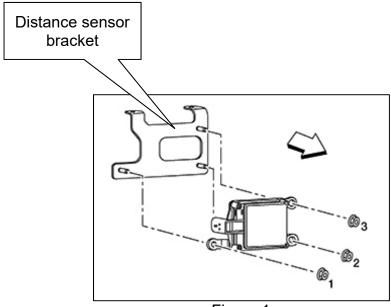
If a distance sensor (ICC sensor) bracket is removed or replaced (see Figure 1 on the next page):

- Take care when handling the distance sensor bracket. It can be damaged if dropped.
- Do not bend the distance sensor bracket to adjust radar alignment.
 - **NOTE:** If the distance sensor is difficult to align, confirm the bracket is not bent by comparing it to a known good vehicle.
- Always perform an ICC Sensor Alignment (Radar Alignment Procedure) whenever the distance sensor bracket is removed or replaced.
 - ➤ To locate the Radar Alignment Procedure in the Electronic Service Manual (ESM), select the "Trouble Diagnosis" section and enter **ICC Sensor Alignment** into the Title Search field.

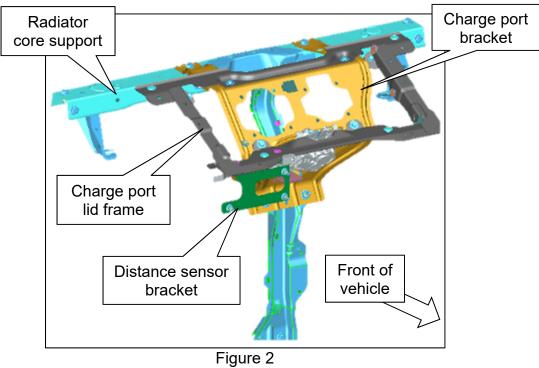
IMPORTANT: Do not bend any of the components called out in Figure 2. If components do not align, one or more associated components may already be bent and must be replaced.

- Do not bend the charge port lid frame to adjust (Figure 2).
- Do not bend any of the components attached to the charge port bracket (Figure 2).
- To locate the Charge Port Lid Adjustment Specs and Procedure in the ESM, select the "Inspection, Removal, and Installation" section and enter Charge Port Lid Assembly into the Title Search field.
- Always perform an ICC Sensor Alignment (Radar Alignment Procedure) whenever any of the components called out in Figure 2 are removed or replaced.
 - ➤ To locate the Radar Alignment Procedure in the Electronic Service Manual (ESM), select the "Trouble Diagnosis" section and enter **ICC Sensor Alignment** into the Title Search field.
