SUBJECT/CONCERN:

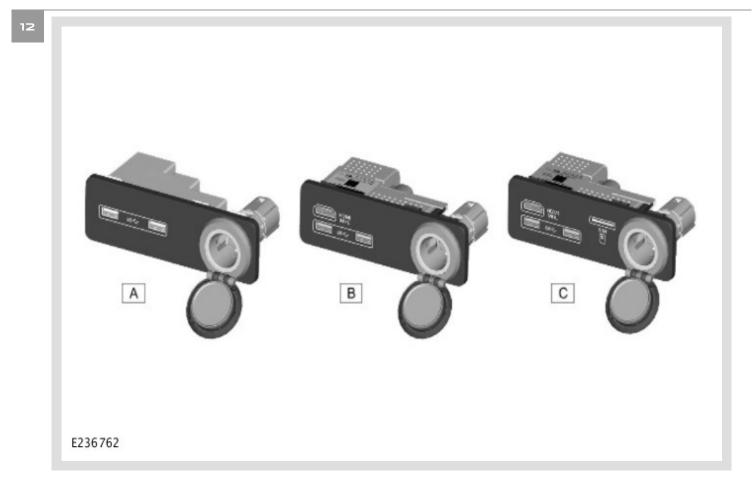
Verify the media interface panels.

- 1 If 'A', go to Step 24. Vehicle NOT eligible for Smartphone pack activation.
- 2 If 'B' or 'C', go to Step 13. Vehicle eligible for Smartphone pack activation.
