**DATE:** 12-17-18

**APPLIES TO:** This service bulletin applies to certain 2002 through 2018 model year Emergency Response Gladiator model chassis cabs equipped with a large bore, heavy duty engine built between November 12 2002 and December 18, 2017.

**CONDITION:** Potential for crack at the engine cutout areas of the frame rail flanges.

**CORRECTION:** Weld repair and frame rail reinforcement.

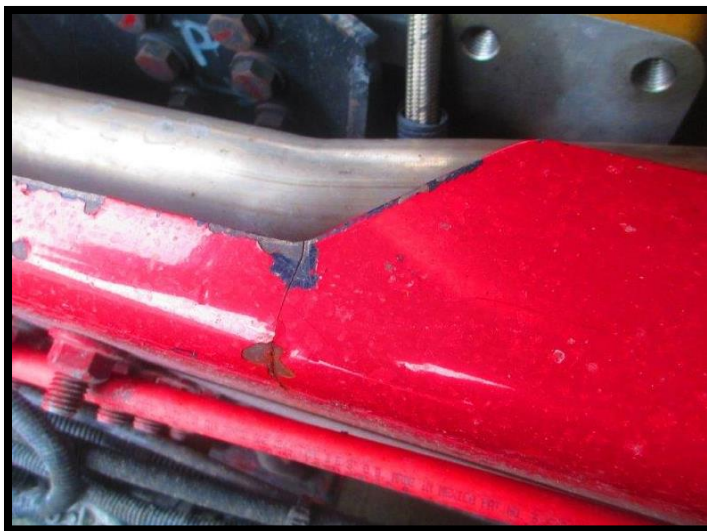
1. Tilt cab to inspect frame rail flanges for cracks. Refer to FIG. 2-1 for one example of an engine-cutout crack. Refer to FIG. 2-2 which illustrates typical engine-cutout inspection locations.
