## ARTICLES CONTAINED IN THIS ISSUE

CODE	ARTICLE	PAGE
(00)	STIS New Releases	7-9
(01)	QMR of the Month	1-2
(01)	QMR of the Month Award Presentations	2
<b>Tech Tips Greatest Tips</b>		
(02)	Fluid Leak Detection Made Easier	3-4
(05)	New Model Alignment Specifications	4
(07)	2019MY Forester, Driver Monitoring System (DMS) Inoperative	4-5
(07)	2019MY Forester, Loose Negative Battery Cable / Terminal Connections	6
(12)	Water Draining from Body Panels	6
(15)	Air Conditioning Leak Diagnosis Revisited	7

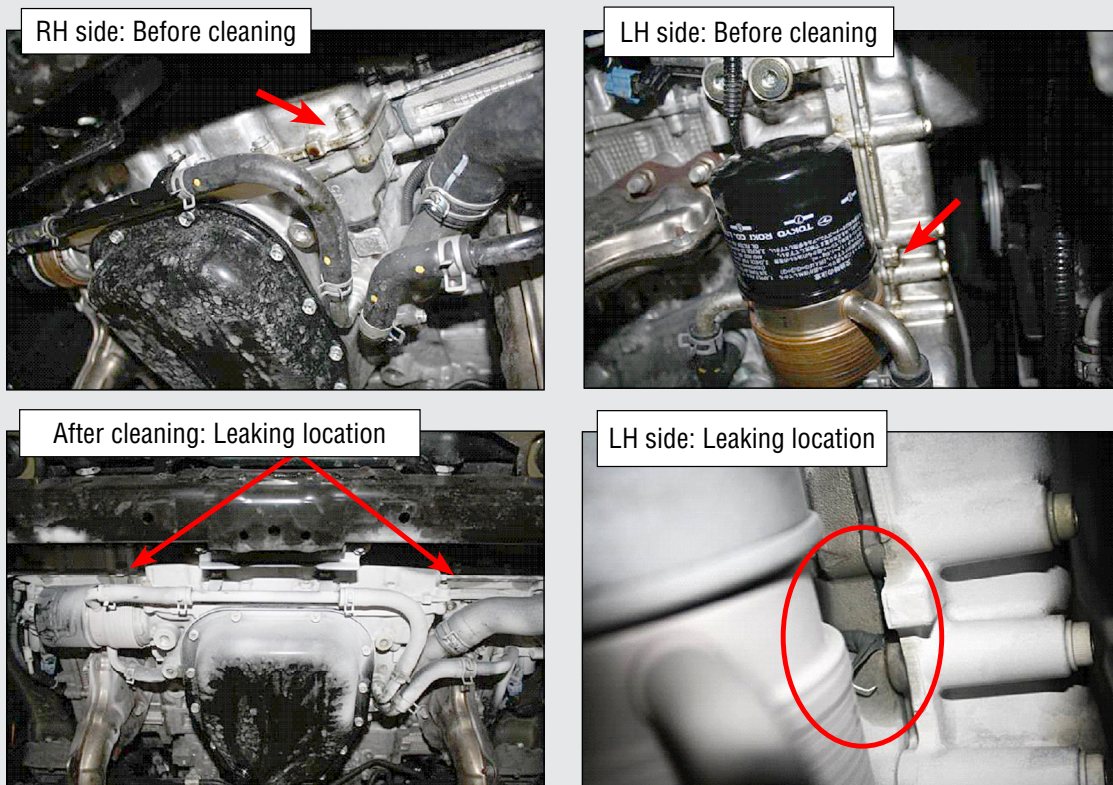
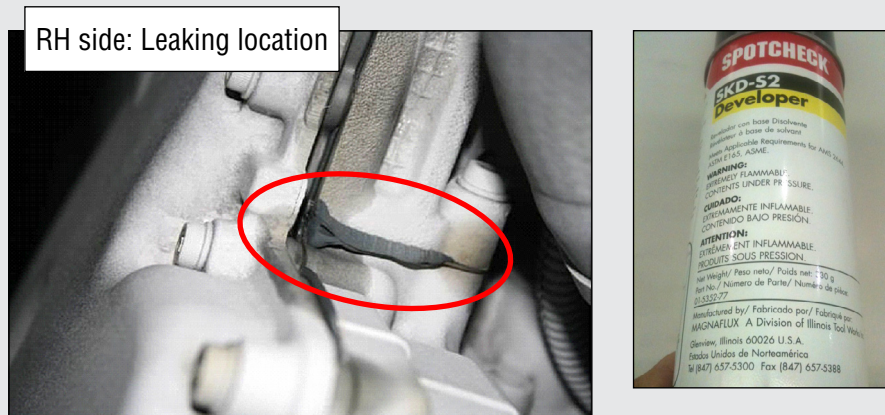
Identifying the true origin of fluid leaks/seepage can be a time consuming and frustrating process. Misdiagnosis can, and often does, result in a costly shop comeback which can erode your profit margins along with your dealership's customer satisfaction index. You can help to minimize these costly shop comebacks by using Magnaflux SKD-S2 developer. Simply clean the suspect area, apply the developer and watch the results. The SKD-S2 quickly and accurately finds the source of the leak so you can "fix it right the first time". This tool can be used to help illustrate to your customers the true nature of what is happening with their vehicle. Being able to demonstrate the source of the leak will build the confidence of both you and your customer that the repair will be effective. The pictures below show how the product works.

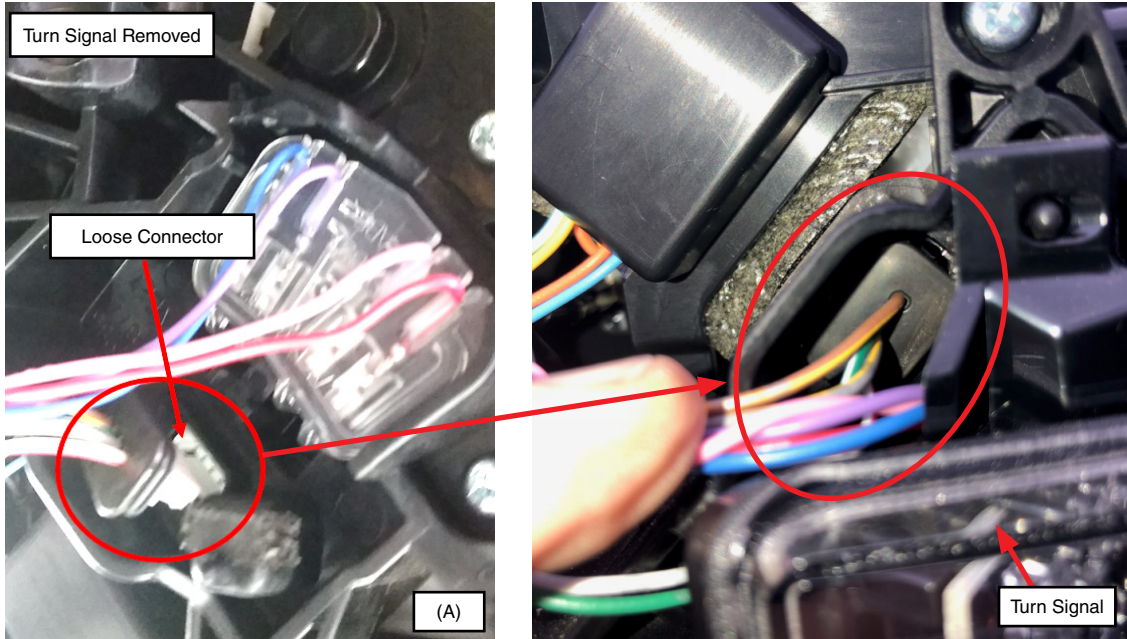
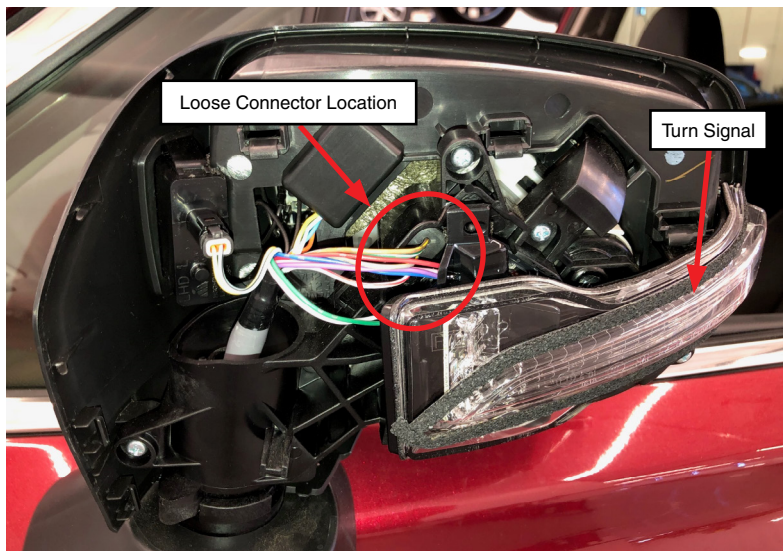
A small number of field reports have been received with a concern involving the DMS system being inoperative. One of these reports stated a DTC U0156 for Lost Communication was stored in multiple modules. In addition, the seat memory feature was also found to be inoperative. After performing extensive electrical diagnostics, the root cause was traced to a loose harness connector located behind the exterior trim cover of the driver's door mirror assembly. The upper and lower covers were **CAREFULLY** removed using a plastic trim tool. With the covers removed, access to this connector was made easier by removing the turn signal lamp from the mirror housing (A). After re-seating the connector and confirming it was fully locked in place, all systems returned to normal operation. The photos below show the loose connector and its location.

**TIP:** When **removing** the covers, remove the lower cover first, then the top. On **re-installation**, refit the top cover first then the bottom.

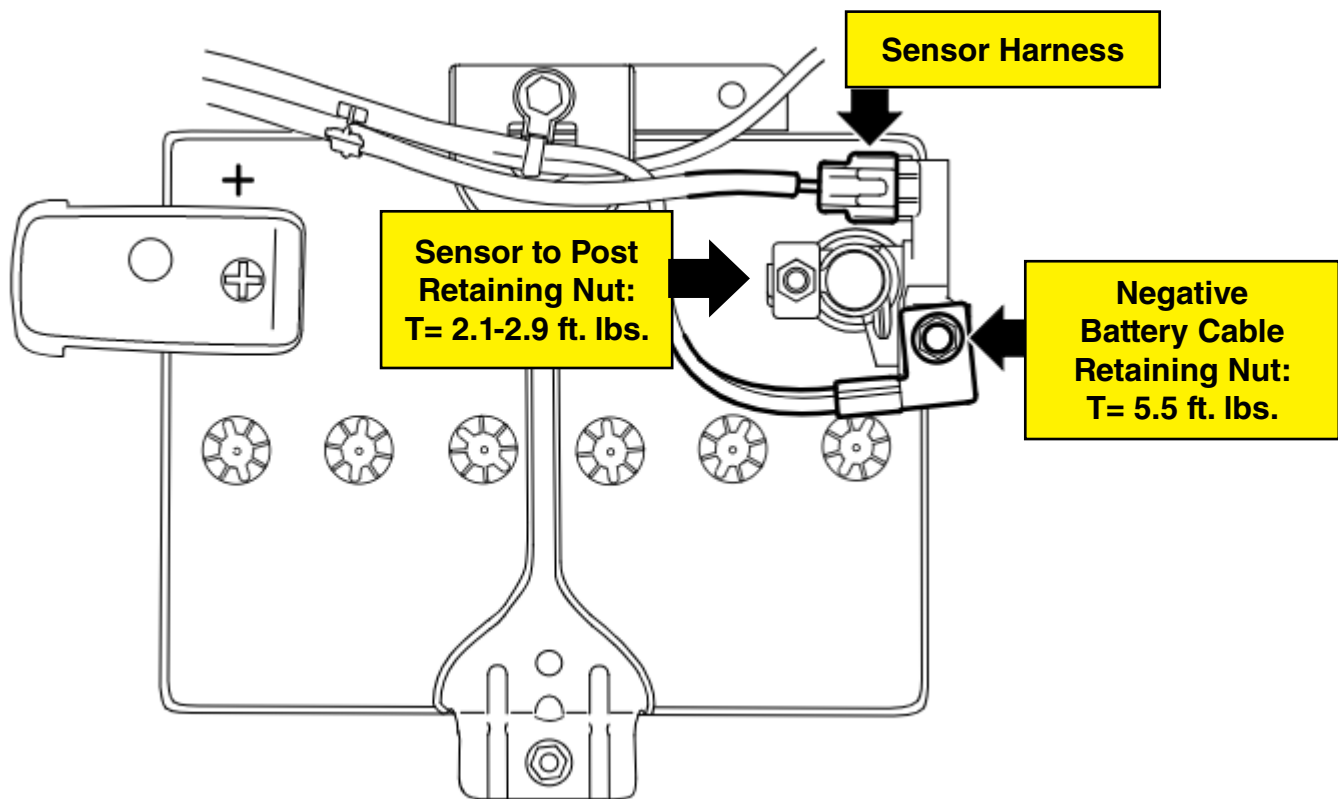
During review of reports received by the Quality Monitoring Team supporting the launch of the new 2019MY Forester, there have been several cases involving damaged or deformed battery sensors. These reports usually describe a loose negative battery terminal (battery sensor) and / or cable connection. **As a reminder, unless the battery or the battery sensor is being replaced, the sensor should not be removed from the negative battery post.** When disconnecting the negative battery cable, it should be removed from the battery sensor NOT the sensor assembly from the battery post.

**VERY IMPORTANT:** When removing or installing the negative battery cable from or to the battery sensor, **always support it and hold it in place with one hand** while loosening or torquing either retaining nut. Doing so will prevent battery sensor damage / deformation from unnecessary movement.

**NOTE:** The torque specification for the battery sensor retaining nut (secures the sensor to the post) has been changed from 6 Nm (4.4 ft. lbs.) to **2.9 – 3.9 Nm (2.1 – 2.9 ft. lbs.)**. The torque specification for the negative battery cable retaining nut is unchanged: 7.5 Nm (5.5 ft. lbs.). Never over-torque either nut.
