## SERVICE BULLETIN

**APPLICABILITY:** 2019MY Ascent  
**SUBJECT:** Loose “A” Pillar Trim

**NUMBER:** 12-254-18  
**DATE:** 11/27/18

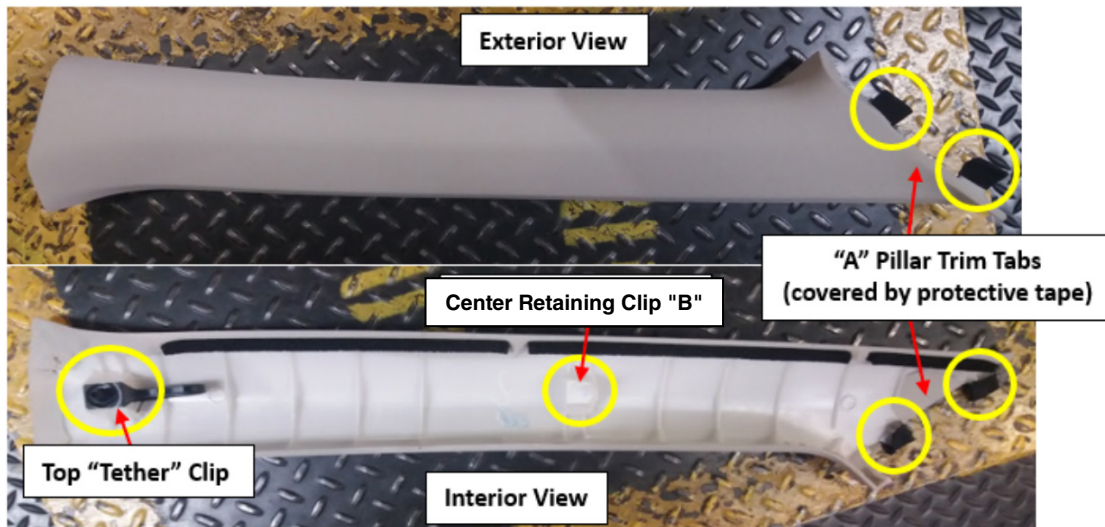
In addition to the two molded-in tabs which secure the base of the trim at the instrument panel (IP), 2 other clips are used; a tether clip at the top and a second trim clip in the middle. The clip part numbers are: **909150040** (“Tether” Clip) and **909150034** (center retaining clip “B”). Both these clips are **one-time use** items.

**IMPORTANT NOTE:** If an inspection of the “A” Pillar trim panel does not find any damage to the clip mounting locations, the trim panel itself may be reused. All clips **MUST** be replaced as they are one-time use.

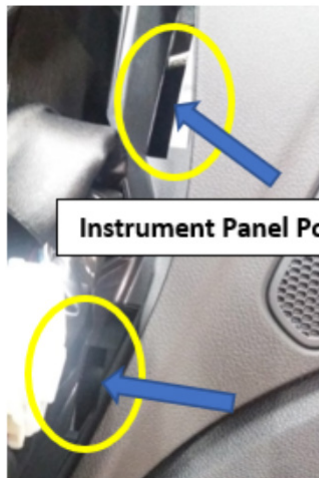
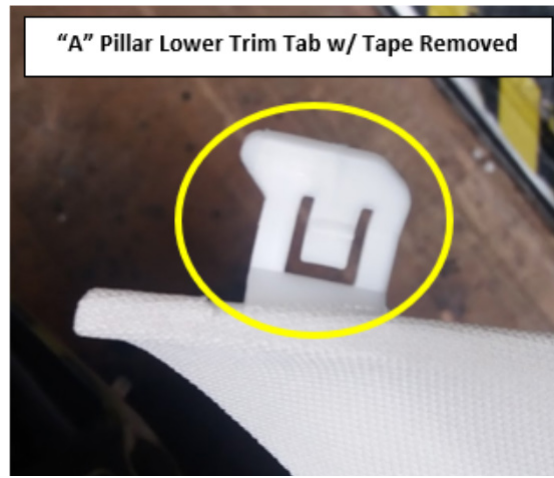
- Whenever a loose “A” Pillar trim is identified, both retaining clips **MUST** be replaced as they are one-time use. The black “tether” clip goes at the top of the trim panel, closest to the head liner. The trim panel’s 2 lower tabs fit into the 2 pockets as shown in the photo on the left.

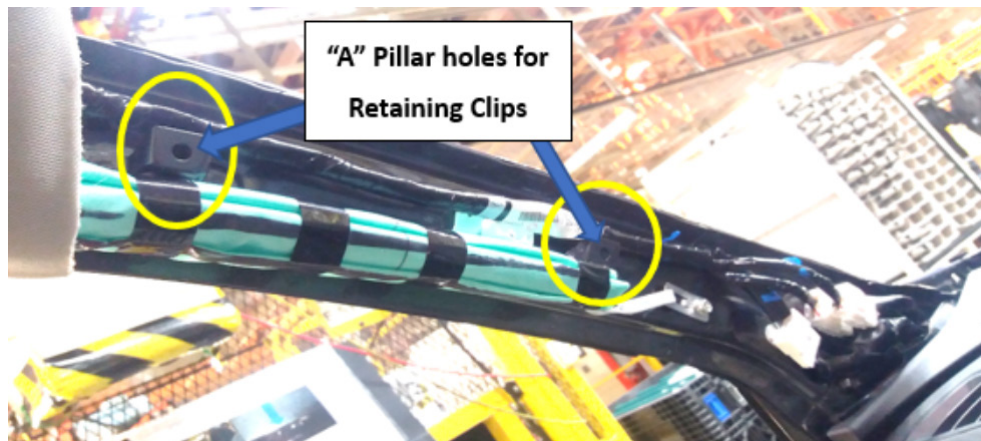
- This photo shows the 2 holes in the “A” Pillar the trim retaining clips fit into.

**CRITICAL:** After the 2 new retaining clips are installed onto the trim panel and before installation, confirm all side curtain airbag material is clear of the area around the “A” Pillar center hole where **Clip “B”** fits into.
