"No Overtaking" Displayed in Combination Meter RSA Menu

Service Category Vehicle Interior

Section Meter/Gauge/Display

YEAR(S)	MODEL(S)	ADDITIONAL INFORMATION
2019	ES350

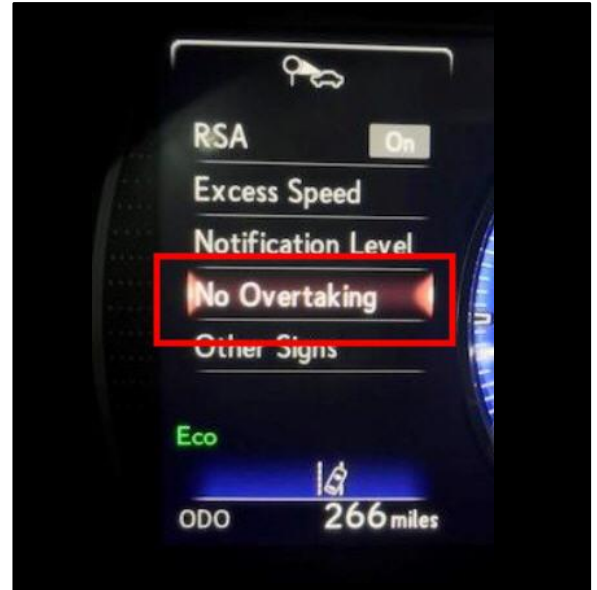
Figure 1.

Is "No Overtaking" displayed in the RSA menu on the combination meter multi-information display screen?

- **YES** — Go to step 2.
 - **NO** — This bulletin does NOT apply. Continue diagnosis using the applicable Repair Manual.

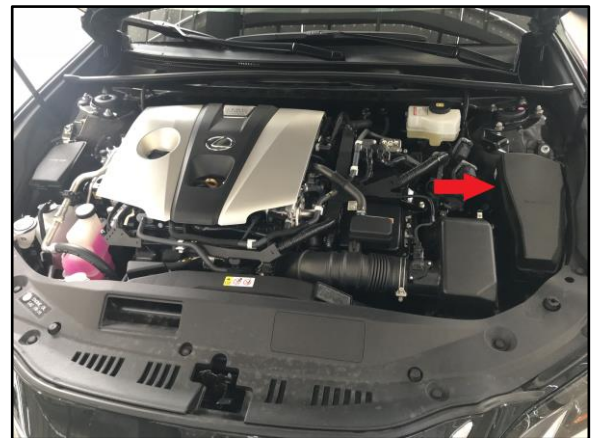
Figure 2. Engine Room Relay Block Location

3. Remove the cover from the engine room relay block.

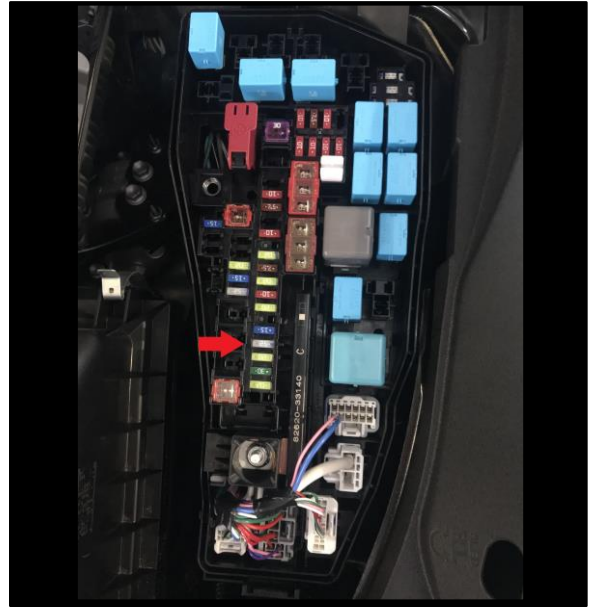
Figure 3. D/C Cut Fuse Location

4. Remove the D/C cut fuse (25A).
5. Wait 5 minutes.
6. Reinstall the D/C cut fuse (25A).
