SUBJECT: **SPECIAL POLICY ADJUSTMENT FOR 1988 – EARLY 1990 TRUCK &
4RUNNER WITH 3VZ-E V6 ENGINES
AND
SPECIAL SERVICE CAMPAIGN (V06) FOR 1990 – EARLY 1995 TRUCK,
4RUNNER & T100 WITH 3VZ-E V6 ENGINES**

3VZ-E Head Gasket Special Policy Adjustment

3VZ-E Head Gasket Special Service Campaign (V06)

3VZ-E Cylinder Head/Block Inspection

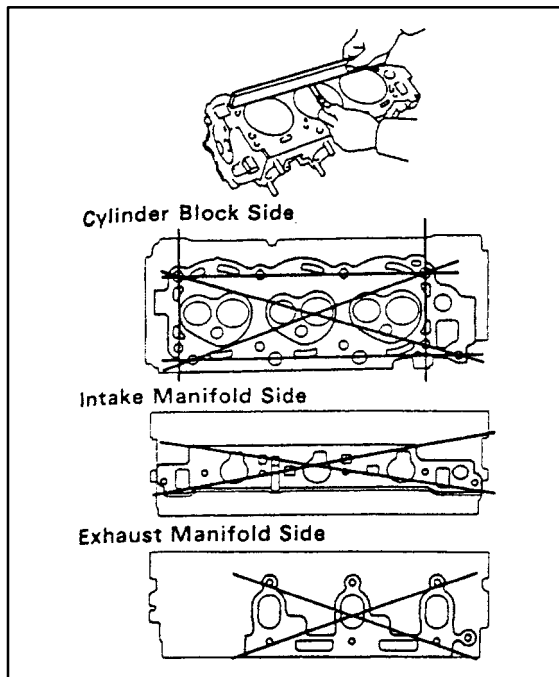
2. INSPECT CYLINDER HEAD FOR FLATNESS.

- (a). Using a precision straight edge and feeler gauge, measure the surfaces contacting the cylinder block and the manifolds for warpage.

CYLINDER HEAD MEASUREMENT		
Less than 0.10 mm (0.0039 in)	More than 0.10 mm (0.0039 in) but less than 0.25 mm (0.010 in)	More than 0.25 mm (0.010 in)
Cylinder head may be reused without machining	*Cylinder head may be machined to a maximum of 0.25 mm (0.010 in)	Cylinder head must be replaced

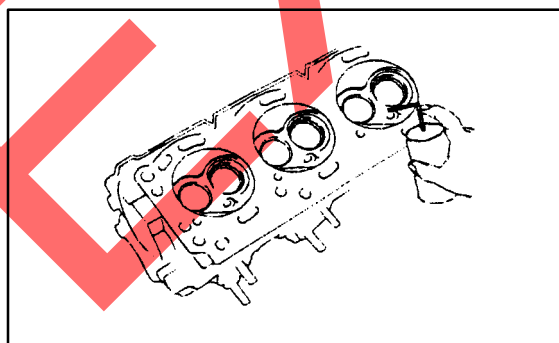
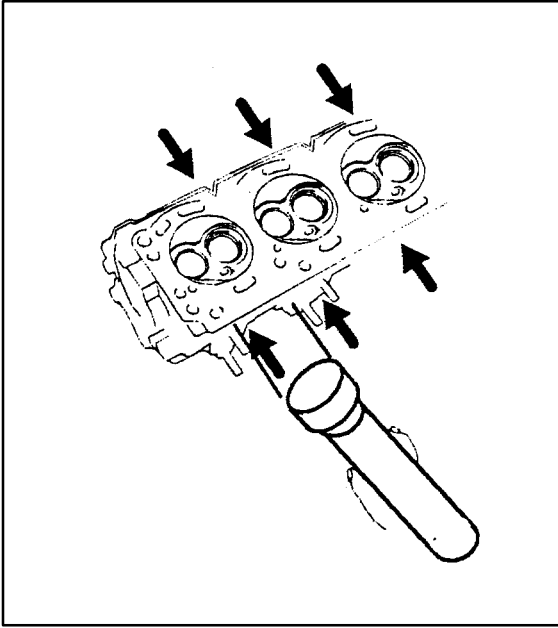
4. INSPECT VALVES AND VALVE SEATS.

- (a). With the cylinder head inverted and the spark plugs installed, fill the combustion chambers with solvent to determine if any of the valves or valve seats have been damaged by the entry of coolant into the cylinder.

- (b) Examine the intake and exhaust ports for signs of the solvent leaking past the valve seats, paying particular attention to cylinders number one and number six. If any solvent leakage is detected those valves must be removed for further inspection and repair as necessary.

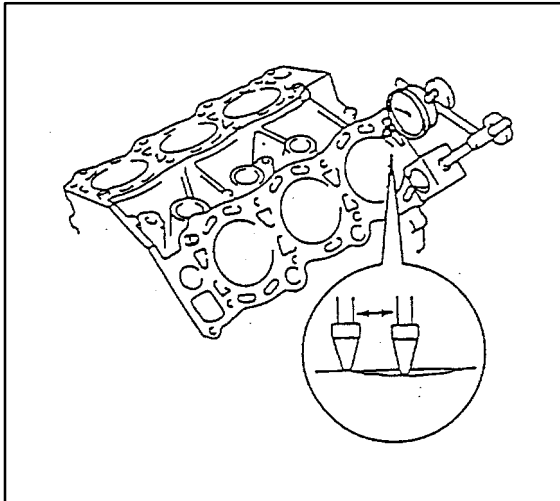
3. MEASURE TOP SURFACE OF CYLINDER BLOCK FOR EROSION.

BLOCK MEASUREMENT		
Less than 0.05 mm (0.002 in)	More than 0.05 mm (0.002 in) but less than 0.25 mm (0.010 in)	More than 0.25 mm (0.010 in)
Block may be reused without machining	*Block may be machined to a maximum of 0.25 mm (0.010 in)	Replace short block assembly

- (a). Using a dial indicator, measure the depth of erosion of the surfaces contacting the cylinder head gasket.

***NOTE: WHEN MACHINING CYLINDER HEAD AND BLOCK THE COMBINED AMOUNT OF MATERIAL REMOVED MUST NOT EXCEED 0.25 mm (0.010 in).**

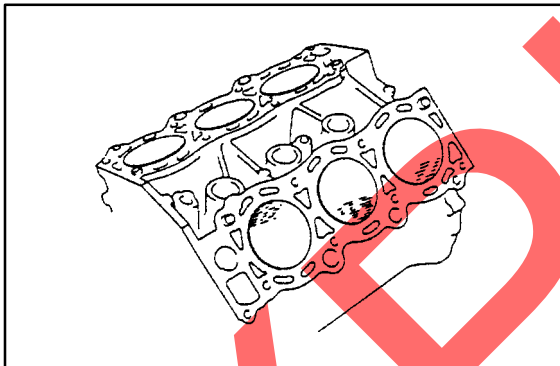
1. INSPECT CYLINDERS FOR VERTICAL SCRATCHES

- (a). Visually check the cylinders for vertical scratches. If deep scratches are present, replace the short block assembly.
