Subject		Market
<b>Air Conditioning System – Improved Component Inspection</b>		USA
Service Category	Section	
Vehicle Interior	Heating/Air Conditioning	
Applicability		
Lexus

In certain cases of leaking air conditioning systems, the root cause of the leak is inadvertently overlooked, causing a repeat repair. To improve customer satisfaction and repair A/C system leaks in one dealer visit, Toyota has developed a set of guidelines for evaluating A/C system components.

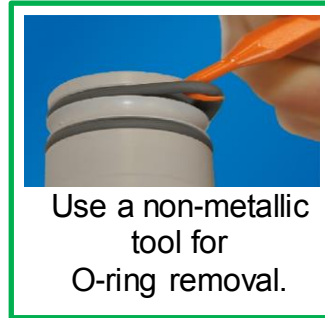
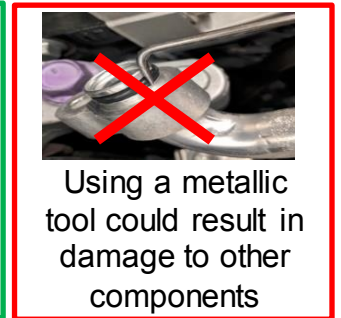
**OK Part\*** - Line at middle of O-ring is straight with no deformation. No tears, or crushed areas.  
\*O-rings should be replaced anytime they are removed from a pipe/component to prevent leaks and foreign material.

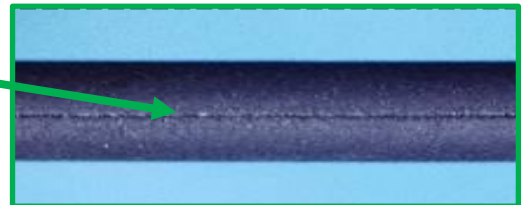
**Twisted O-Ring – No Good Part**  
Line at middle of O-ring is not straight.

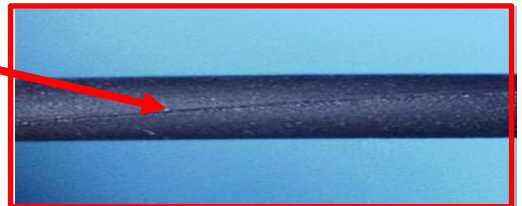
**Cut/Dent/Crush – No Good Part**  
O-ring damaged by another component. Replace O-ring, proceed with A/C Pipe Inspection.

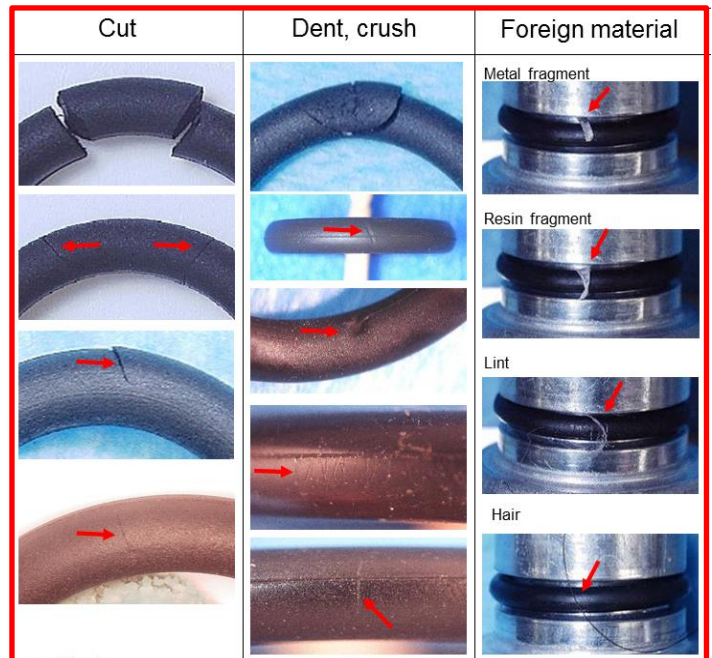
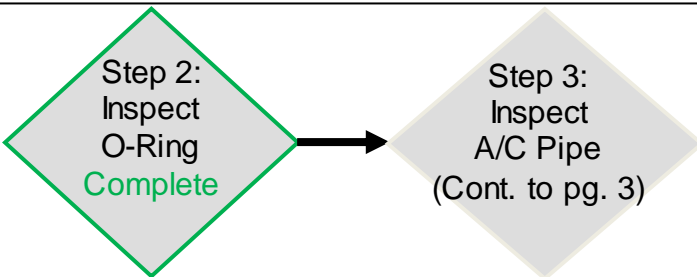
**Foreign Material– No Good Part**  
O-ring contaminated by material outside A/C system. Replace O-ring, proceed with A/C Pipe inspection.

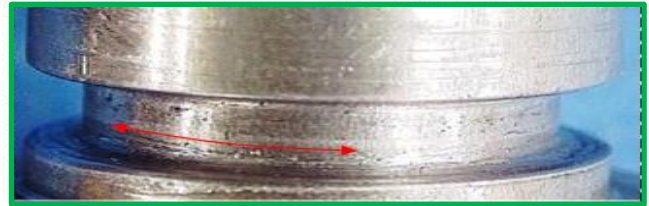
**OK Part** - Light scratching parallel with O-ring groove. This is caused by normal part processing. Pipe is ok to reuse.

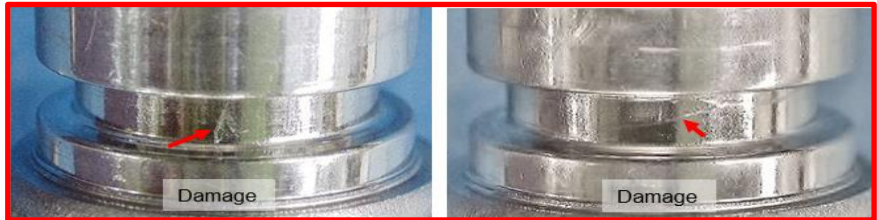
**Damage – No Good Part**  
Pipe is damaged due to deep scratching or gouge of base metal. Pipe replacement is recommended to prevent repeat repair.

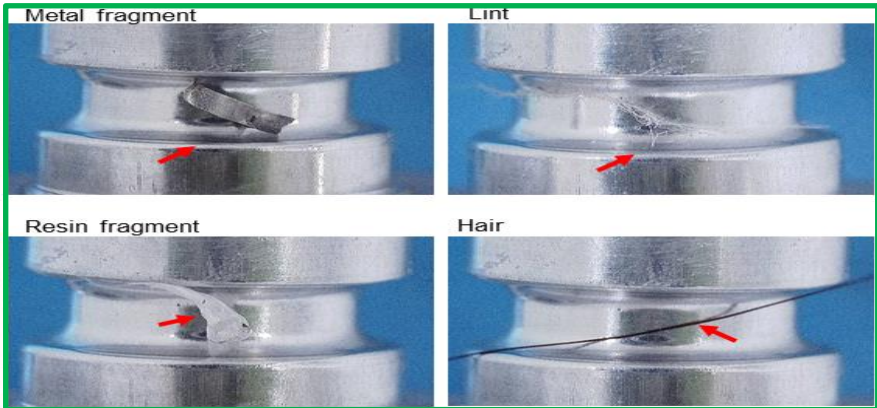
**Foreign Material – OK Part**  
Pipe has foreign material stuck to it. Material can be cleaned off using a non-metallic tool and the pipe is ok to be reused.

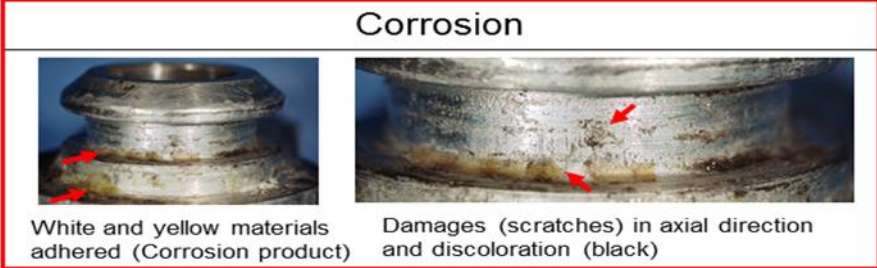
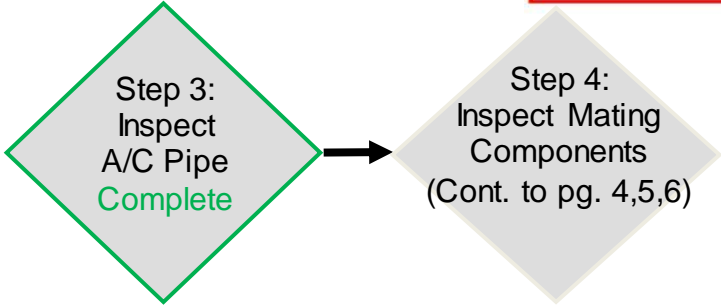
**Corrosion – No Good Part**  
Pipe is damaged due to corrosion of base material. Pipe replacement is recommended to prevent repeat repair.

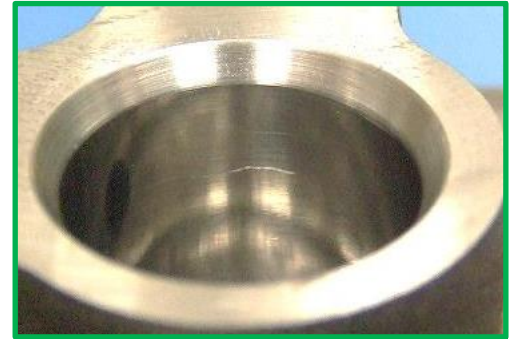
**OK Part** - Light scratching parallel with O-ring groove. This is caused by normal part processing. Compressor is ok to reuse.

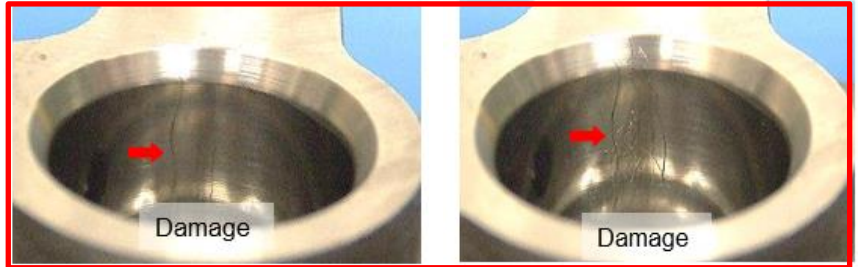
**Damage – No Good Part**  
Compressor seal bore is damaged due to deep scratching perpendicular to O-ring groove.

Compressor replacement is recommended to prevent repeat repair.

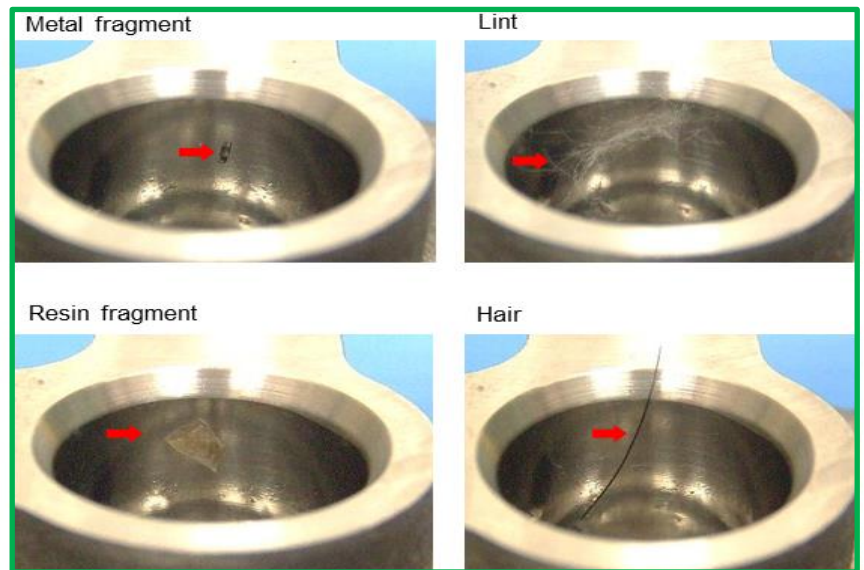
**Foreign Material – OK Part**  
Compressor has foreign material stuck to seal bore.

Material can be **carefully** cleaned off using a non-metallic tool and the compressor is ok to be reused.

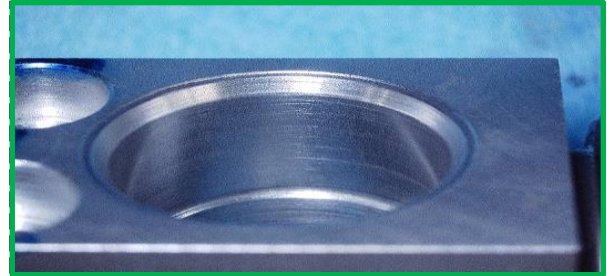
**OK Part** - Light scratching parallel with O-ring groove. This is caused by normal part processing. Expansion valve is ok to reuse.

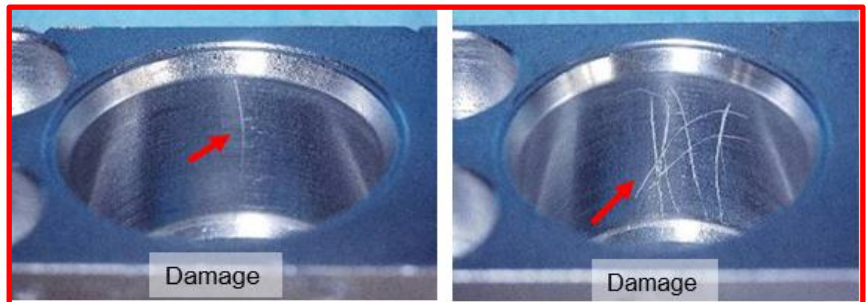
**Damage – No Good Part**  
Expansion valve seal bore is damaged due to deep scratching perpendicular to O-ring groove.

Expansion valve replacement is recommended to prevent repeat repair.

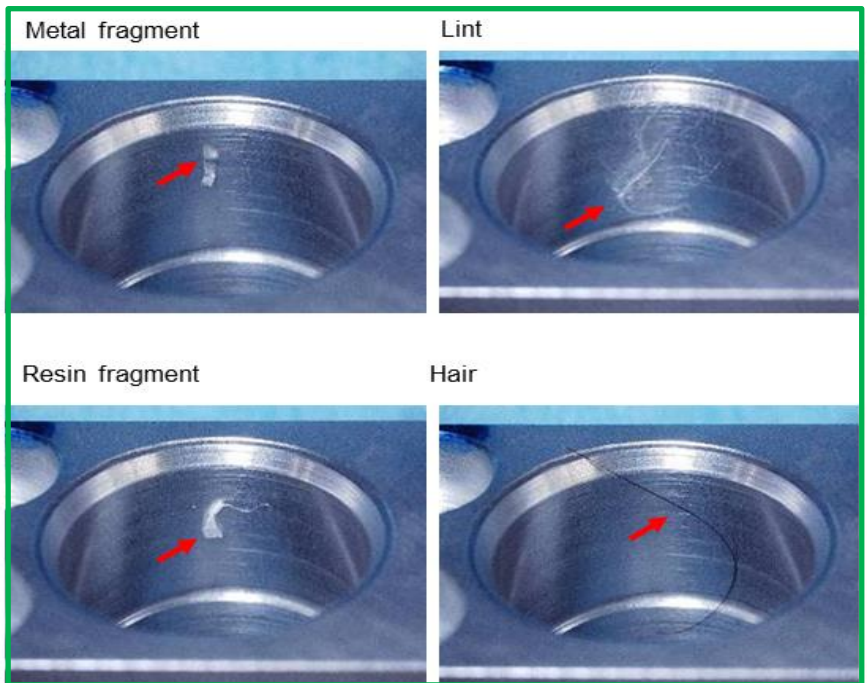
**Foreign Material – OK Part**  
Expansion Valve has foreign material stuck to seal bore.

Material can be **carefully** cleaned off using a non-metallic tool and the expansion valve is ok to be reused.

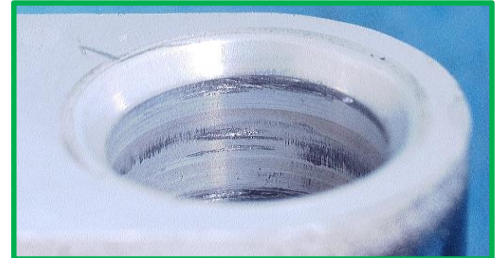
**OK Part** - Light scratching parallel with O-ring groove. This is caused by normal part processing. Condenser is ok to reuse.

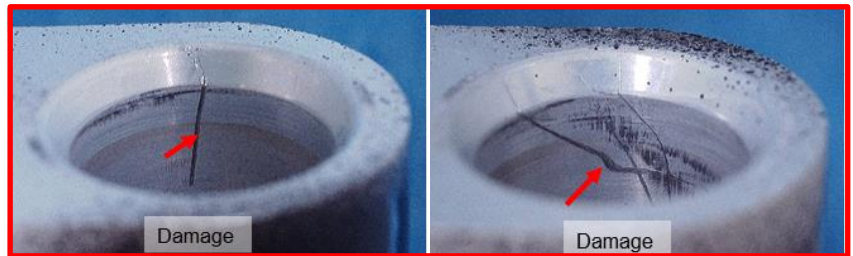
**Damage – No Good Part**  
Condenser seal bore is damaged due to deep scratching perpendicular to O-ring groove.

Condenser replacement is recommended to prevent repeat repair.

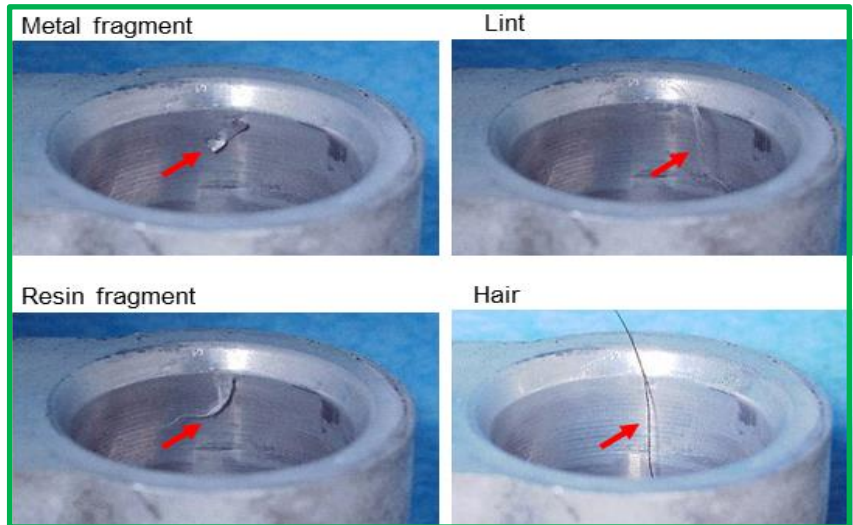
**Foreign Material – OK Part**  
Condenser has foreign material stuck to seal bore.

Material can be **carefully** cleaned off using a non-metallic tool and the condenser is ok to be reused.

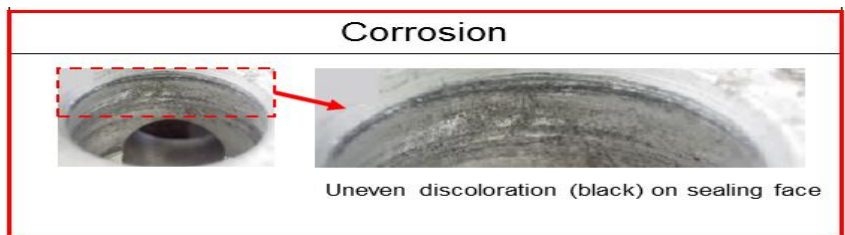
**Corrosion – No Good Part**  
Seal bore is damaged due to corrosion of base material.

Condenser replacement is recommended to prevent repeat repair.
