Subject Missing 35 MPa O-ringMPa O-ring		Market USA
Service Category Engine/Hybrid System	Section Fuel System	
Applicability 2016-2020 Toyota Mirai

APPLICABLE VEHICLES	
2016-2020	Mirai

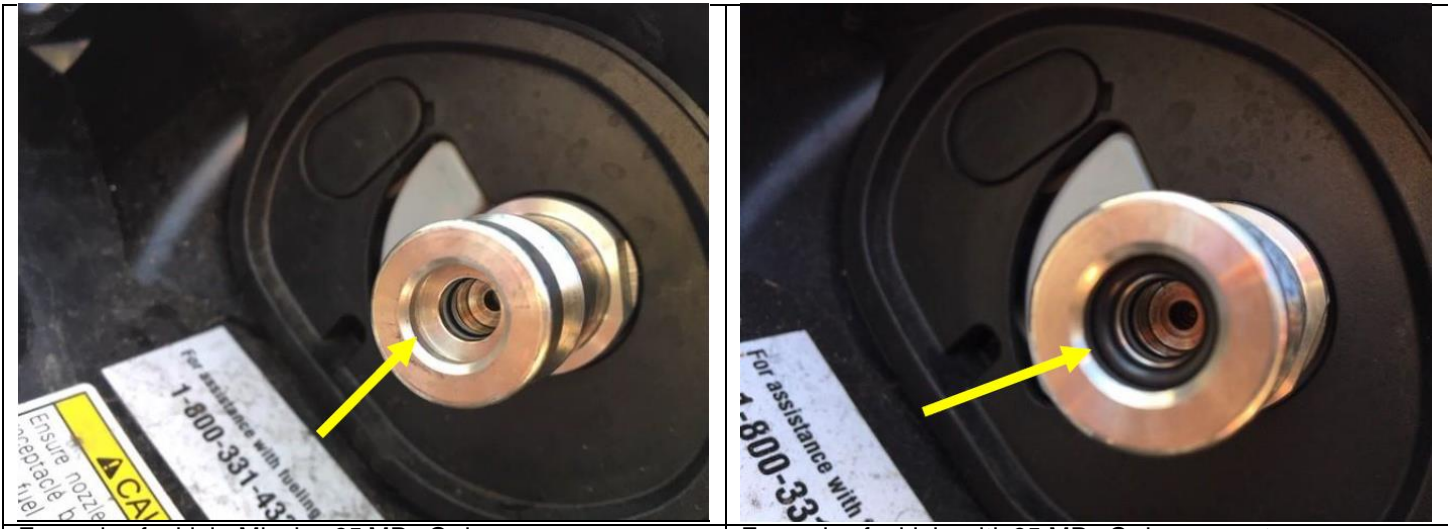
CONDITION
Some 2016-2020 model year Mirai vehicles might encounter fueling issues which may result in the loss of the 35 MPa O-ring.

Example of vehicle Missing 35 MPa O-ring

Example of vehicle with 35 MPa O-ring present

RECOMMENDATIONS
During any service of the Mirai, please inspect the fueling receptacle for the presence of the 35 MPa O-ring. The following photos have been provided to assist in identification.

If the vehicle matches the condition, create a TAS case and contact TAS and provide details prior to the repair. If it's a Sunday or holiday, continue with diagnosis and repair, save all parts and details, contact TAS on the next available work day and review details with TAS engineer.
