# Technical Service Bulletin

**CUSHION TAPE AT FRONT END OF DASHBOARD COMING OFF**

**Bulletin No.:** 09-043/18

**Last Issued:** 12/06/2018

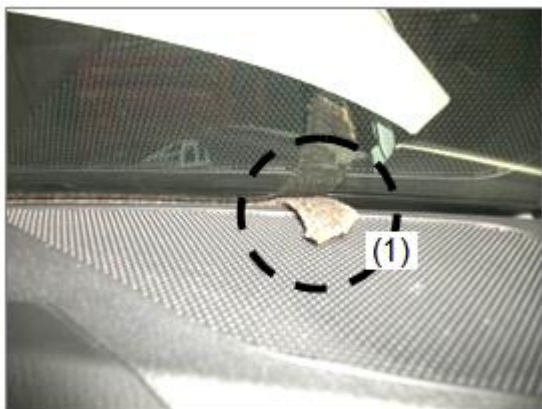
CX-5 (R.H.D.)

Some vehicles may exhibit the cushion tape (1) attached to the front end of dashboard coming off and showing at the base of the windshield.

This is caused by the cushion tape peeling off from the end(s) due to interference with the windshield and vehicle vibration. To prevent the tape from peeling off, both ends of the cushion tape are now folded over to the back side of the dashboard or stapled depending on the model.

Customers having any of these concerns should have their vehicle repaired using the following repair procedure.
