# Technical Service Bulletin

Subject: FRONT SEAT CUSHION TRIM COMING OFF SEAT FRAME	Bulletin No.: 09-044/18		
	Last Issued: 12/18/2018

2014-2018 Mazda3 (Mexico built) with VINS starting with 3MZ

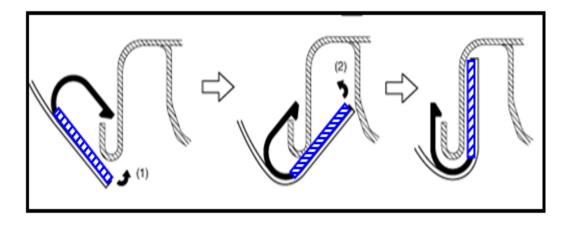
Cross section of the seat cushion frame

This is caused by the collars slipping out of the seat frame when an excessive force is applied to the seat cushion.

Hook		
	Front seat cushion frame		
	Front cushion trim		
77	Таре

2. Attach strips of double sided tape to the folding collars (hooks) to increase the grasping force by filling the gap.

**NOTE:** The double-sided tape is not intended to adhere to the seat cushion frame.

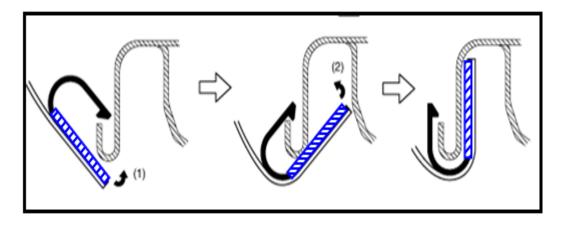
Cross section of the seat cushion frame

Hook		
Front seat cushion frame		
Front cushion trim		
Таре

d. Move the folding collars (hooks) in the order of arrows (1) and (2) shown in the figure and install the front seat cushion trim to the front seat cushion frame.
