Technical Service Bulletin

**POWER WINDOW DOES NOT WORK PROPERLY AND/OR
ABNORMAL NOISE WHEN OPERATING**

Bulletin No.: 09-045/18

2016-2019 MX-5 vehicles

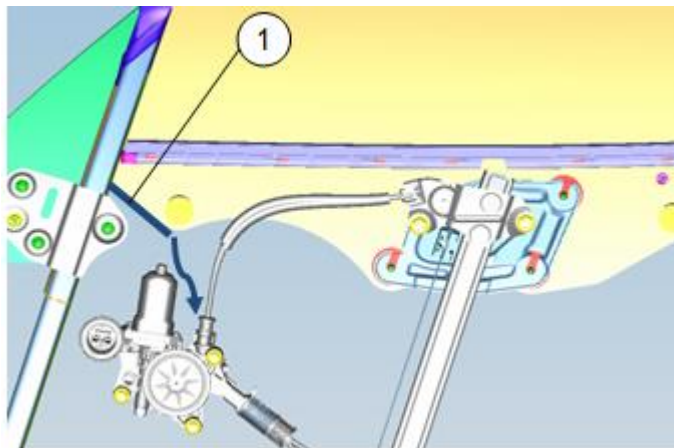
Some vehicles may exhibit the power window(s) not working properly (window does not move or has fallen into the door) and/or making an abnormal noise while operating the power window switch. This may be caused by the cable of the power window motor being damaged from water entry through area (1) of the front beltline molding.

To eliminate this concern, the shape of the door glass will be modified during mass production to prevent water entry to the power window regulator.

1. Verify the customer concern.
2. Replace the power window regulator with a new one and attach the rubber seal to the front glass to prevent water entry into the door.
