# Technical Service Bulletin

<b>Subject:</b> <b>SCBS / SBS, LAS / LDWS, MASTER AND/OR HBC WARNING LIGHTS ON WITH DTC U3000:98 STORED DURING HOT WEATHER</b>	<b>Bulletin No.:</b> 15-002/18
	<b>Last Issued:</b> 12/05/2018

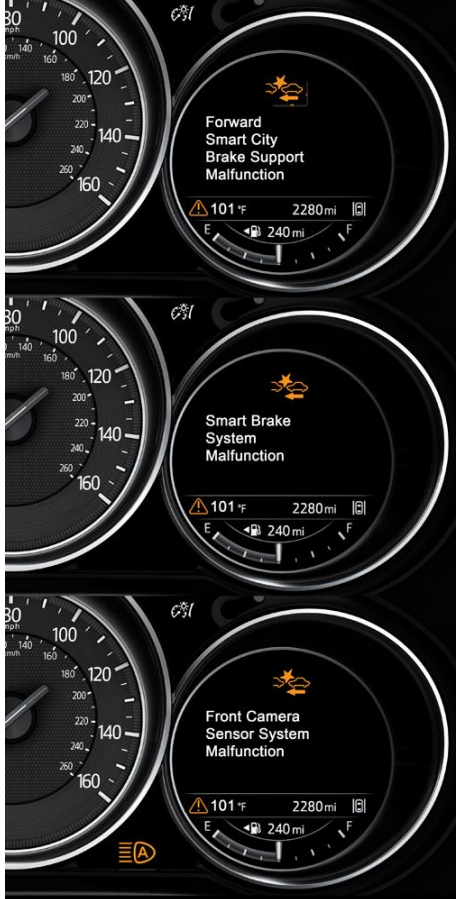
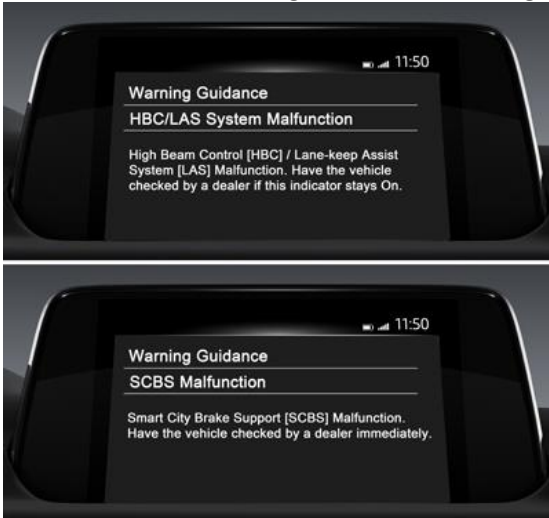
<p>Instrument Cluster Warning Lights (Without Multi-Information Display)</p>	<p>Instrument Cluster Warning Lights and Warning Messages (With Multi-Information Display)</p>	<p>MAZDA CONNECT Warning Messages</p>

**[Earlier production Mazda3, Mazda6, CX-3 and CX-5 until summer 2017]** The warning lights may stay on and these functions are deactivated until the ignition switch is turned off. Both U3000:98 (FSC) and U3000:04 (FSC) are stored.

This condition may be caused by FSC control logic that is too sensitive. When the FSC detects DTC U3000:98 during high temperature, it stops the internal communication and stores DTC U3000:04. DTC U3000:04 will not clear and SCBS/SBS, LAS/LDWS, and/or HBC functions will not resume until the ignition switch has been turned OFF even if the temperature of the FSC cools.

The warning lights/messages will be displayed until the FSC cools and the ignition is turned OFF, then back ON.

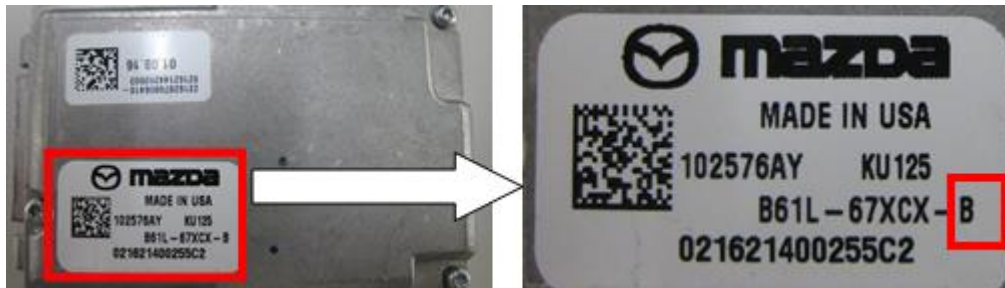
3. Remove the FSC according to the instructions on MGSS (FORWARD SENSING CAMERA (FSC) REMOVAL/INSTALLATION) and check the part number suffix on the label (sample shows suffix "B").

- If the part number suffix is "T" or later, this is the modified part that should NOT be replaced. Go to step 6.
- If the part number suffix is "S" or before, go to next step.

4. Replace the FSC with a modified one according to the instructions on MGSS (FORWARD SENSING CAMERA (FSC) REMOVAL/INSTALLATION).

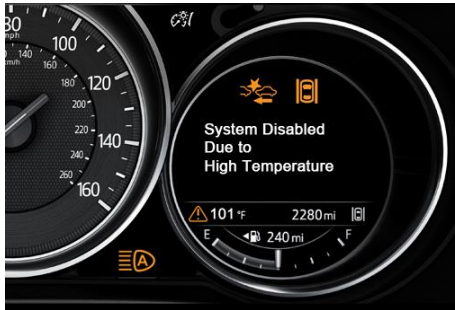
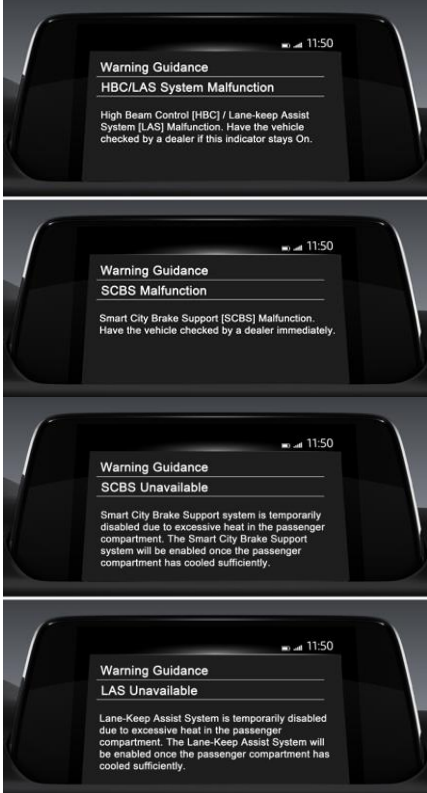
Instrument Cluster Warning Lights (Without MID)	Instrument Cluster Warning Lights and Warning Message (With Multi-Information Display (MID))	MAZDA CONNECT Warning Messages

**NOTE:** Even with the modified part, U3000:98 may still be stored depending on how hot the environment is. This is not a FSC failure, but rather a thermal protector function to avoid damage to the FSC hardware.

The warning lights/messages will be displayed until the FSC cools (No need to turn the ignition OFF).
