## Technical product information

<b>Topic</b>	Flying Spur: Rear Seat Entertainment fails
<b>Market area</b>	Bentley: worldwide (2WBE),Hongkong-Macau (5HK)
<b>Brand</b>	Bentley
<b>Transaction No.</b>	2044490/2
<b>Level</b>	EH
<b>Status</b>	Approval
<b>Release date</b>

Flying Spur Rear Seat Entertainment fails

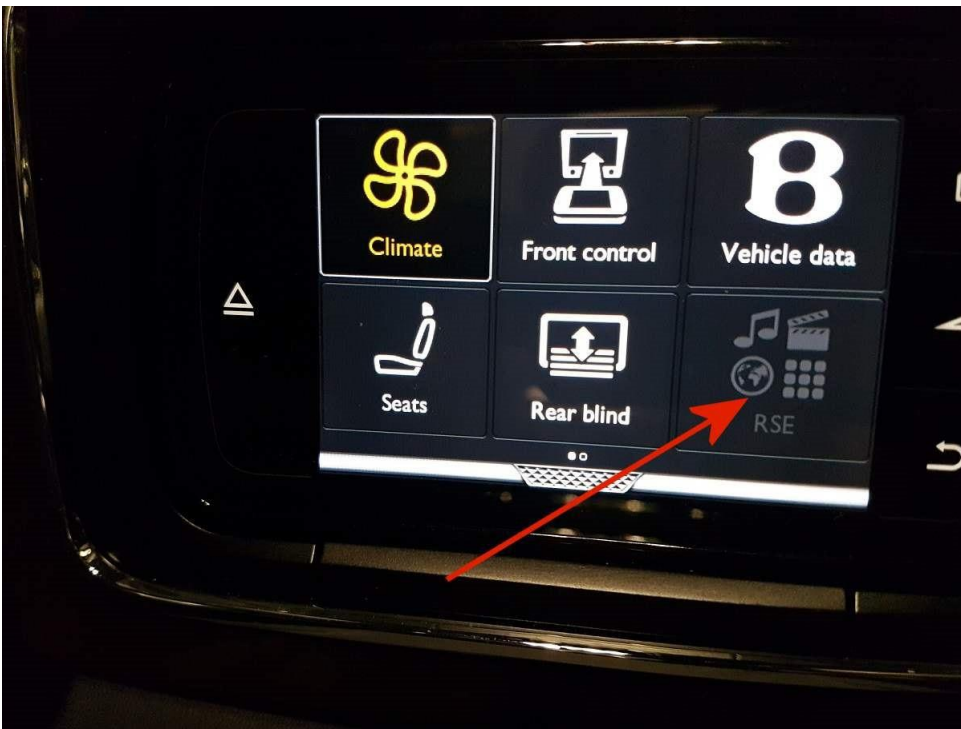
1. No system communication with RSE control module (RSE option cannot be selected)
2. RSE Control Module fails to connect to the TSR (RSE option cannot be selected)

3. Memory corruption of RSE Control Module which leads to a full failure (in many cases the system can try rebooting with the ignition off causing a battery drain)

If any of the failure modes occur, carry out a Hard System Reset;

Remove fuse for **7F - information control unit 2 (J829)** and fuses for both **media player control units (R118 and R119)**

Refit all fuses then carry out an ignition cycle

After applying the Hard System Reset, wait at least 5 minutes for the RSE system to fully initialize and switch on
