**Mack Models**

**Volvo Models**

| Title | Premium Tech Tool (PTT) - Message For Data Mismatch, Product Configuration Mismatch; Instruction To Run An Accessory Kit Displayed When Attempting To Run Diagnostics For Diagnostic Trouble Codes (DTC) Or Programming - <b>US10+OBD13 And Newer Emissions, Common Model Year 2014 And Newer</b> |

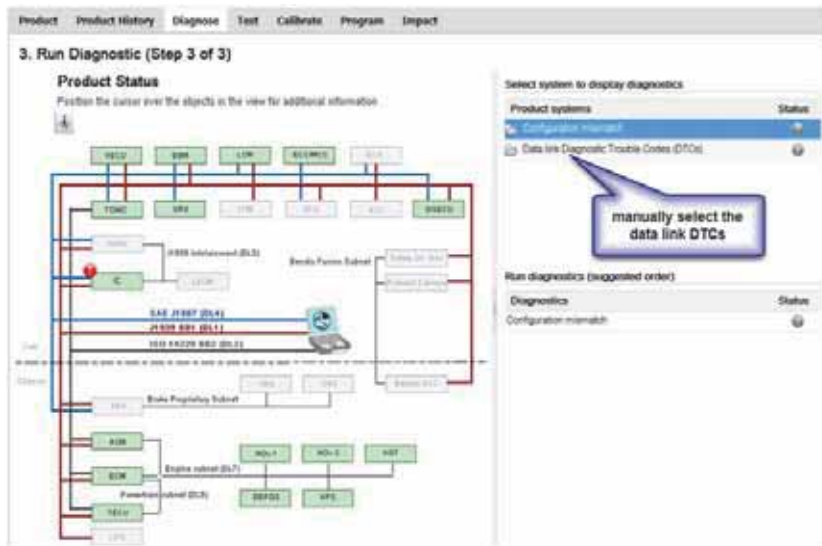
4.1. If both Configuration mismatch and Data link DTCs options are displayed, the Data link DTCs option should be selected **first**.

4.2. The active data link codes that were observed on the readout screen should be selected **first**.

4.3. The chassis should be re-identified to check that the problem is resolved following repair of the data link.
