SIL 694

Date: November 7, 2018

Units Affected: AT37, AT41, AT48 M/P/S units with GX or GY in the serial number  
(Example 0717GX0253 or 0717GY128. If GH or GV is in serial number,  
it is NOT affected by this SIL. See attached list)

## Articulating Arm Drain Holes

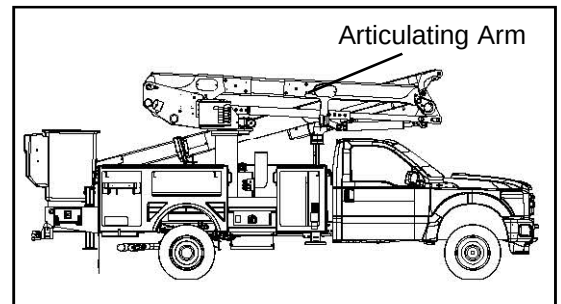
**Figure 1 — Articulating Arm**

Altec found that some drain holes in the articulating arm had been filled with sealant instead of being left open to the air.

1. Position the unit on a level surface, apply the parking brake and chock the wheels. The inspection can be done with the boom stowed in the boom rest.
2. Inspect the articulating arm (refer to Figure 1) for four drain holes on the bottom of the arm. Look to see if the holes are plugged with sealant. Remove any sealant or contaminants that seal the holes using a  $\frac{5}{16}$ " drill bit so all holes are open.
