# QUALITY ACTION

## CAMPAIGN BULLETIN

### Generator Harness Dealer Inventory

# PC673 – TITAN, TITAN XD GENERATOR (ENGINE NO. 2) HARNESS INSPECTION

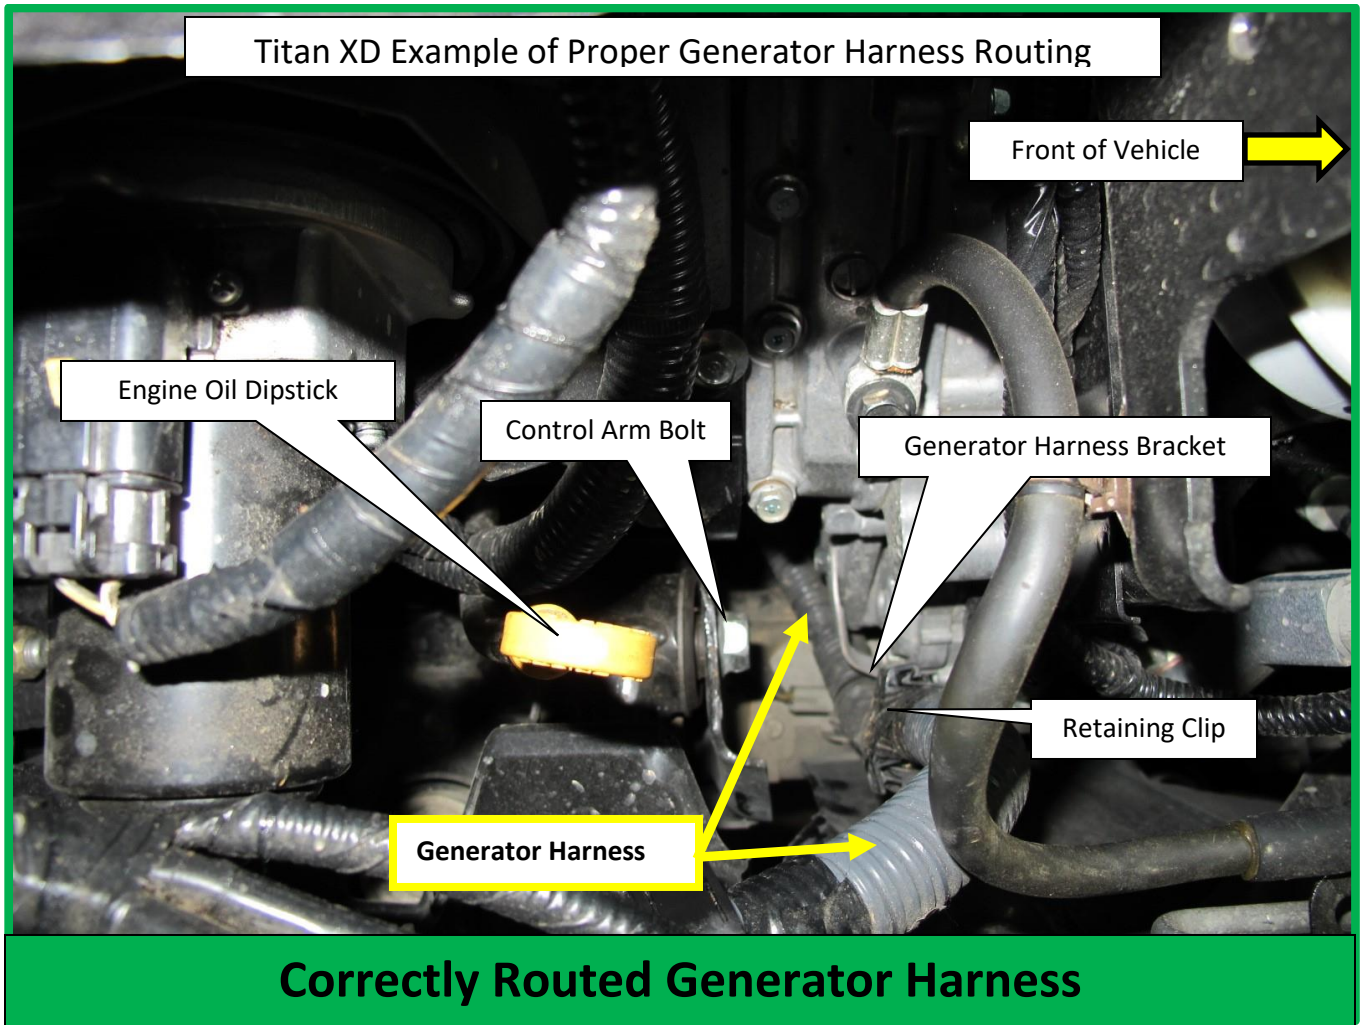
Figure 5

4. Locate the generator harness.

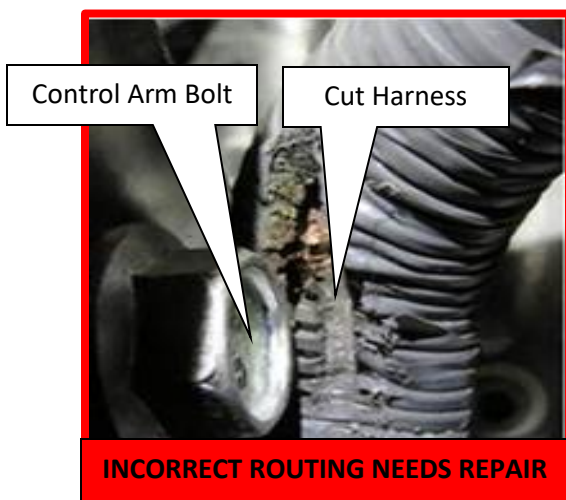
Figure 6

- a. Verify the harness is **NOT trapped, pinched or cut**.

- Routing **CORRECT**, close the hood, submit a warranty claim using OP Code PC6730 (See claims info), and release the vehicle. No further repair is needed.
- Routing **INCORRECT**, similar to Figure 6,7,8, or 9, take a clear picture and follow the instructions in Step 7.

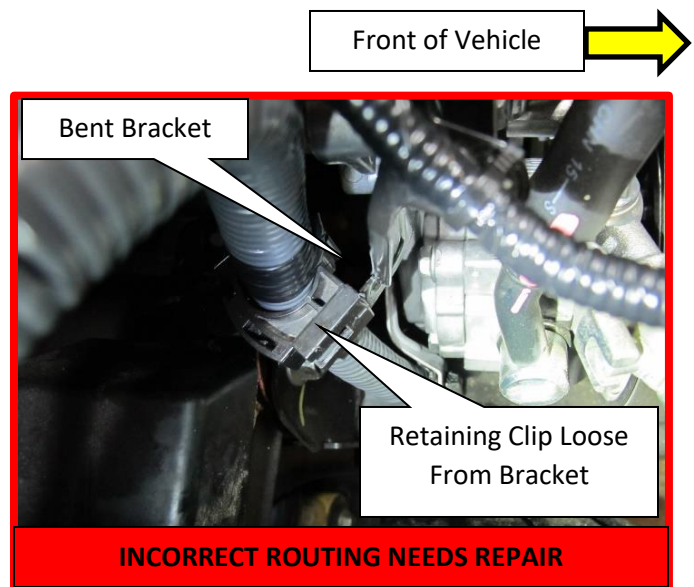
Figure 8

- b. Verify the generator harness bracket is **NOT bent** toward the control arm bolt and the retaining clip is **NOT loose** from the bracket.

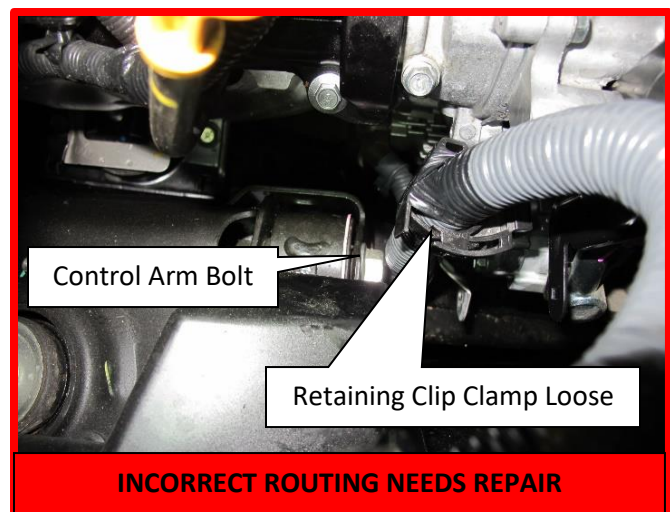
Figure 9

- c. Verify the generator harness is secured by the retaining clip and into the metal bracket.
