**Noise Symptom - Creaking Noise from Panoramic Roof When Driving (I-no. 3FU):
Reworking panoramic roof (SY 139/18)**

Vehicle Type: **Panamera (971)**

Model Year: **As of 2017 up to 2018**

Equipment: **Porsche large roof system (I-no. 3FU)**

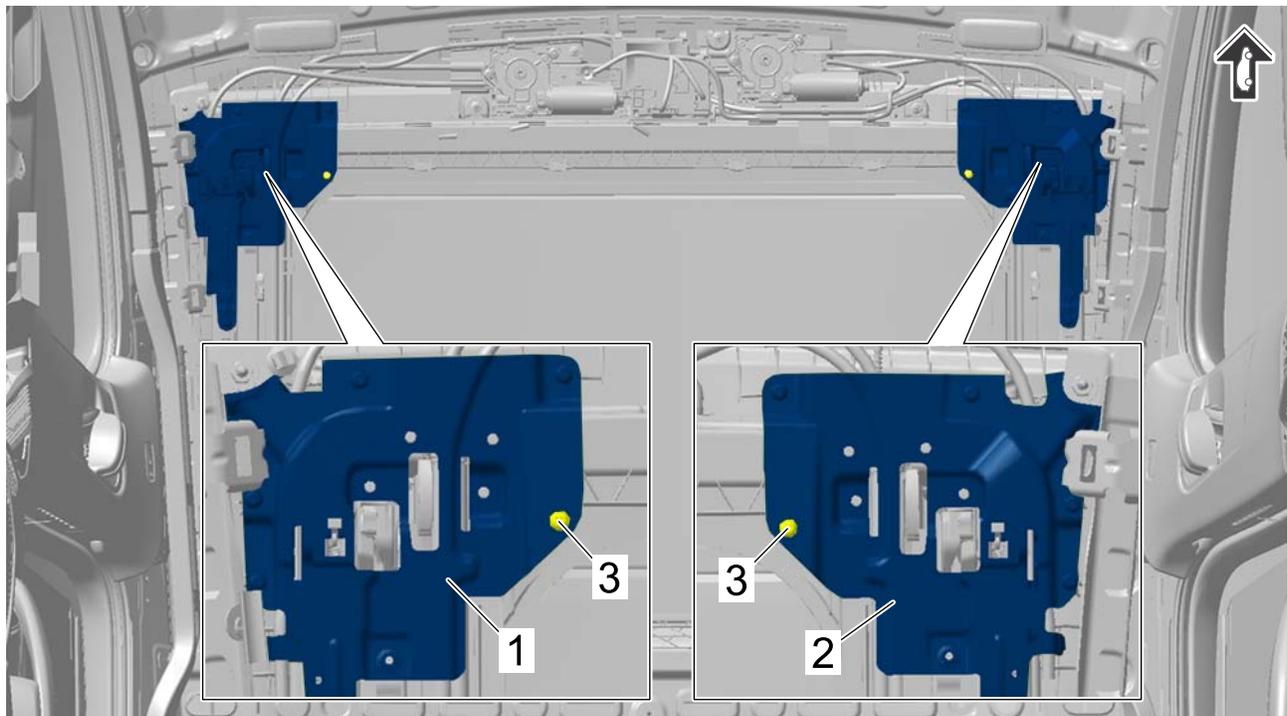
Overview: Front reinforcement plates

Cause: Certain threaded joints between the roof assembly and reinforcement plates can settle. This behavior can result in play between the components and can cause the creaking noise.

3.1 Spray Carbaflo into a suitable container and have a application brush ready.

3.2 Unscrew the relevant screw (⇒ *Overview: Front reinforcement plates -3-*).

3.3 Lift the relevant reinforcement plate slightly. Using the brush, apply a thin film of Carbaflo around the loosened threaded joint between the body and reinforcement plate.

3.4 Re-fit the loosened screw and tighten to **Tightening torque 2.5 Nm (1.75 ftlb.)
+/-0.3 Nm (+/-0.2 ftlb.)** .

Warning: Low torque value, care must be taken not to over torque fasteners and strip threads.

3.5 Remove excess Carbaflo around the threaded joint using a clean cloth.
