WJ89 - Changing Vehicle Order in the Instrument Cluster (Workshop Campaign)

Model Year: 2017

Model Line: Panamera (971)

Subject: Instrument cluster

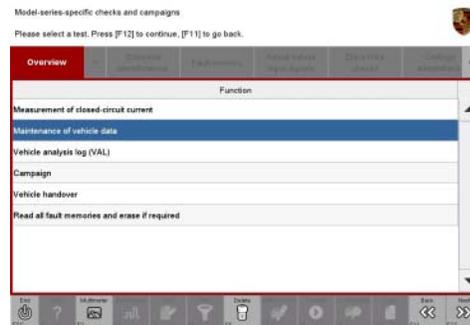
Coding value SP7

Information: **Due to a process error, the control number SP7 for the software variant of the PDK control unit was not stored in the vehicle order on the affected vehicles.**

When the PDK control unit is programmed again using the PIWIS Tester, the wrong software variant will be written into the control unit because the control number is not stored. When programming is complete, a red error message will be displayed in the instrument cluster due to the fact that the wrong PDK software is assigned and this will prevent the driver from engaging the required gear and driving the vehicle.

- 6 Add the coding value **'SP7 – REPAIR DATA RECORD FOR MAIN TRANSMISSION'** to the vehicle data. To do this, click on the tick in the "Installed" field for the relevant coding value to select the value.
Make sure that the 'Installed' column is **ticked** and that the pen symbol appears in the 'Changed' column ⇒ *Coding value SP7*.
