**Noise Symptom - Knocking Noises in the Air Conditioning System: Reworking air conditioning system (SY 170/18)**

Model Line: All **911 Carrera (991)** vehicles excluding GTx models.

Model Year: **As of 2017 up to 2019**

Subject: **Air conditioning**

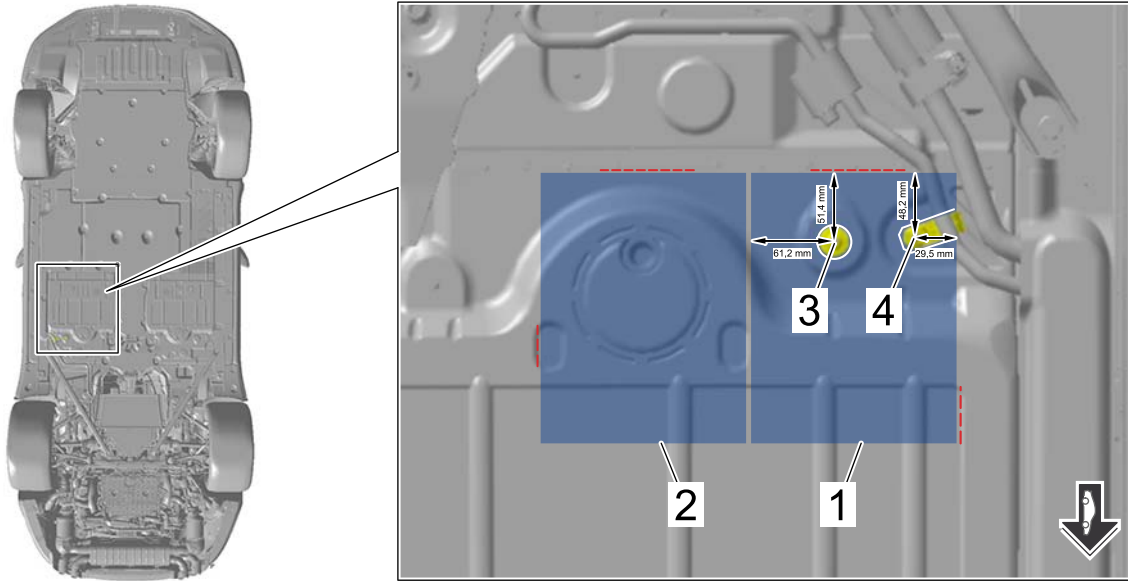
*Cutting and positioning damping mats*

Symptom: Complaint about "knocking noises" from the underbody area.

Cause: Vibrations from the air-conditioning compressor can be transmitted via the refrigerant lines and holders to the underbody.

2.1 Cut damping mat (⇒ *Cutting and positioning damping mats -1-*) as shown in the screw point (⇒ *Cutting and positioning damping mats -3-*) and refrigerant line holder (⇒ *Cutting and positioning damping mats -4-*) area leaving 5 mm all the way around (⇒ *Cutting and positioning damping mats -white markings-*).

2.2 Affix damping mats (⇒ *Cutting and positioning damping mats -1 and 2-*) flush on the seam seals (⇒ *Cutting and positioning damping mats -red markings-*).
