Oil Leakage from Cylinder Head of 3.0 and 2.9-Liter V6 Engines

Bulletin #: 1802

Part ID: 1570

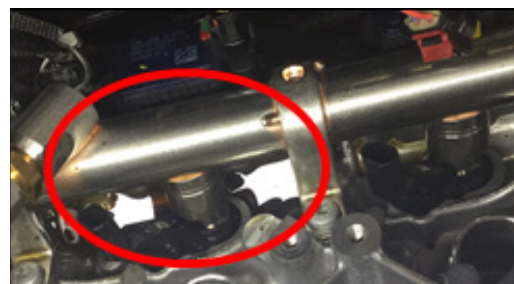
Figure 1 shows an oil leak in the region of the cylinder six-injector with the cylinder head cover removed.

If this condition is found, please submit a TLAR through the PTEC system.

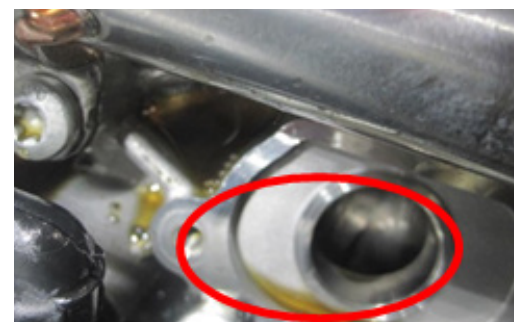
Figure 2 shows an oil leak in the machined feature of the cylinder cover where the camshaft adjuster(s) mounts.
