Technical Service Bulletin

40 Rumbling/creaking noises from front of vehicle while driving

40 18 90 2048266/6 December 13, 2018. Supersedes Technical Service Bulletin Group 40 number 18-86 dated October 4, 2018 for reasons listed below.

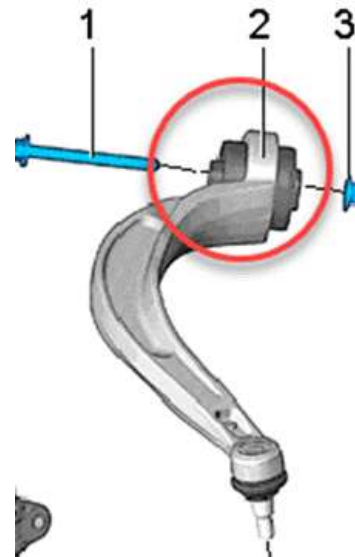
The noises can be generated on the lower left control arm in the area of the hydro-bushing.

Modified hydro-bushing in control arm link (Figure 1):

Figure 1. Hydro-bushing.

- A6/A7 – 12/11/2017, part number 4G0407183B
- A8 - 06/01/2016, part number 4H0407183C
- Q7 - 04/29/2016, part number 4M0407183B

Check the lower guide link of the front axle as it may be the source of the noises. If necessary, replace the hydro-bushing on the guide link.
