# Technical Service Bulletin

## 91 MIB2 High: Audi Smartphone Interface (ASI) does not work after reversing

91 18 22 2053226/1 December 10, 2018.

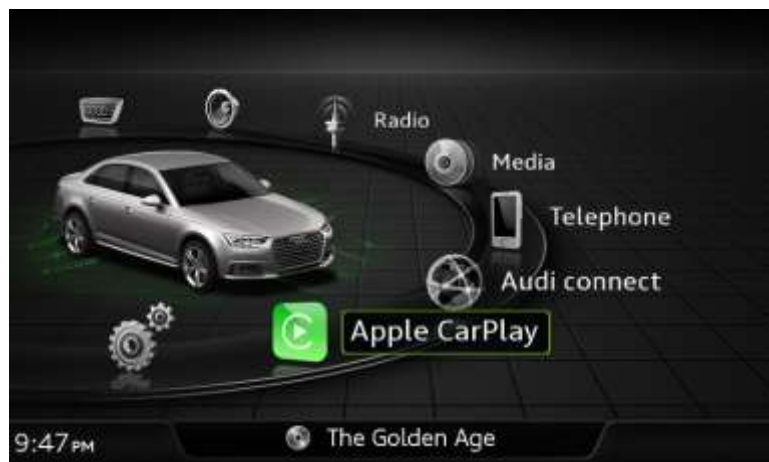
- After driving in reverse, the Audi Smartphone Interface (ASI) menu cannot be selected any more, although the music is still playing (Figure 1).

Figure 1. ASI menu cannot be selected anymore.

The software needs to be updated.

Update the MIB2 High infotainment system using either Method 1 or Method 2 according to TSB 2047576: *91 MIB2 High Software Update Instructions (PR Code 7UG)* and use SVM code indicated below:
