SERVICE BULLETIN

APPLICABILITY: 2019MY Ascent “Touring” Models

NUMBER: 12-255-18

SUBJECT: Rear Door Handle Frame- Design Change

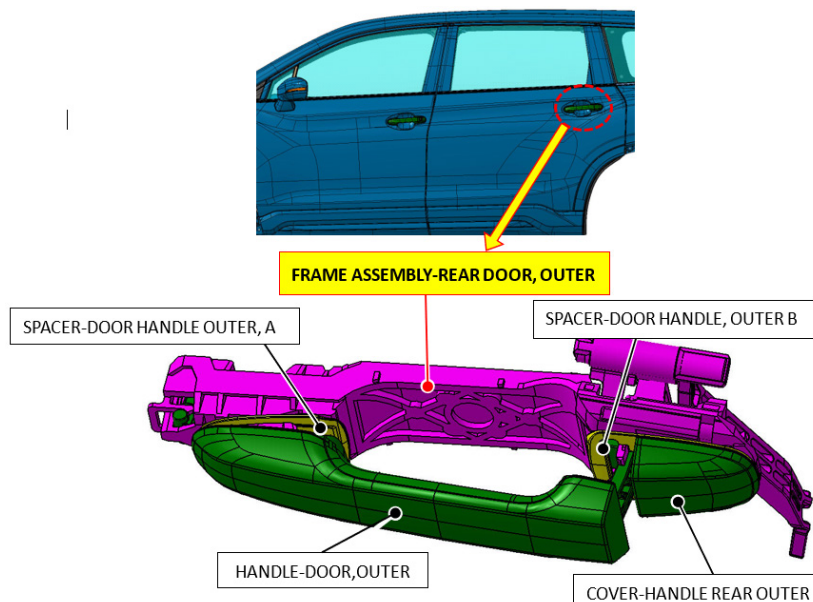
This bulletin outlines a design change made to the inner frame assembly used with the silver (“chrome”) type outer door handle to improve its reliability.

NOTE: The changes were made to the Frame Assembly, not the outer door handle. See illustration below.

- If the customer reports there are times when the rear door(s) is unlocked but cannot be opened from outside the vehicle, replace the corresponding Frame Assembly following the procedure in the applicable Service Manual. If the door will not open when presented, let it cool to room temperature or colder and try again to open it before attempting any internal dismantling.
